GEORGETOWN STEAM PLANT
HISTORIC STRUCTURE & CULTURAL LANDSCAPE REPORT

OCTOBER 9, 2013

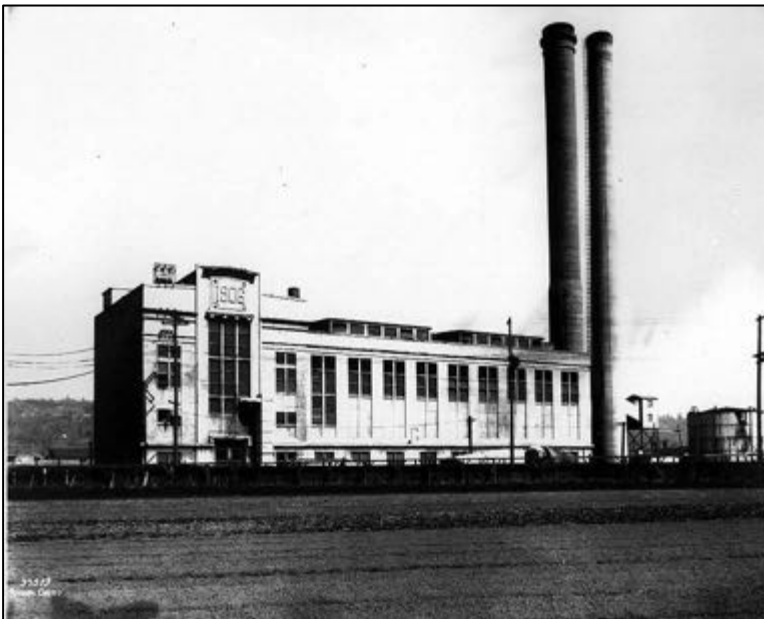
Figure 1: West façade, with two earlier masonry vent stacks, 1920. (University of Washington Libraries Special Collections, A. Curtis 39579)

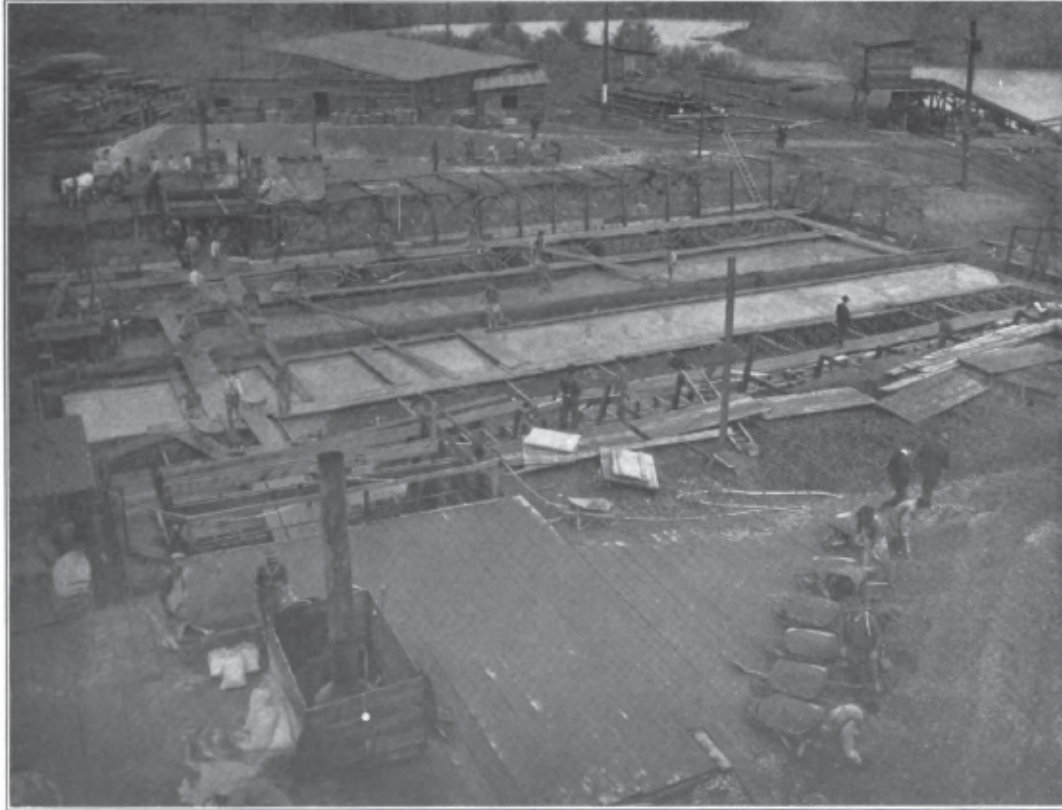
*Figures 3 and 4
May 18, 1906
May 30, 1906*

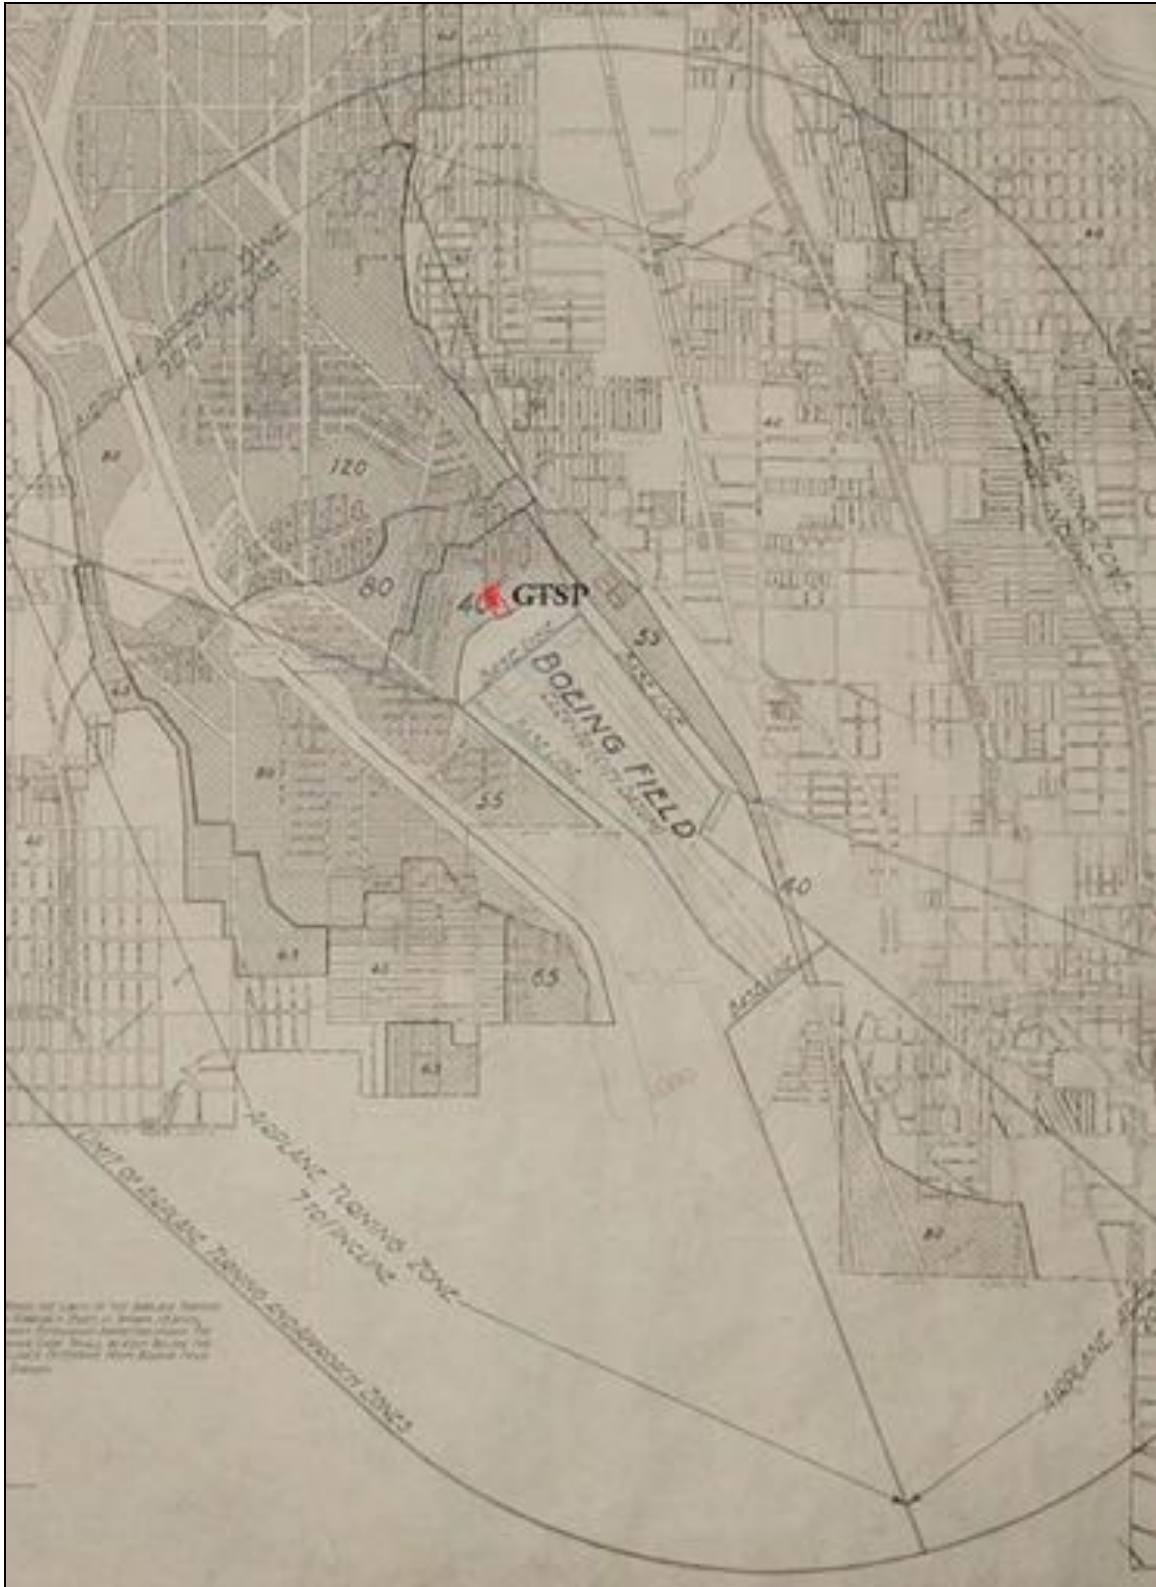
Figure 21: 1940 Boeing Aerial Map, portion of plan, indicating Airport Turning and Approach Area Height Map and legislated height districts. Even with the 225'-tall and 268'-tall chimney stacks removed in 1938 the Steam Plant is 80' in height in a 40' height zone. (Seattle Municipal Archives, item no. 1467)

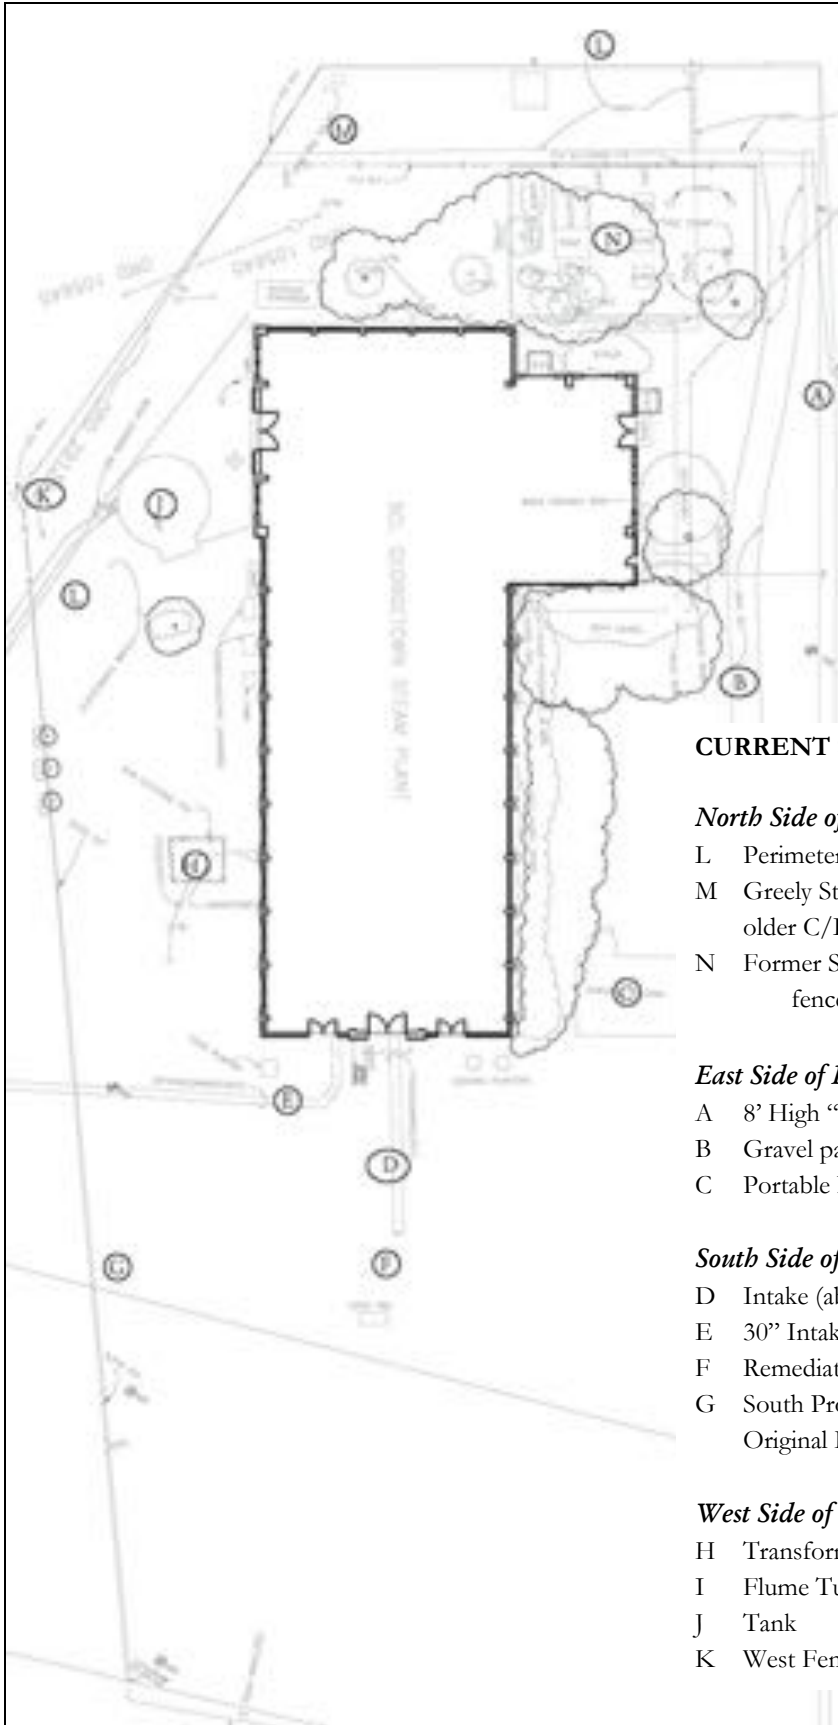
Figure 38: Current Site Conditions

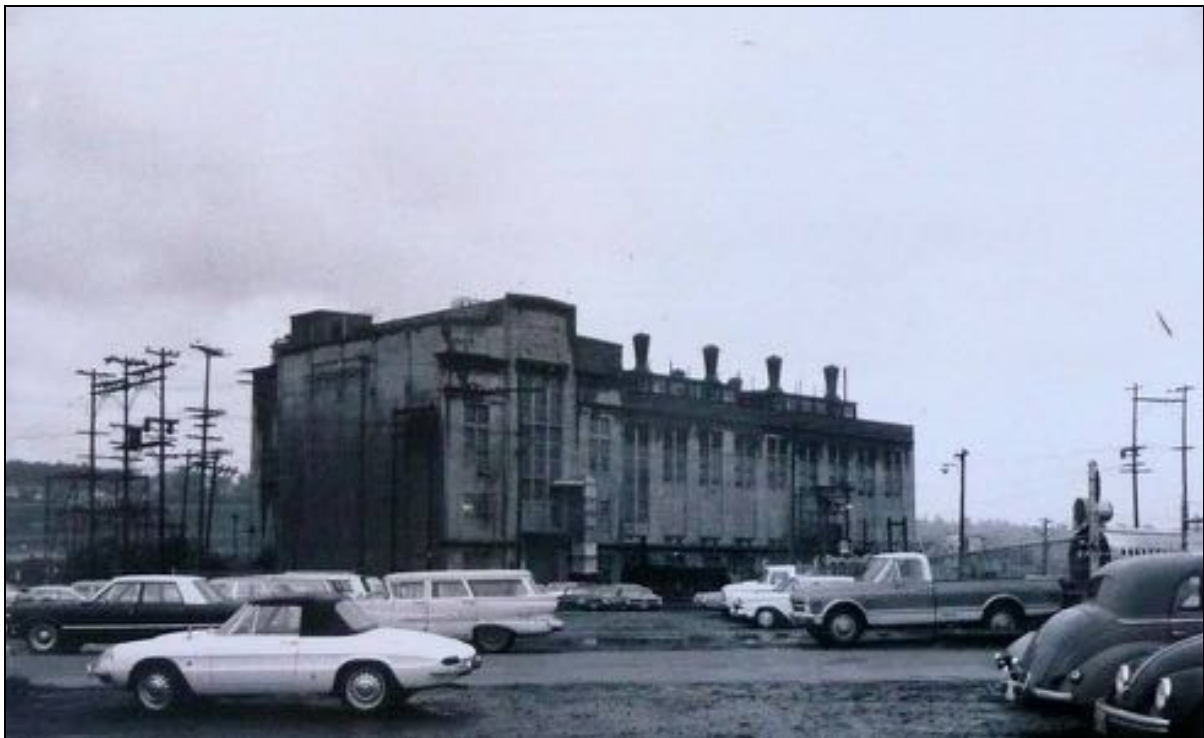
Figure 46: West and north façades, ca. 1960. (Seattle Municipal Archives)

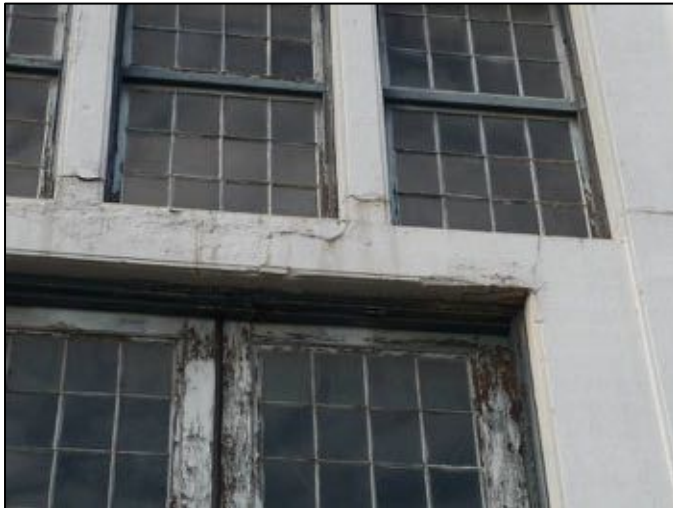
Figure 47: Example of coating cracks, concrete spalls and wood window deterioration.

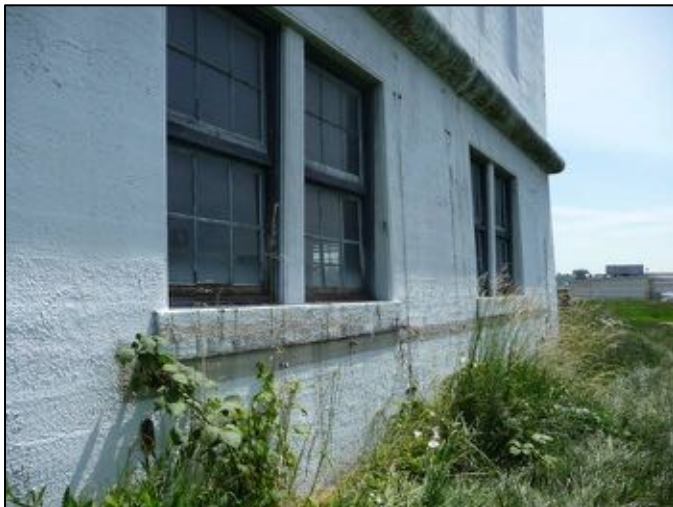
Figure 48: Example of vegetation on the building, biological growth and surface staining and deterioration.

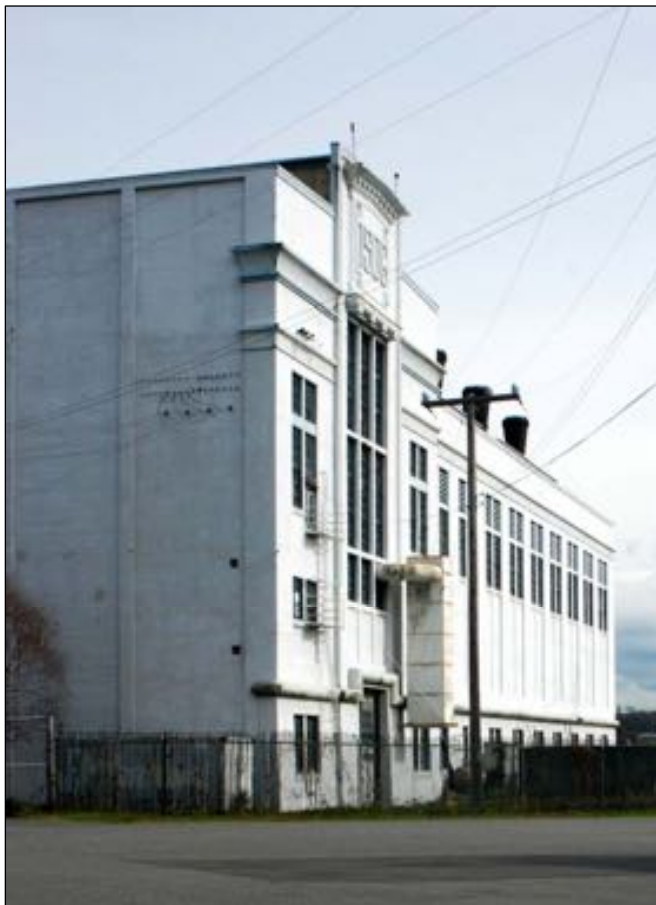
Figure 49: Northwest corner of the Steam Plant, with a view of the west façade and a portion of the north façade.

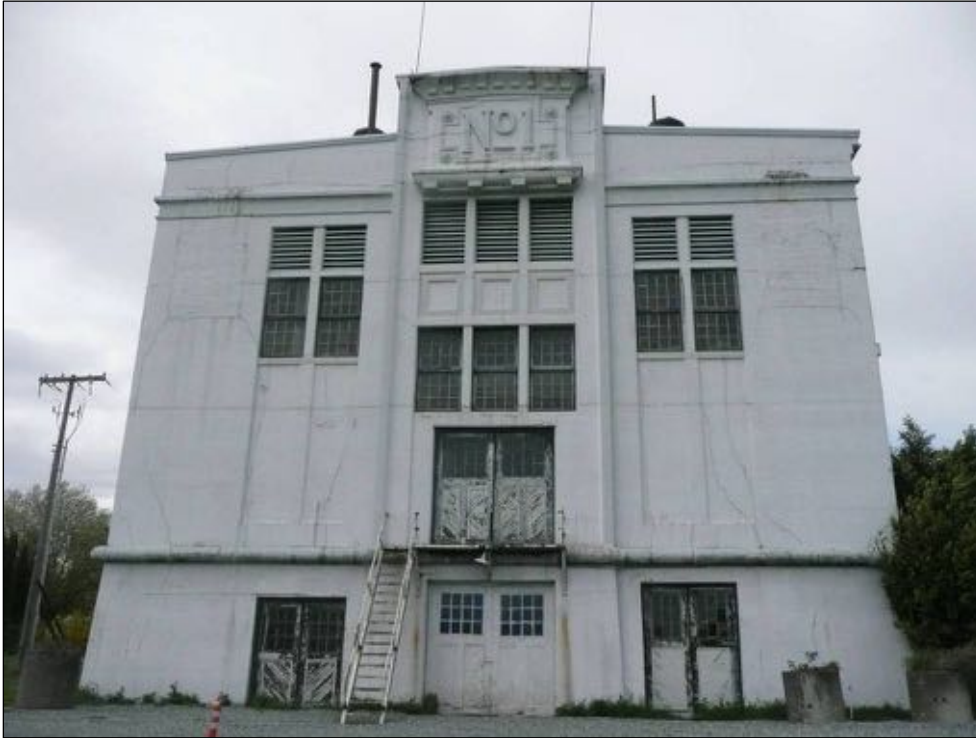
Figure 50: South façade, showing significant cracking throughout the wall areas.

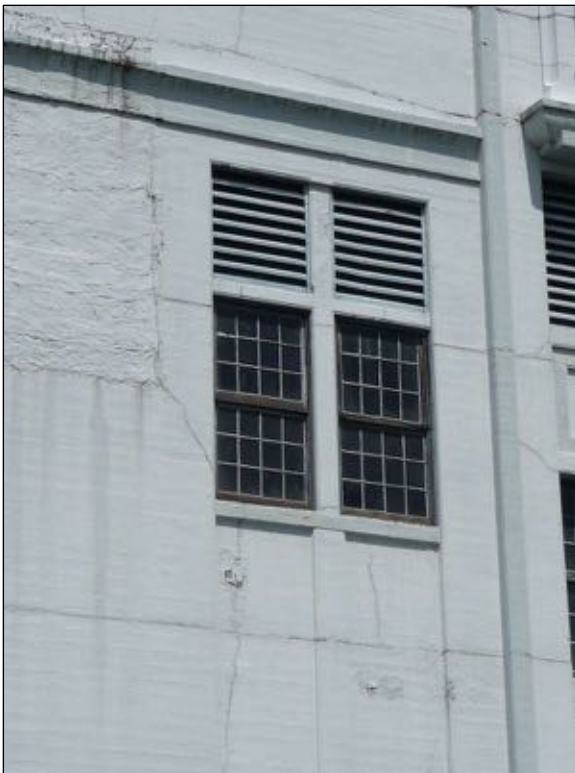
Figure 51: Detail of south wall, showing horizontal cold joints, and various cracks treated with joint sealant.

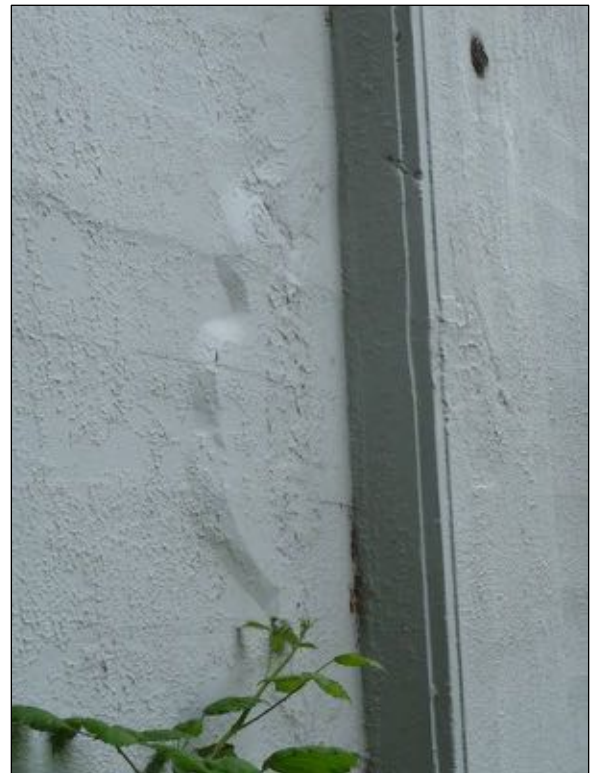
Figure 52: Detail from the east wall, showing a previous patch that has delaminated again. Also visible is the typical incised corner detail.

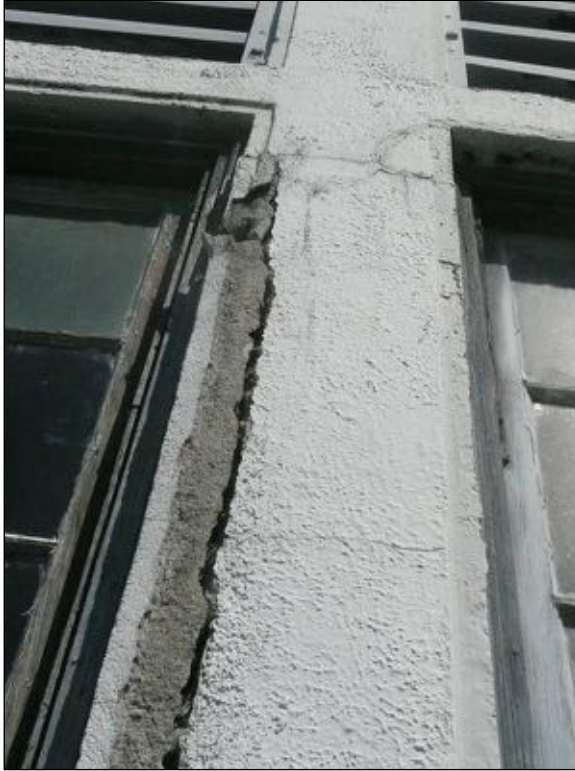
Figure 53: Detail of windows on the south wall. The concrete mullion is cracked and delaminating about an inch from the face of the wall.

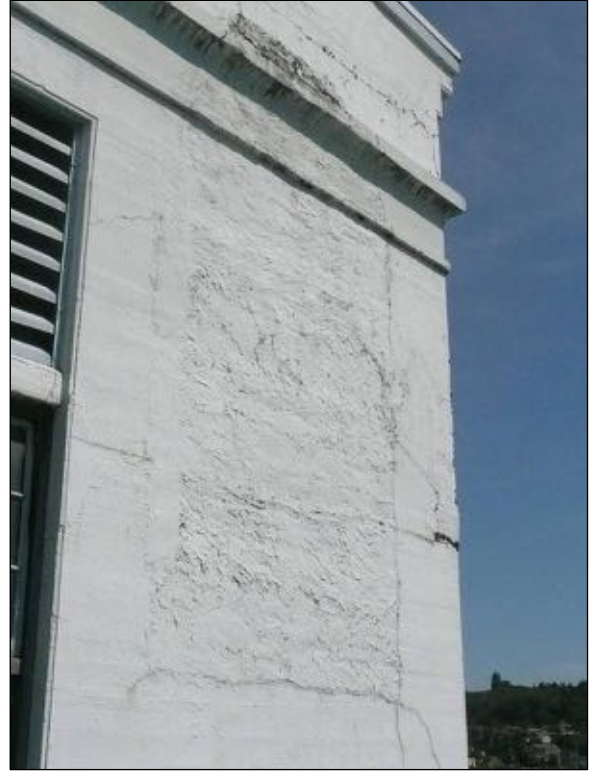
Figure 54: Detail of east arched opening infill on the south wall, with mismatched texture.

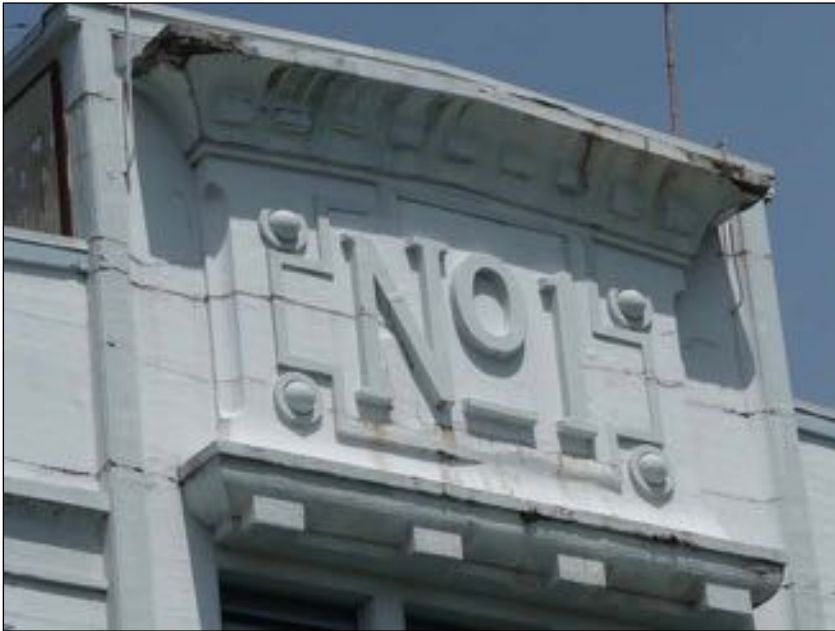
Figure 55: Detail of the “No. 1” casting at the top of the south wall.

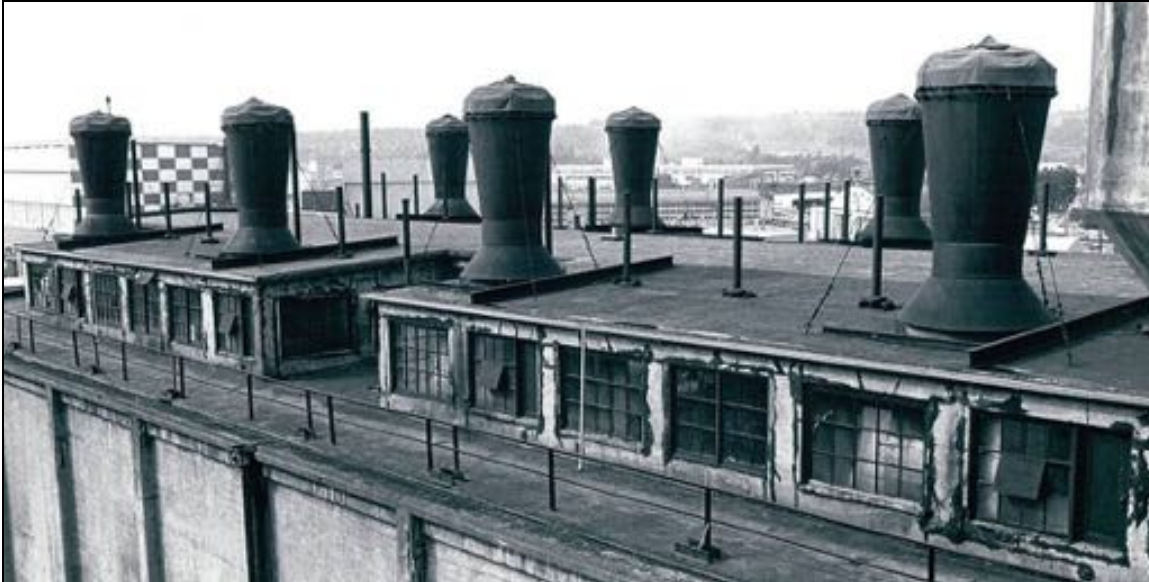
Figure 56: This undated photo shows an example of the extent of repairs to the monitor walls and windows prior to the installation of the fiberglass panels. (Photo courtesy of SCL)

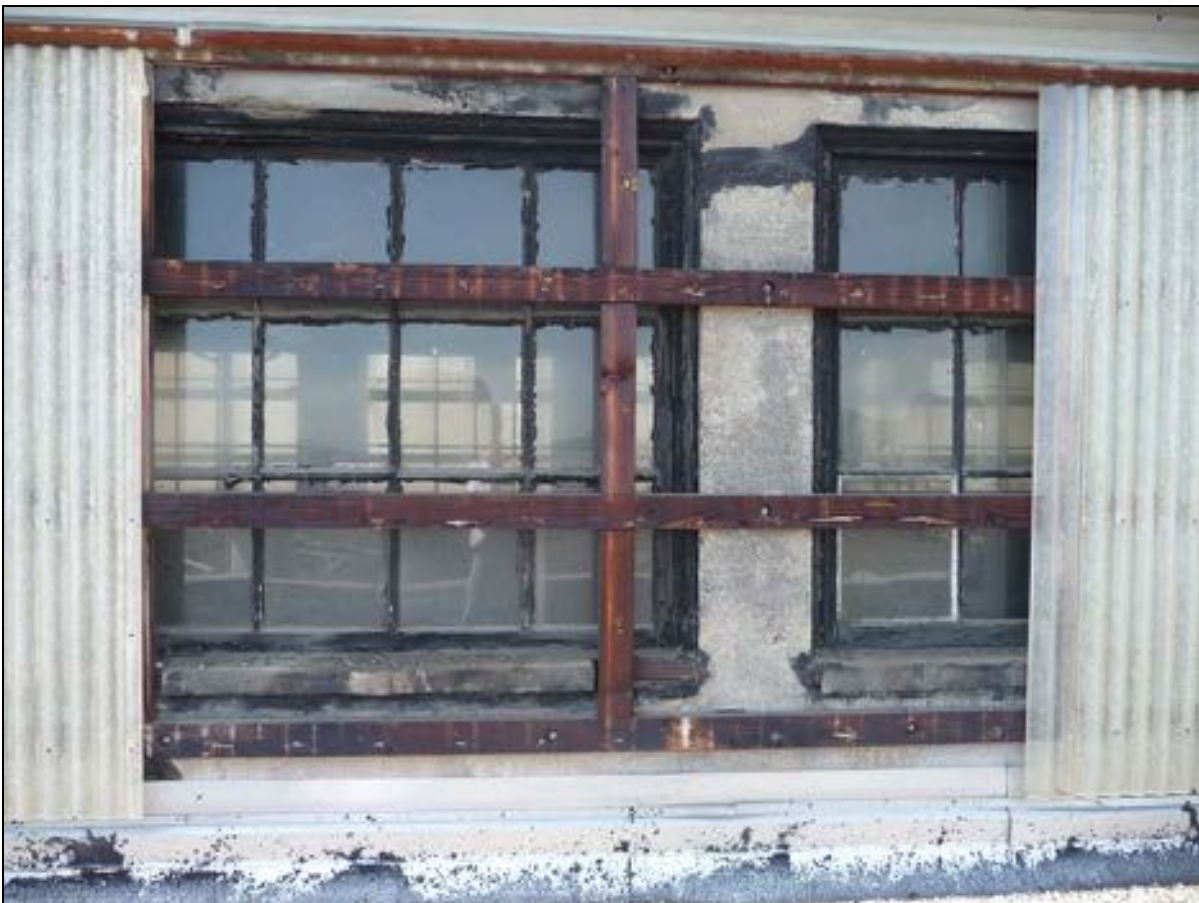
Figure 57: Detail of Engine Room monitor wall with fiberglass panels partially removed. Note the mastic patching, the wood sills notched for the fiberglass support framing, and the framing bolted into the concrete.

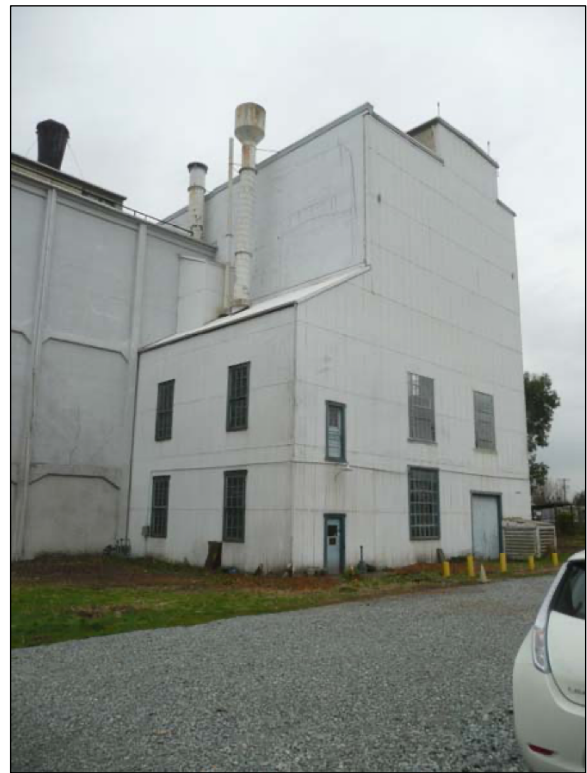
Figure 59: East and south walls of the 1918 Addition with corrugated metal cladding.

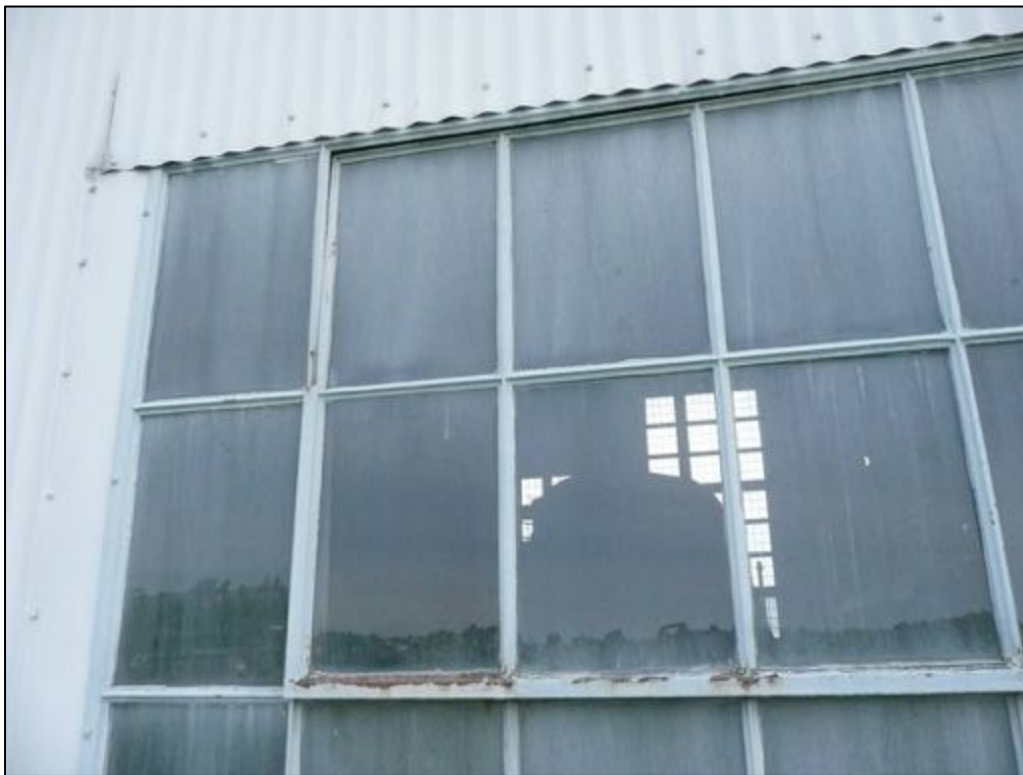
Figure 60: Detail of lapped flashing at steel window depends on caulk for water protection.

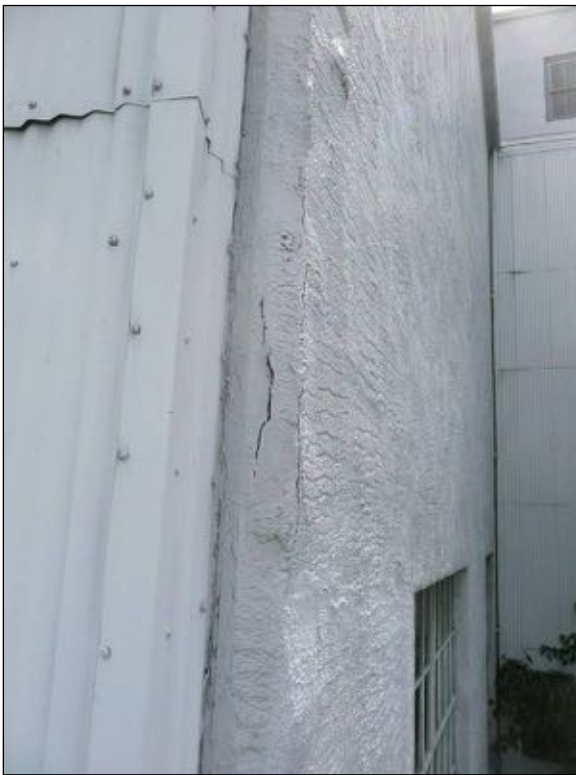
Figure 61: Detail of northeast corner of the 1918 Addition, with corrugated metal and stucco-clad hollow clay tile. Delamination of the stucco is evident at the corner.

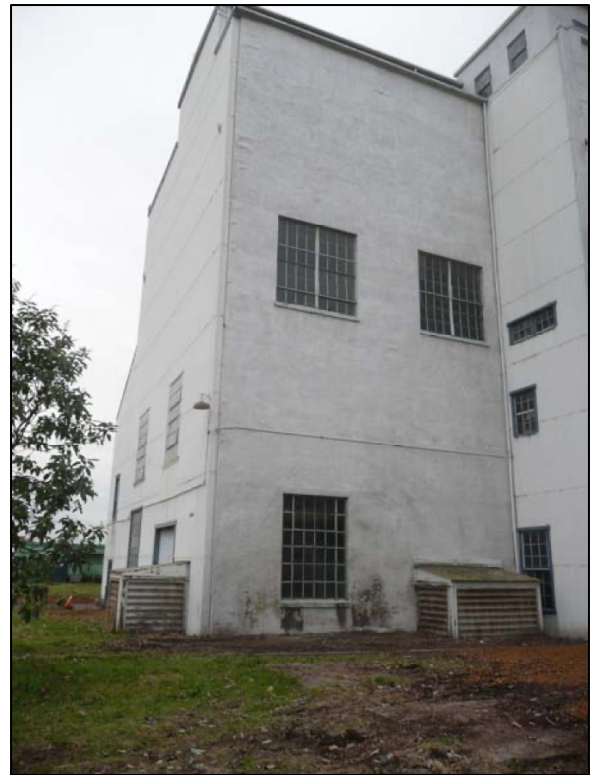
Figure 62: Looking southwest toward the north wall of the 1918 Addition, with stucco-clad hollow clay tile.

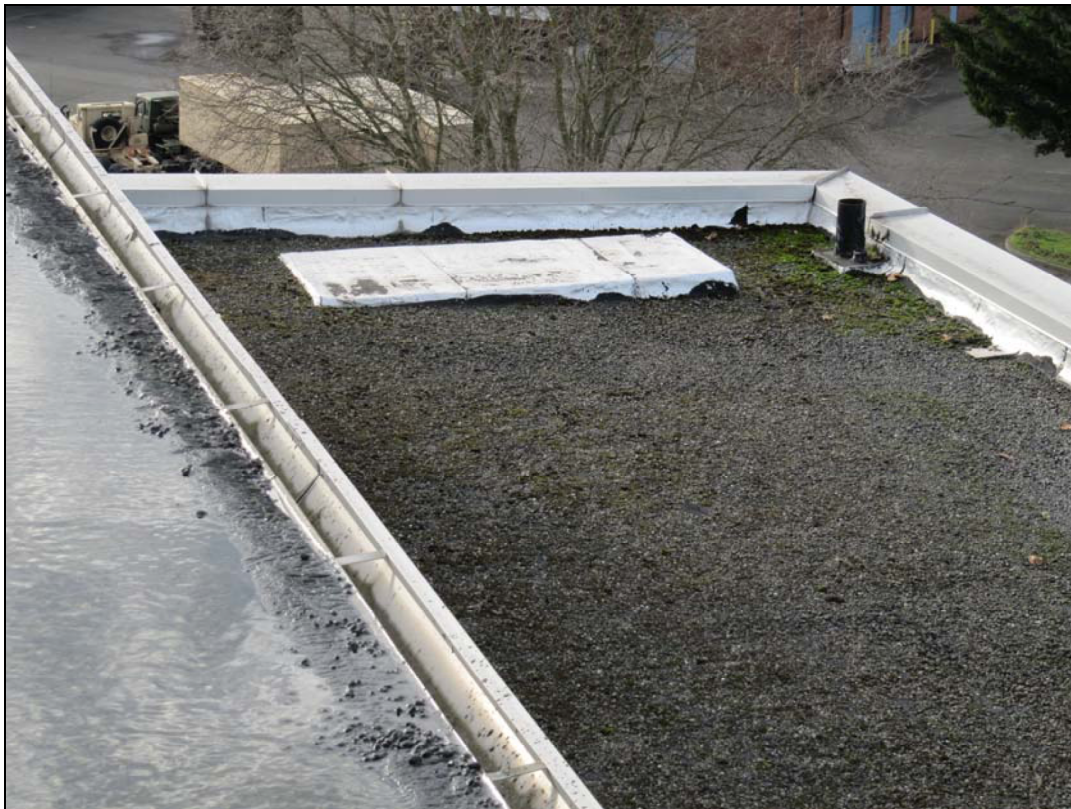
Figure 63: Detail showing the “low profile” eave gutter roof at the Engine Room monitor roof at left, and the raised profile of the parapet at the northwest corner of the Engine Room at right.

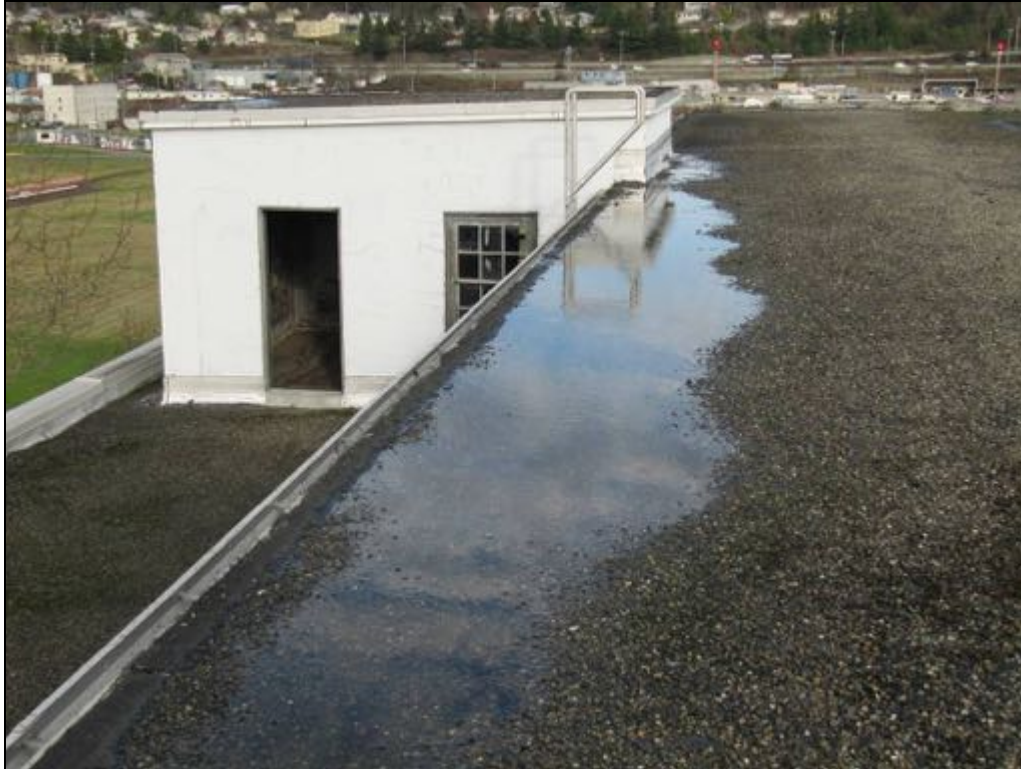
Figure 65: Detail of water ponding in the shallow swale at the edge of the embedded metal eave flashing, atop the Engine Room monitor roof.

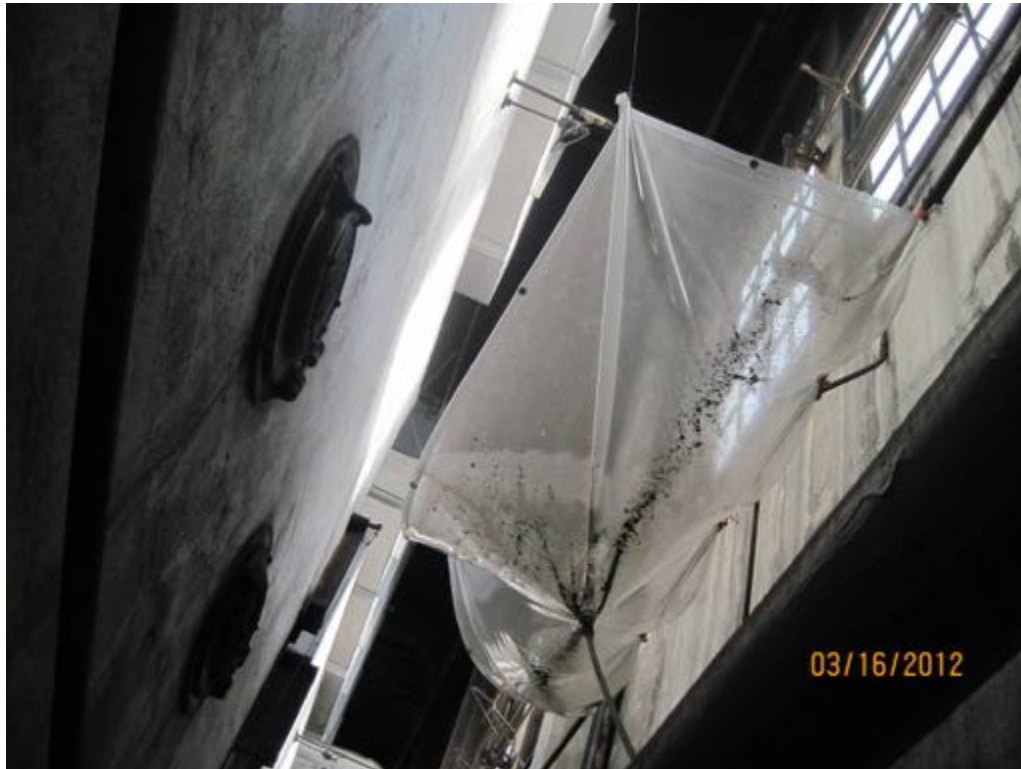
Figure 66: Roof drain leak catcher at the west side of the Boiler Room (photo by Wetherholt and Associates)

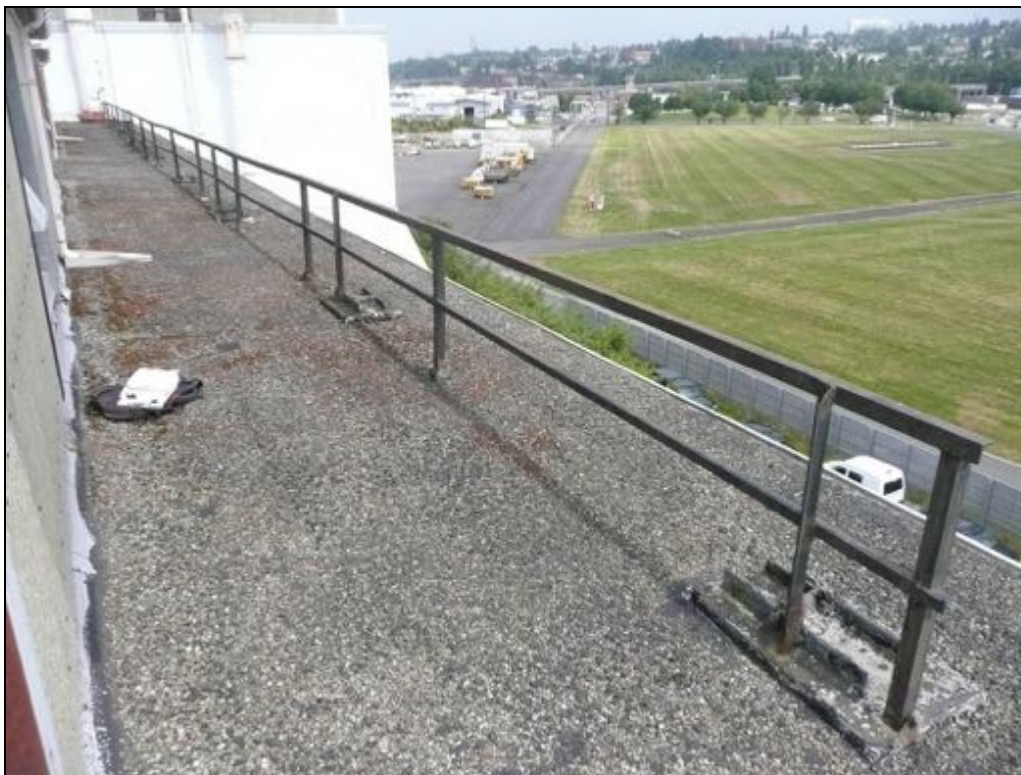
Figure 67: Steel angle railing on the east side of the Boiler Room roof, with steel mounting plates and pitch pockets.

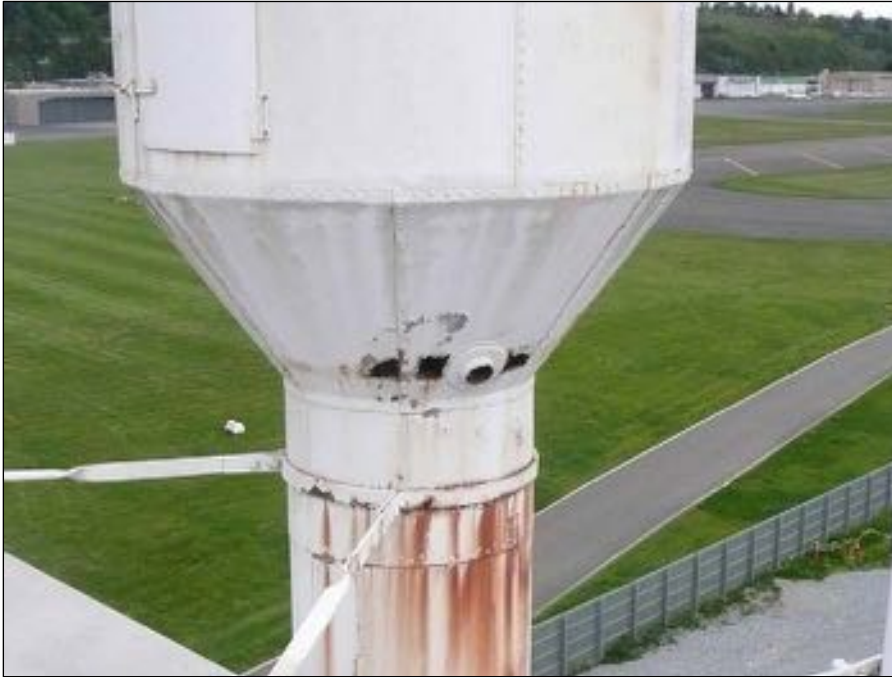
Figure 68: Detail of exhaust vent where the sheet metal has rusted through, providing access for water and pests.

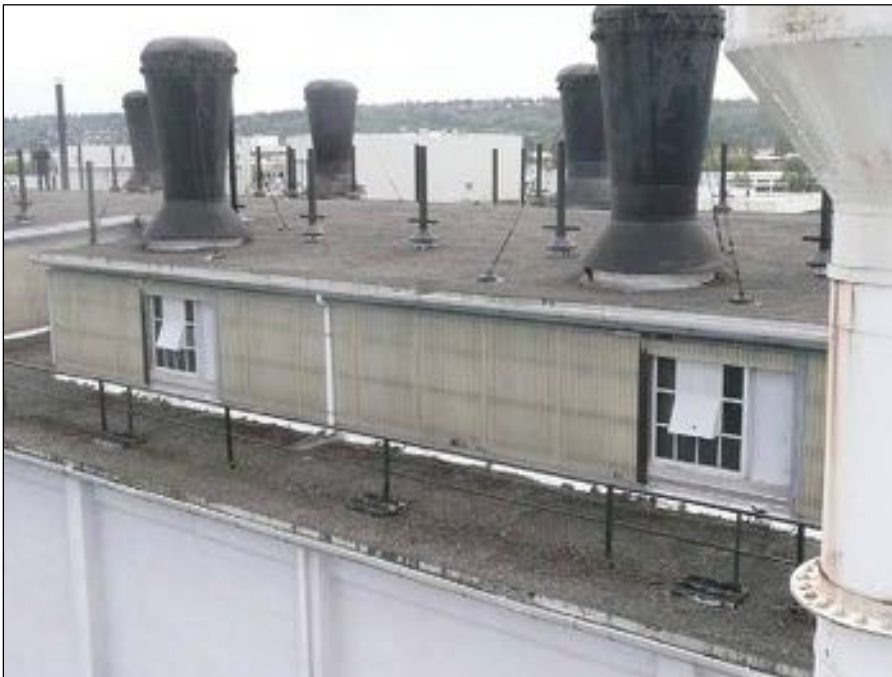
Figure 69: Eliminating penetrations where feasible due to disuse, and if not deemed character-defining features, will serve to protect the structure from further deterioration and reduce maintenance.

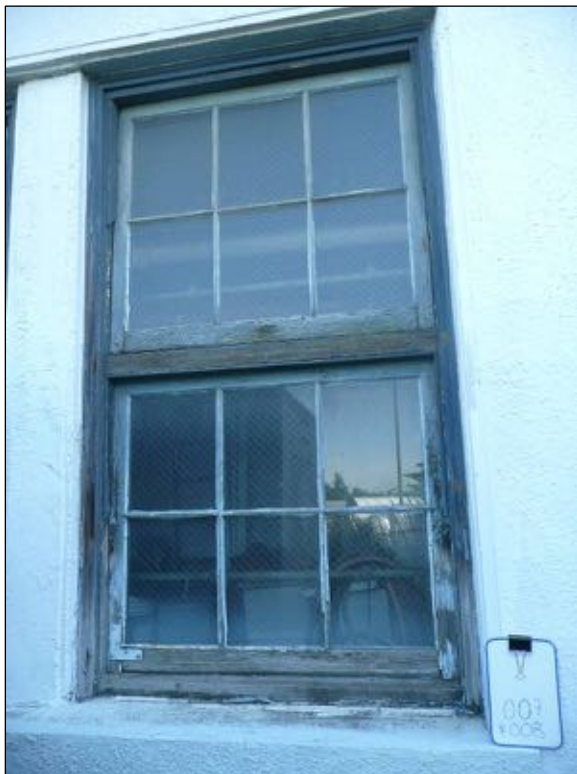
Figure 70: Detail of a window on the west facade, with little remaining paint, missing glazing, missing caulking, and previous repair at the bottom rail of the lower sash.

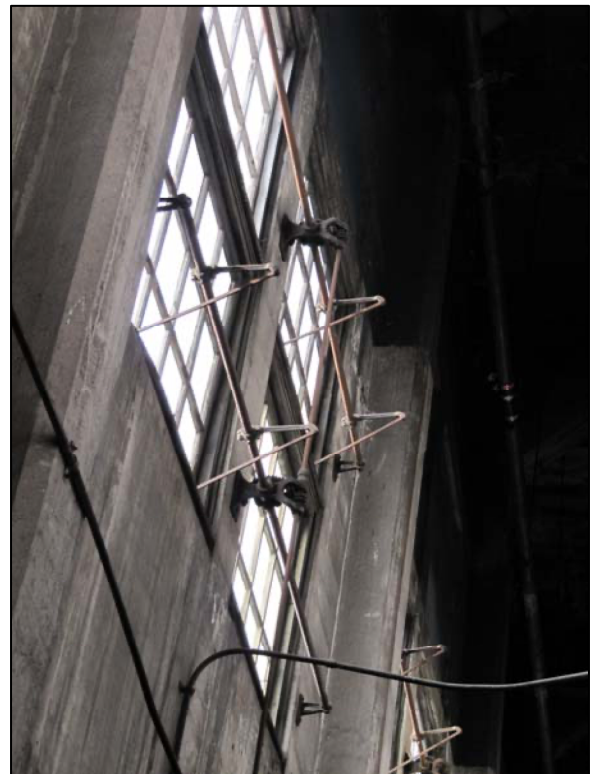
Figure 71: Interior detail of wood pivot window and internal operating mechanism.

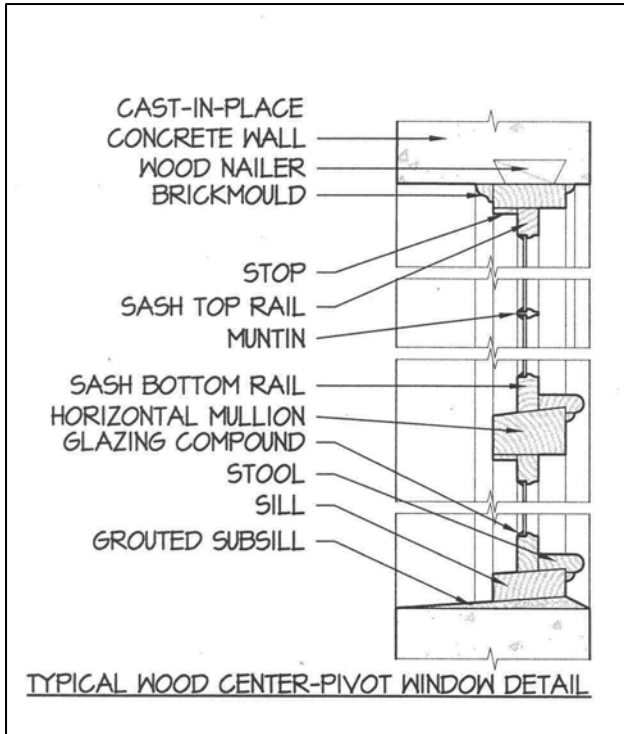
The glass at the first floor windows has all been replaced with 1/4" wire glass, as noted on construction drawings from 1985. Much of the glazing compound (presumably installed at that time) has failed by cracking, or delaminating from the adjacent muntins and frames. Glazing points were observed on one window where significant amounts of the glazing compound were missing. Over time, the glass appears to have been replaced with modern plate glass, and using a variety of glazing compounds and craftsmanship. Asbestos testing confirmed, or assumed at inaccessible locations, that nearly all the wood window glazing compound contains asbestos. (See Hazardous Materials Report in the Appendix for additional information.)

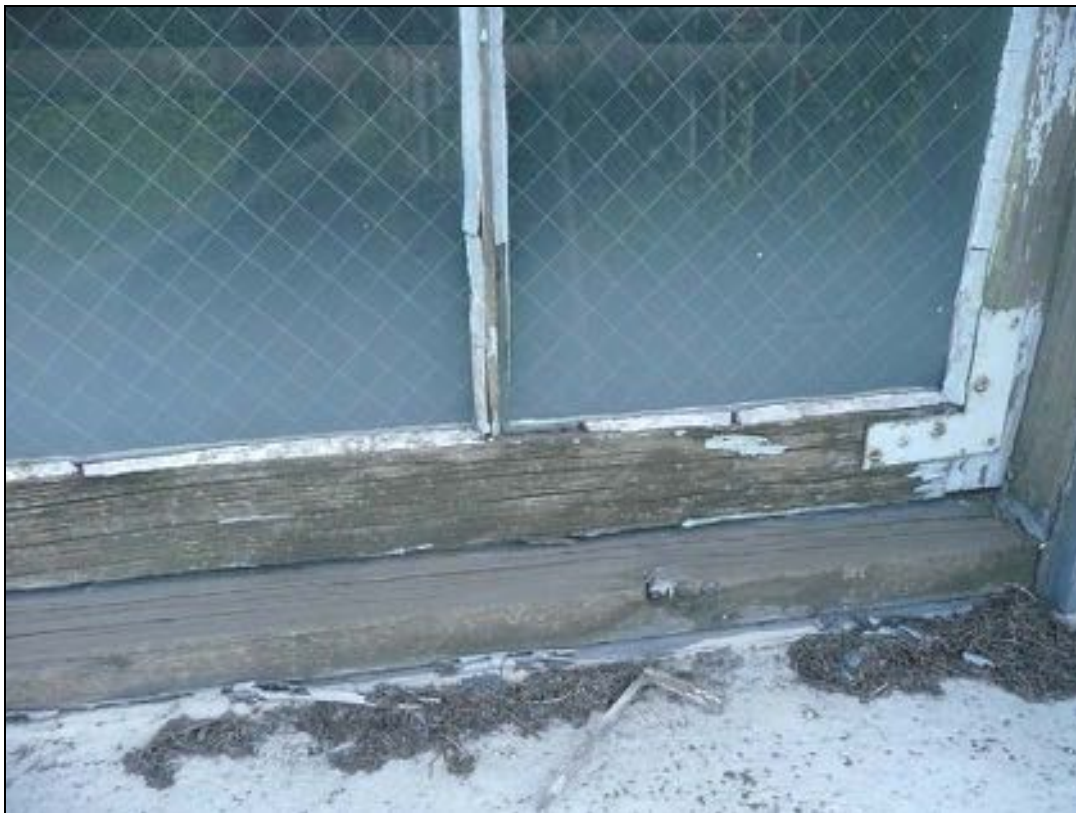
Figure 72: Detail of the sill of a ground floor window, with open grain, checked sill, and loose joint at the stile/bottom rail.

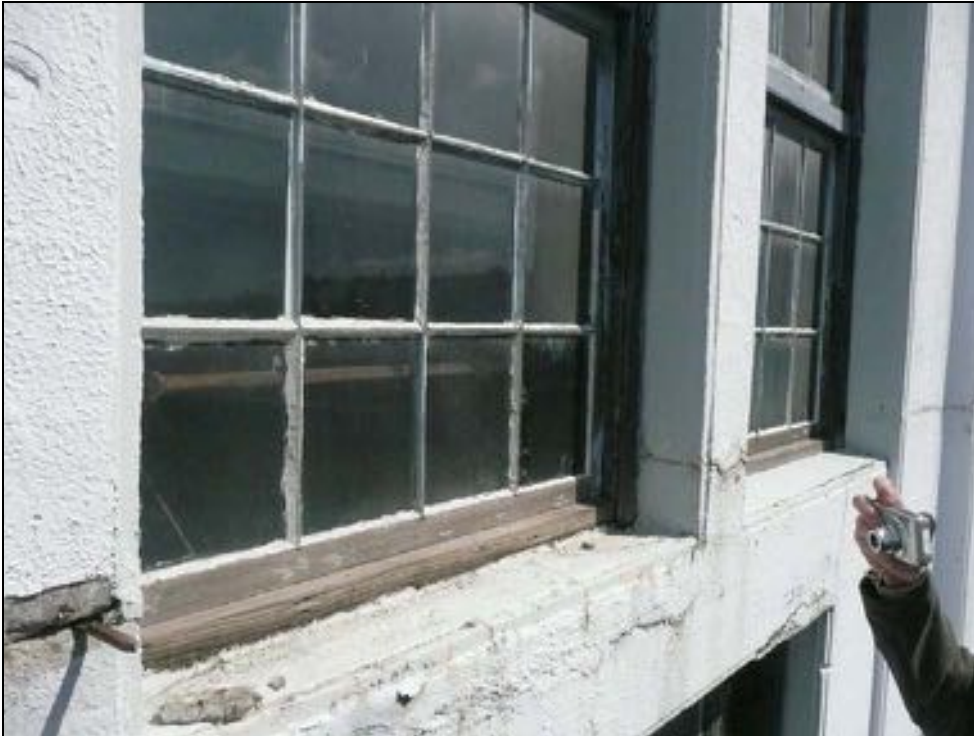
Figure 73: Detail showing existing window sill retrofits. The foreground window has a cementitious cant at the edge of the wood sill, and the background window has a newer sloped sill, which butts into the leading edge of the wood sill.

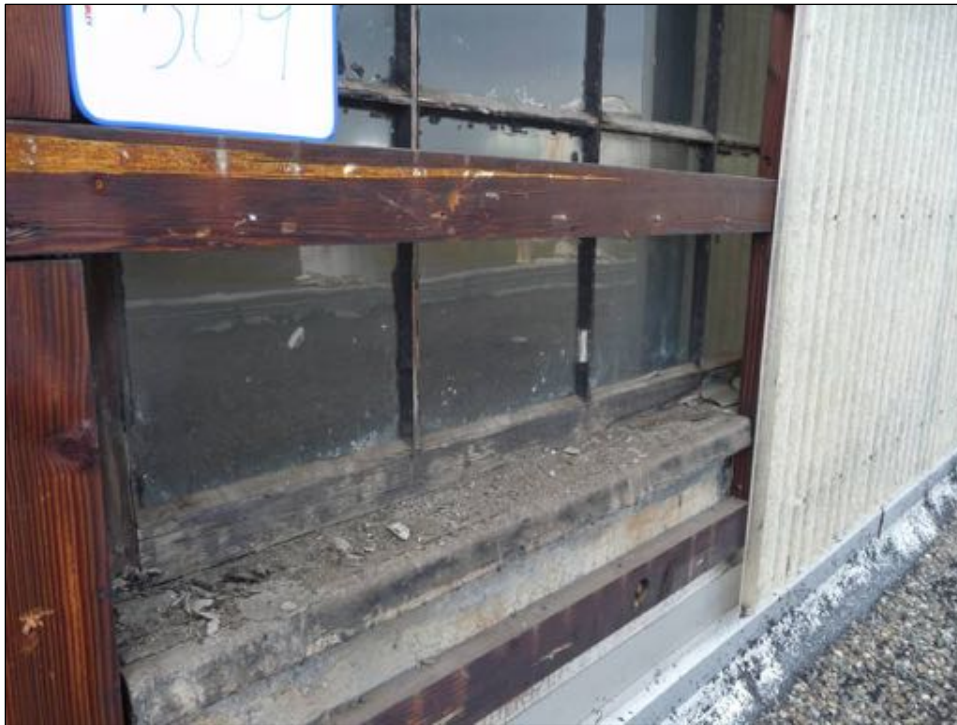
Figure 74: Detail of one of the roof monitor windows, on the south side, showing evidence of previous repairs and waterproofing attempts, including parging over the wood frame, and mastic applied over the frame and glass.
