GEORGETOWN STEAM PLANT
HISTORIC STRUCTURE & CULTURAL LANDSCAPE REPORT

OCTOBER 9, 2013

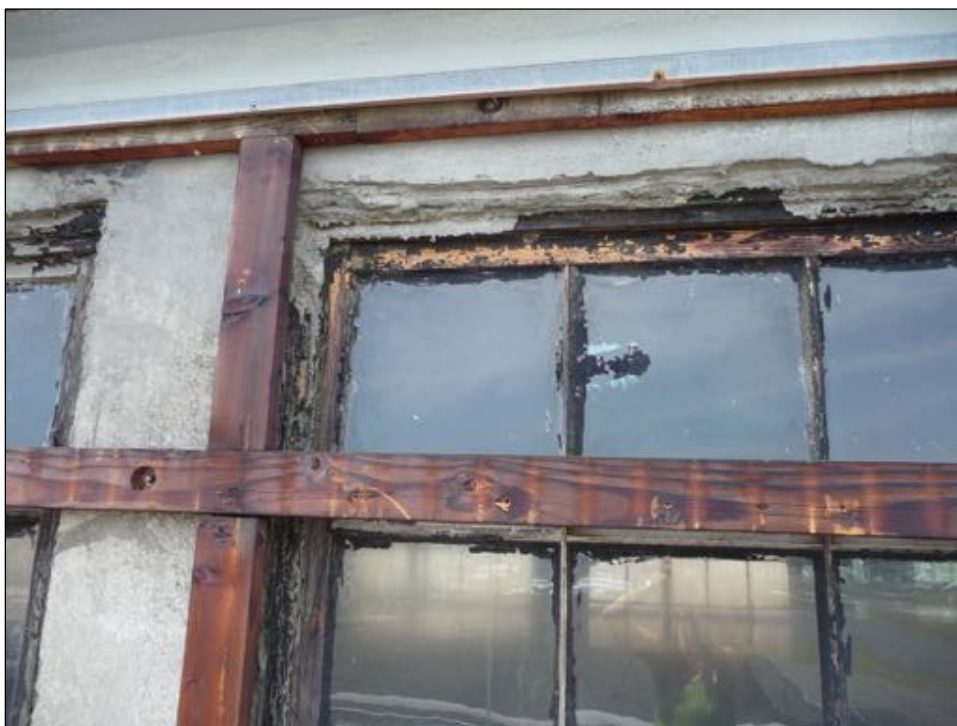
Figure 75: Some monitor window sills retain their original lead covers. In some instances, the wood sills and lead covers were notched or sawn off entirely in order to install the wood framing for the protective fiberglass panels.

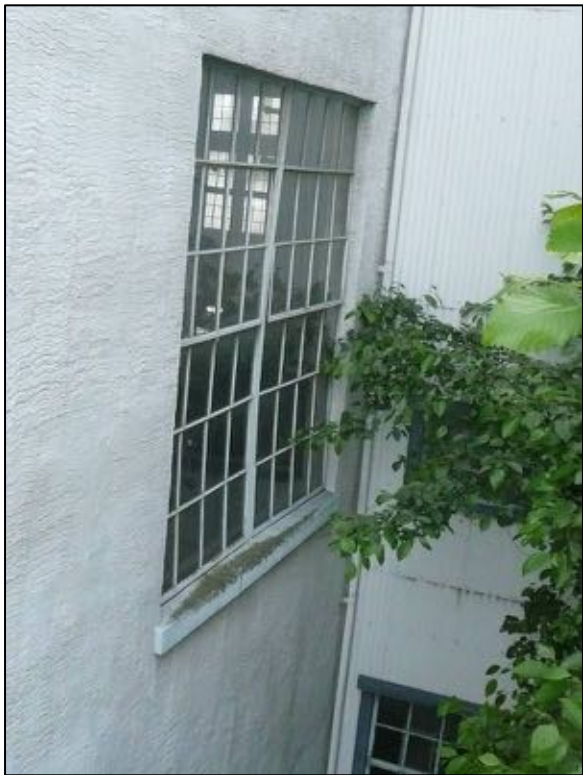
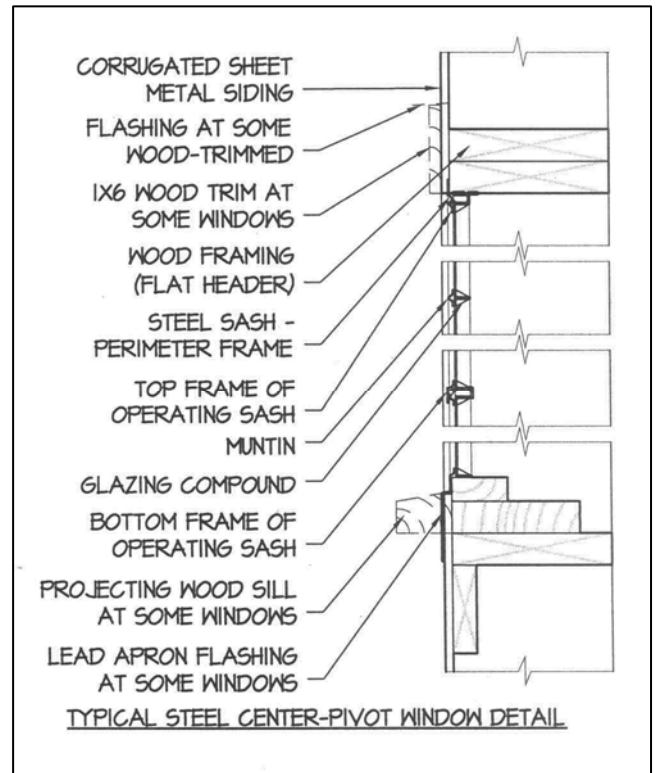
Figure 76: Steel window with bowed frame set in a stucco-clad hollow clay tile wall.

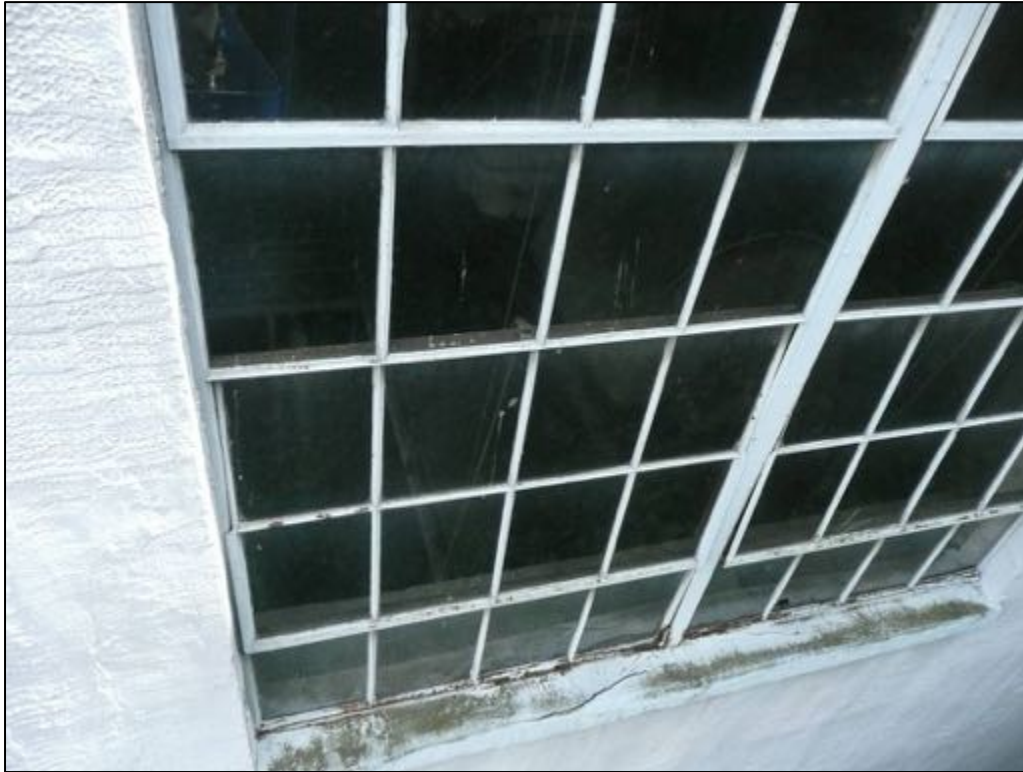
Figure 77: Detail of a steel window, with rust on the frame at the bottom, and a cracked concrete sill.

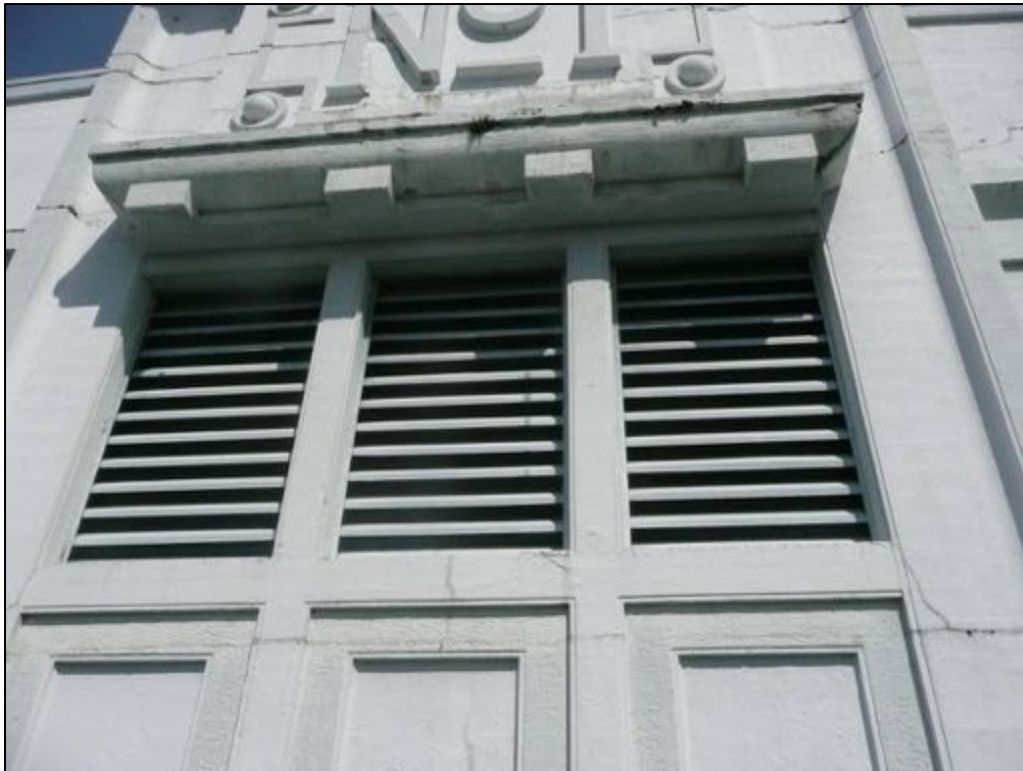
Figure 78: Detail of louvers in the south wall.

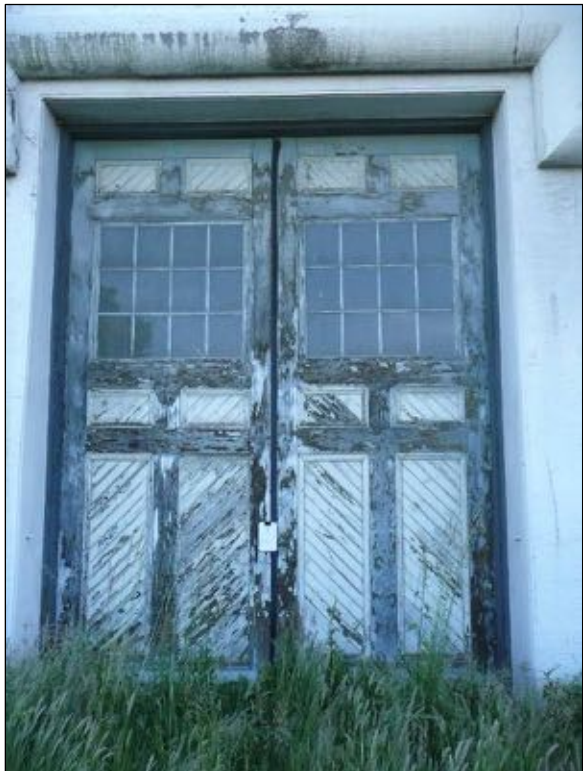
Figure 79: Detail of the large door from the west side of the Engine Room.

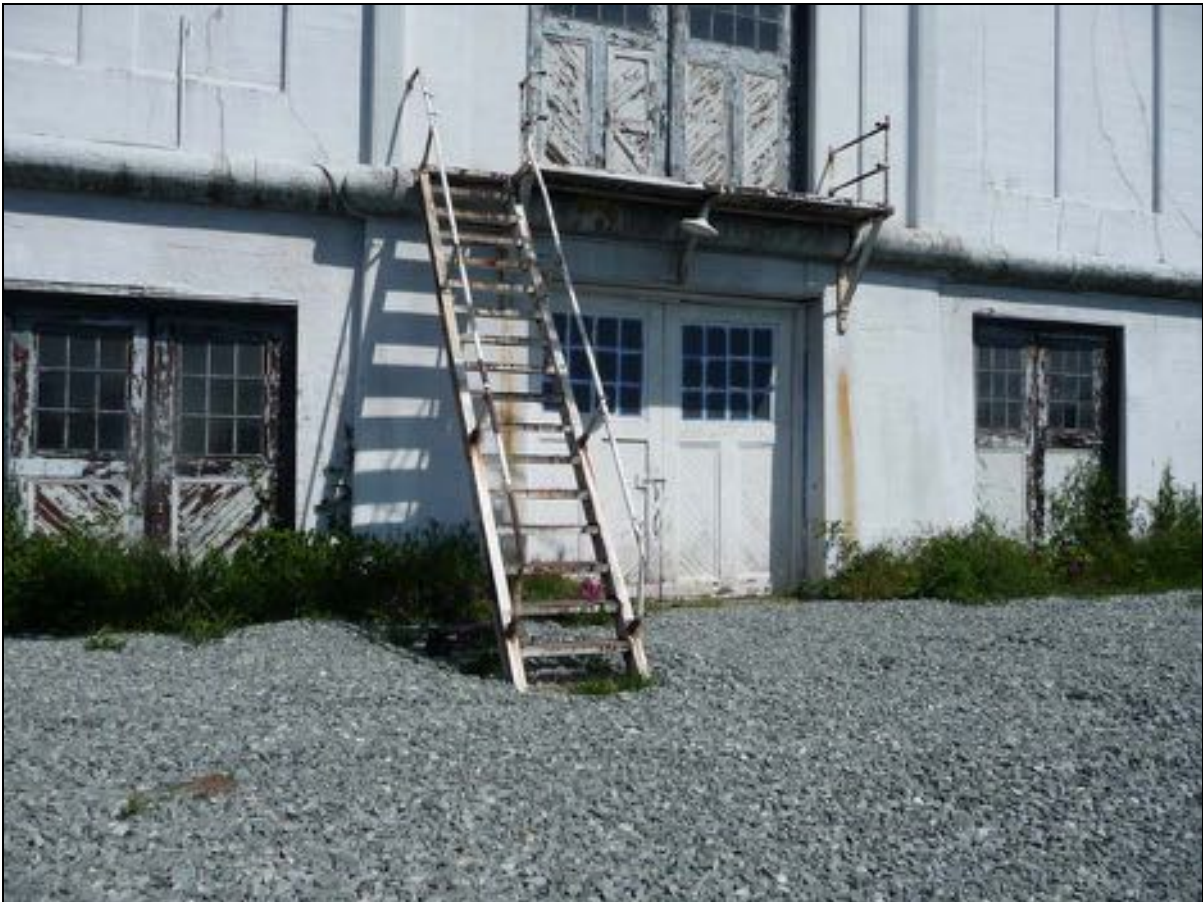
Figure 81: South balcony and stair with deteriorated wood decking and attachments, significant rust, and missing pipe rail elements.

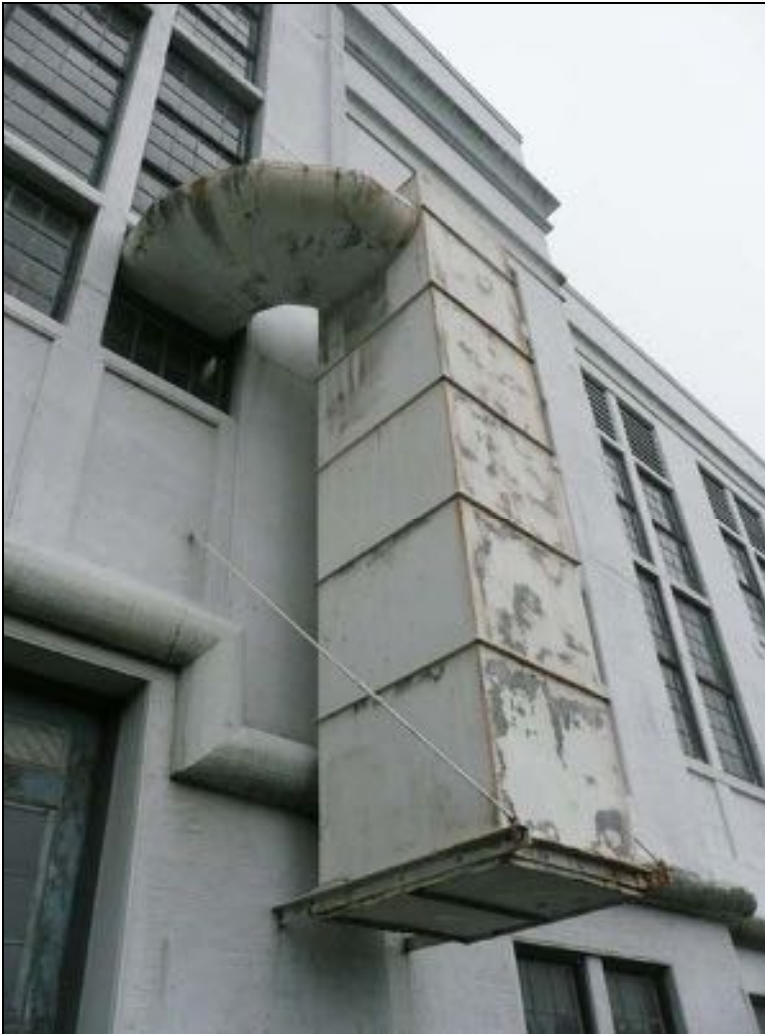
Figure 82: Metal exhaust duct and rusted, deteriorating attachments and support structure on the west side of the Engine Room.

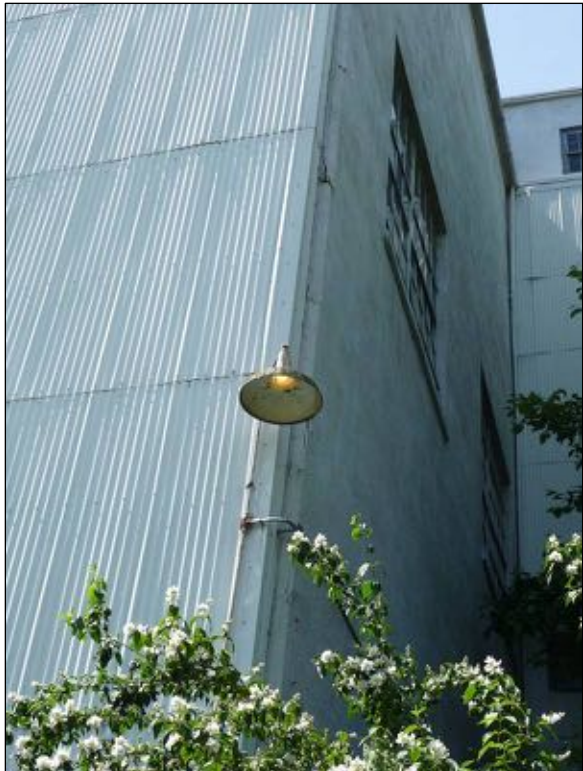
Figure 83: Exterior light at the northeast corner of the 1918 Addition, which is on in the middle of the day.

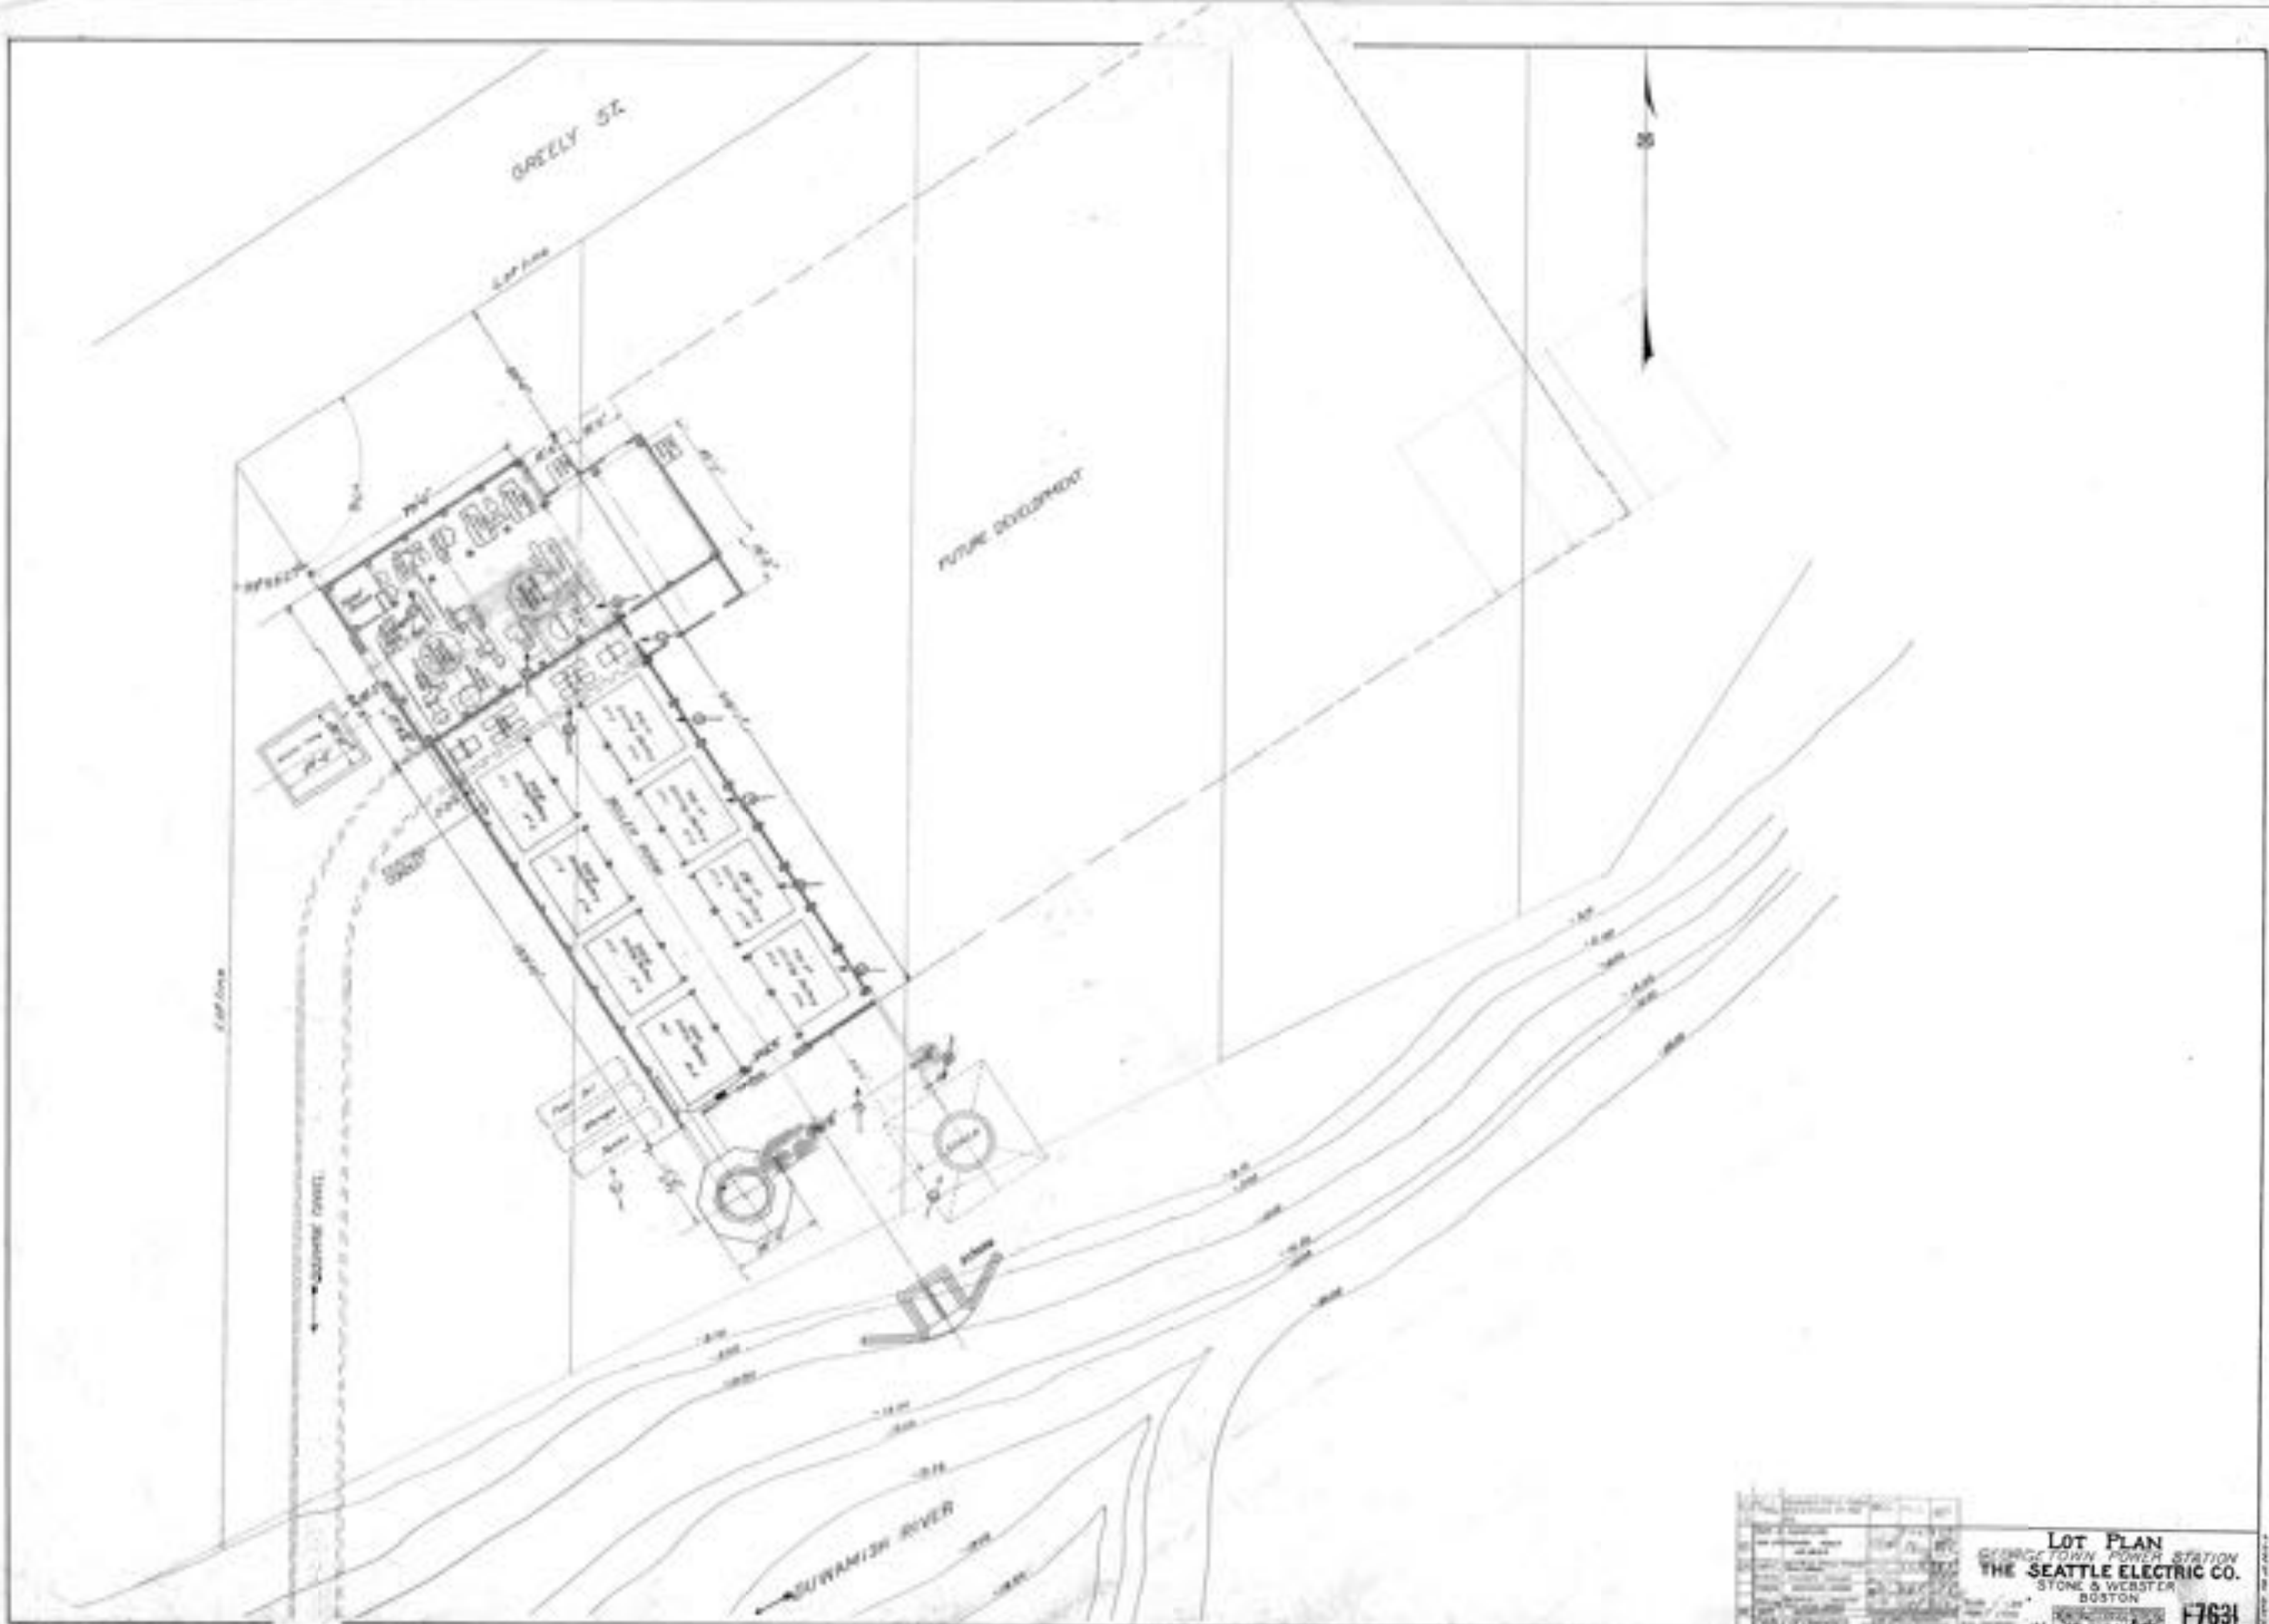
NO.	DESCRIPTION	DATE
1	PRELIMINARY PLAN	1911
2	REVISION	1912
3	REVISION	1913
4	REVISION	1914
5	REVISION	1915
6	REVISION	1916
7	REVISION	1917
8	REVISION	1918
9	REVISION	1919
10	REVISION	1920
11	REVISION	1921
12	REVISION	1922
13	REVISION	1923
14	REVISION	1924
15	REVISION	1925
16	REVISION	1926
17	REVISION	1927
18	REVISION	1928
19	REVISION	1929
20	REVISION	1930
21	REVISION	1931
22	REVISION	1932
23	REVISION	1933
24	REVISION	1934
25	REVISION	1935
26	REVISION	1936
27	REVISION	1937
28	REVISION	1938
29	REVISION	1939
30	REVISION	1940
31	REVISION	1941
32	REVISION	1942
33	REVISION	1943
34	REVISION	1944
35	REVISION	1945
36	REVISION	1946
37	REVISION	1947
38	REVISION	1948
39	REVISION	1949
40	REVISION	1950

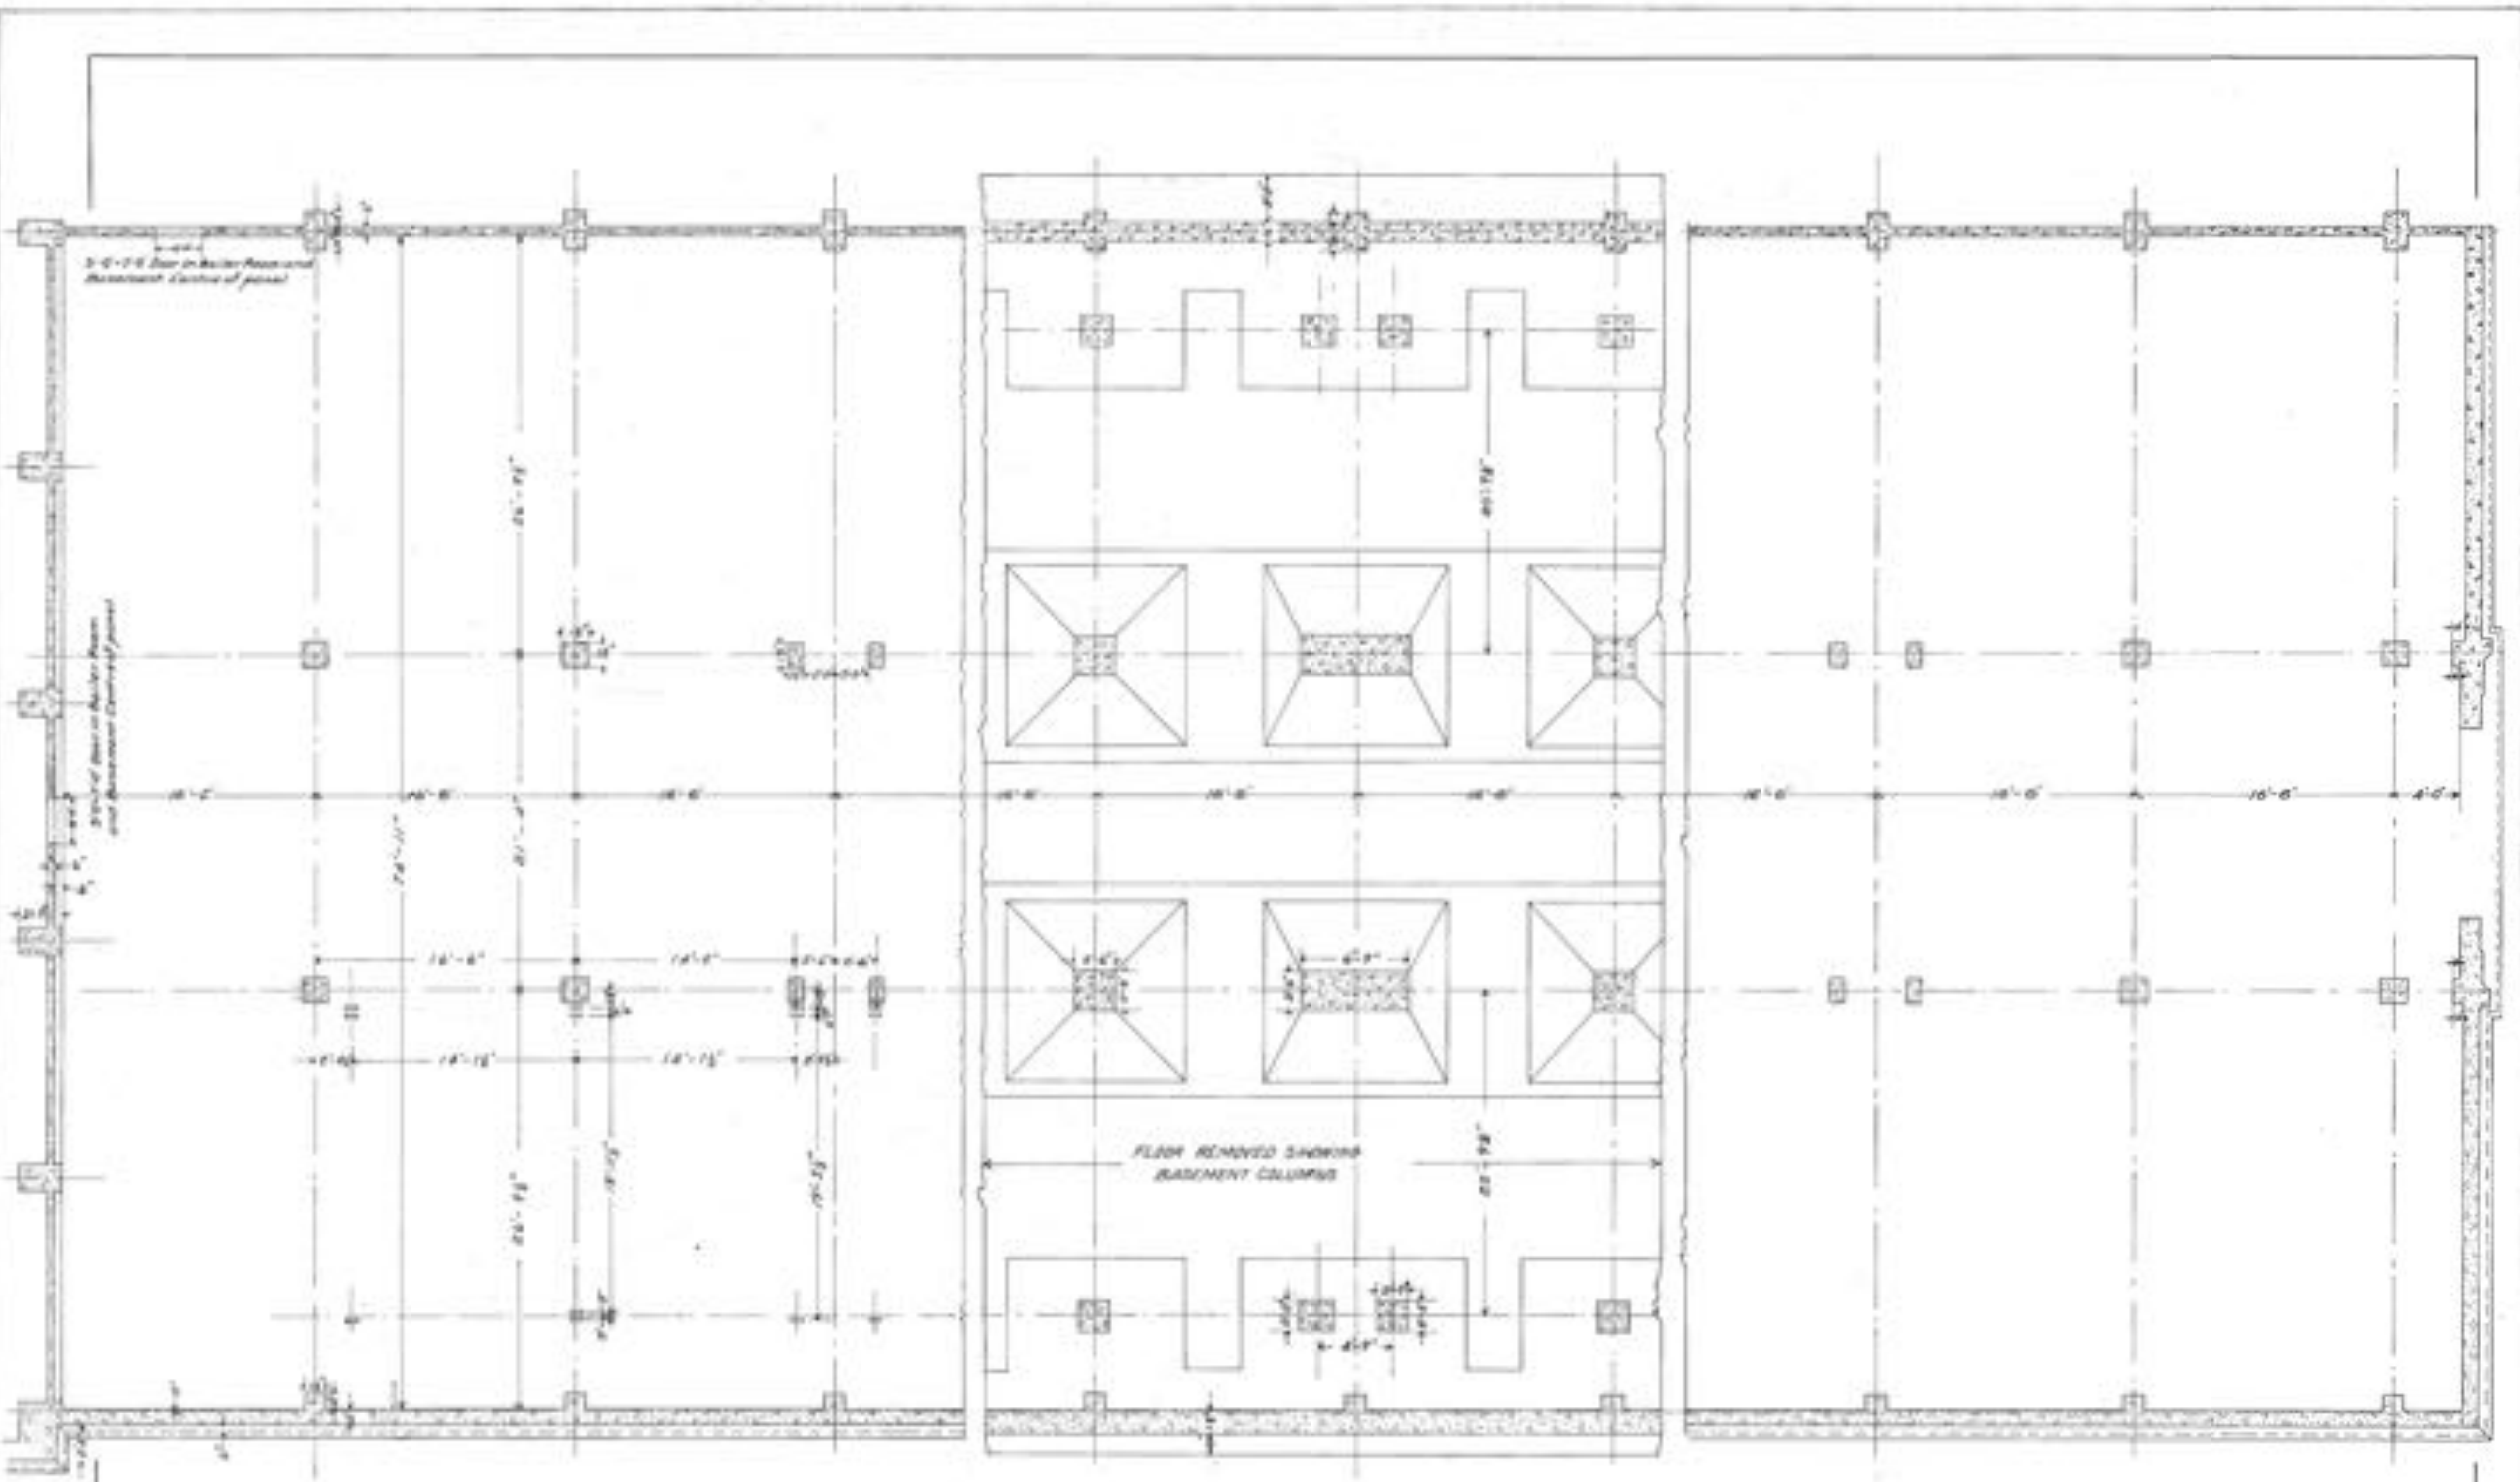
FLASH REMOVED SHOWING
BASEMENT COLUMNS

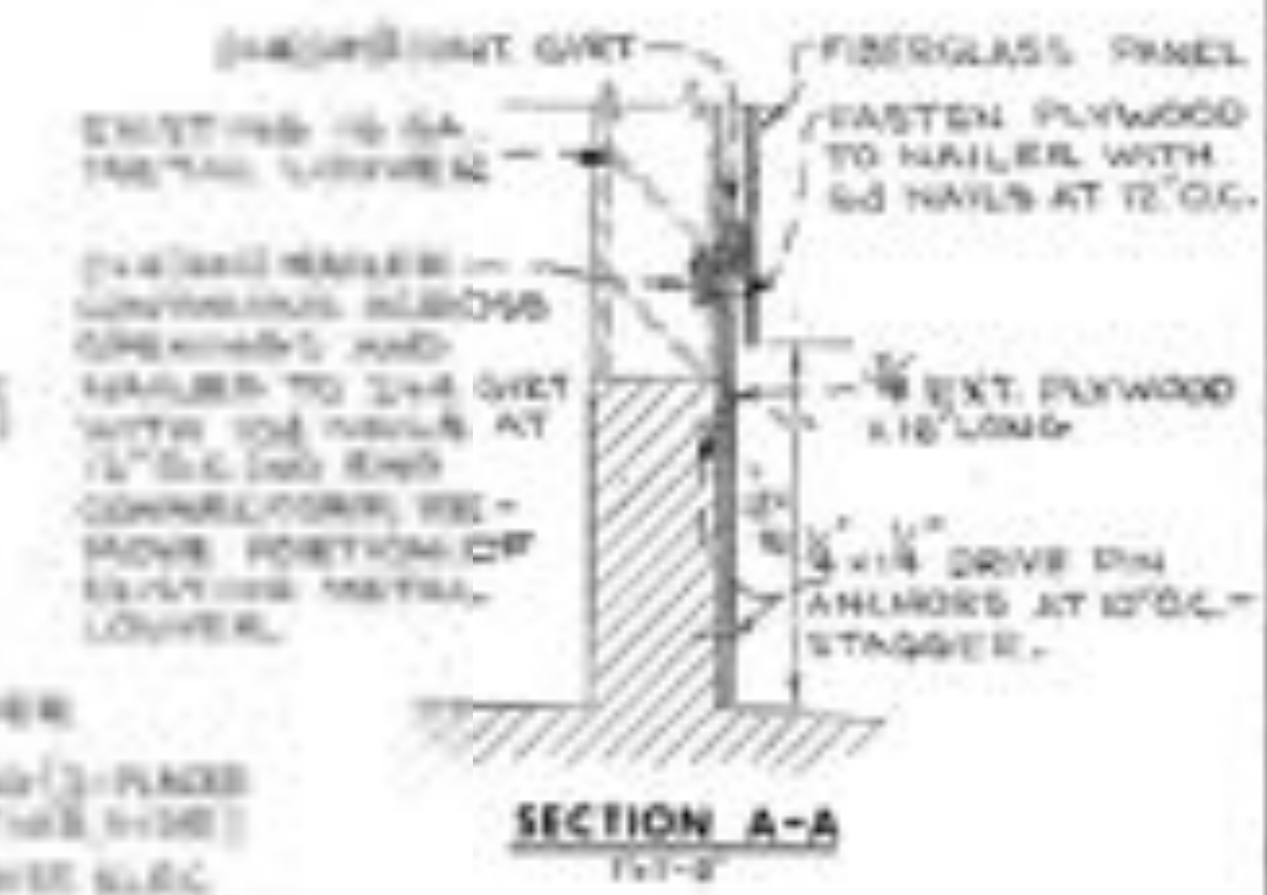
APPROVED: *[Signature]*
 DATE: *[Date]*

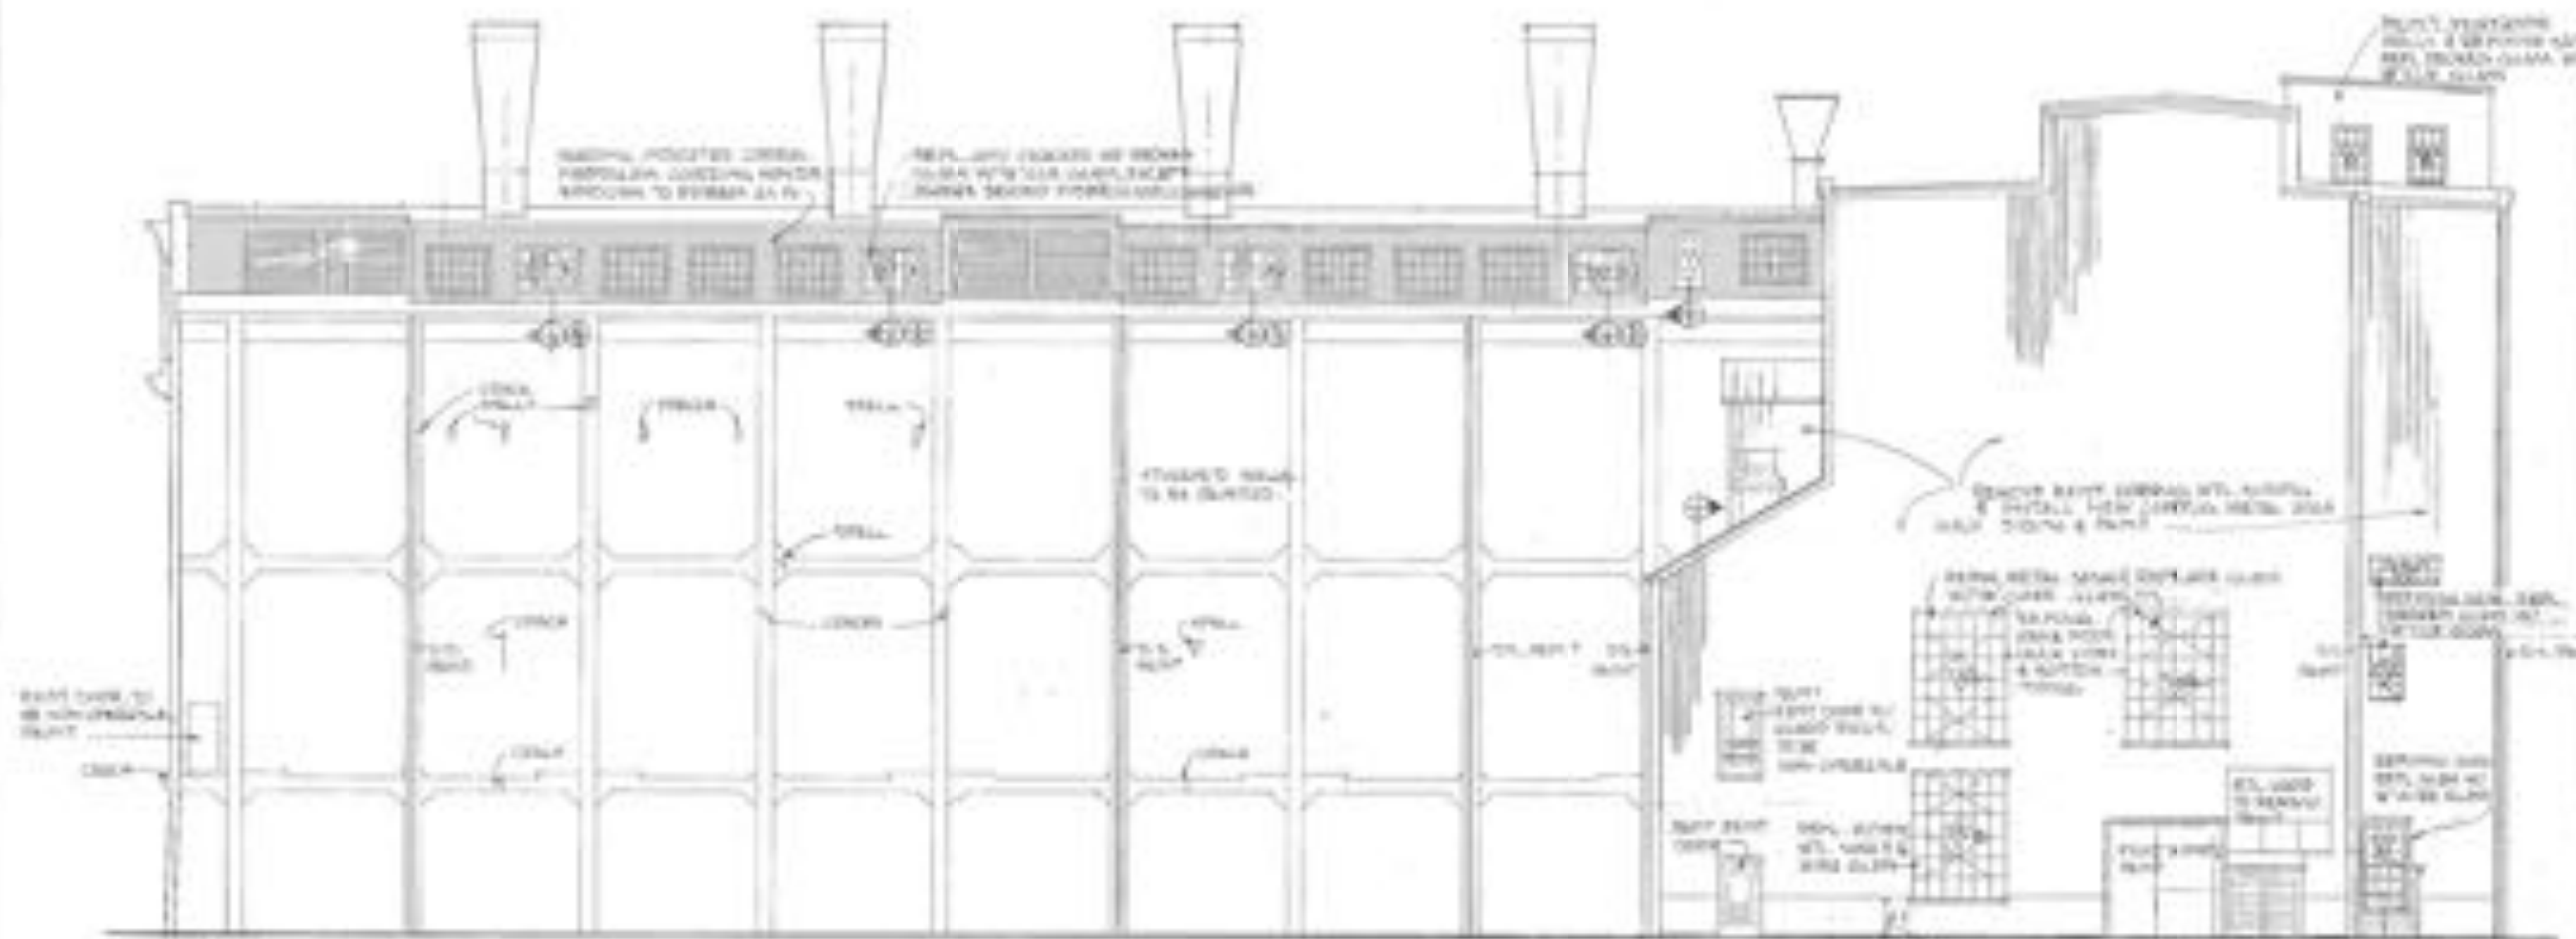
GEORGETOWN BEAM PLANT
BUILDING REPAIR
ELEVATIONS
 CLASS **C1**
 DRAWING NO. **D-25401**
 SHEET **V-1** OF **1**

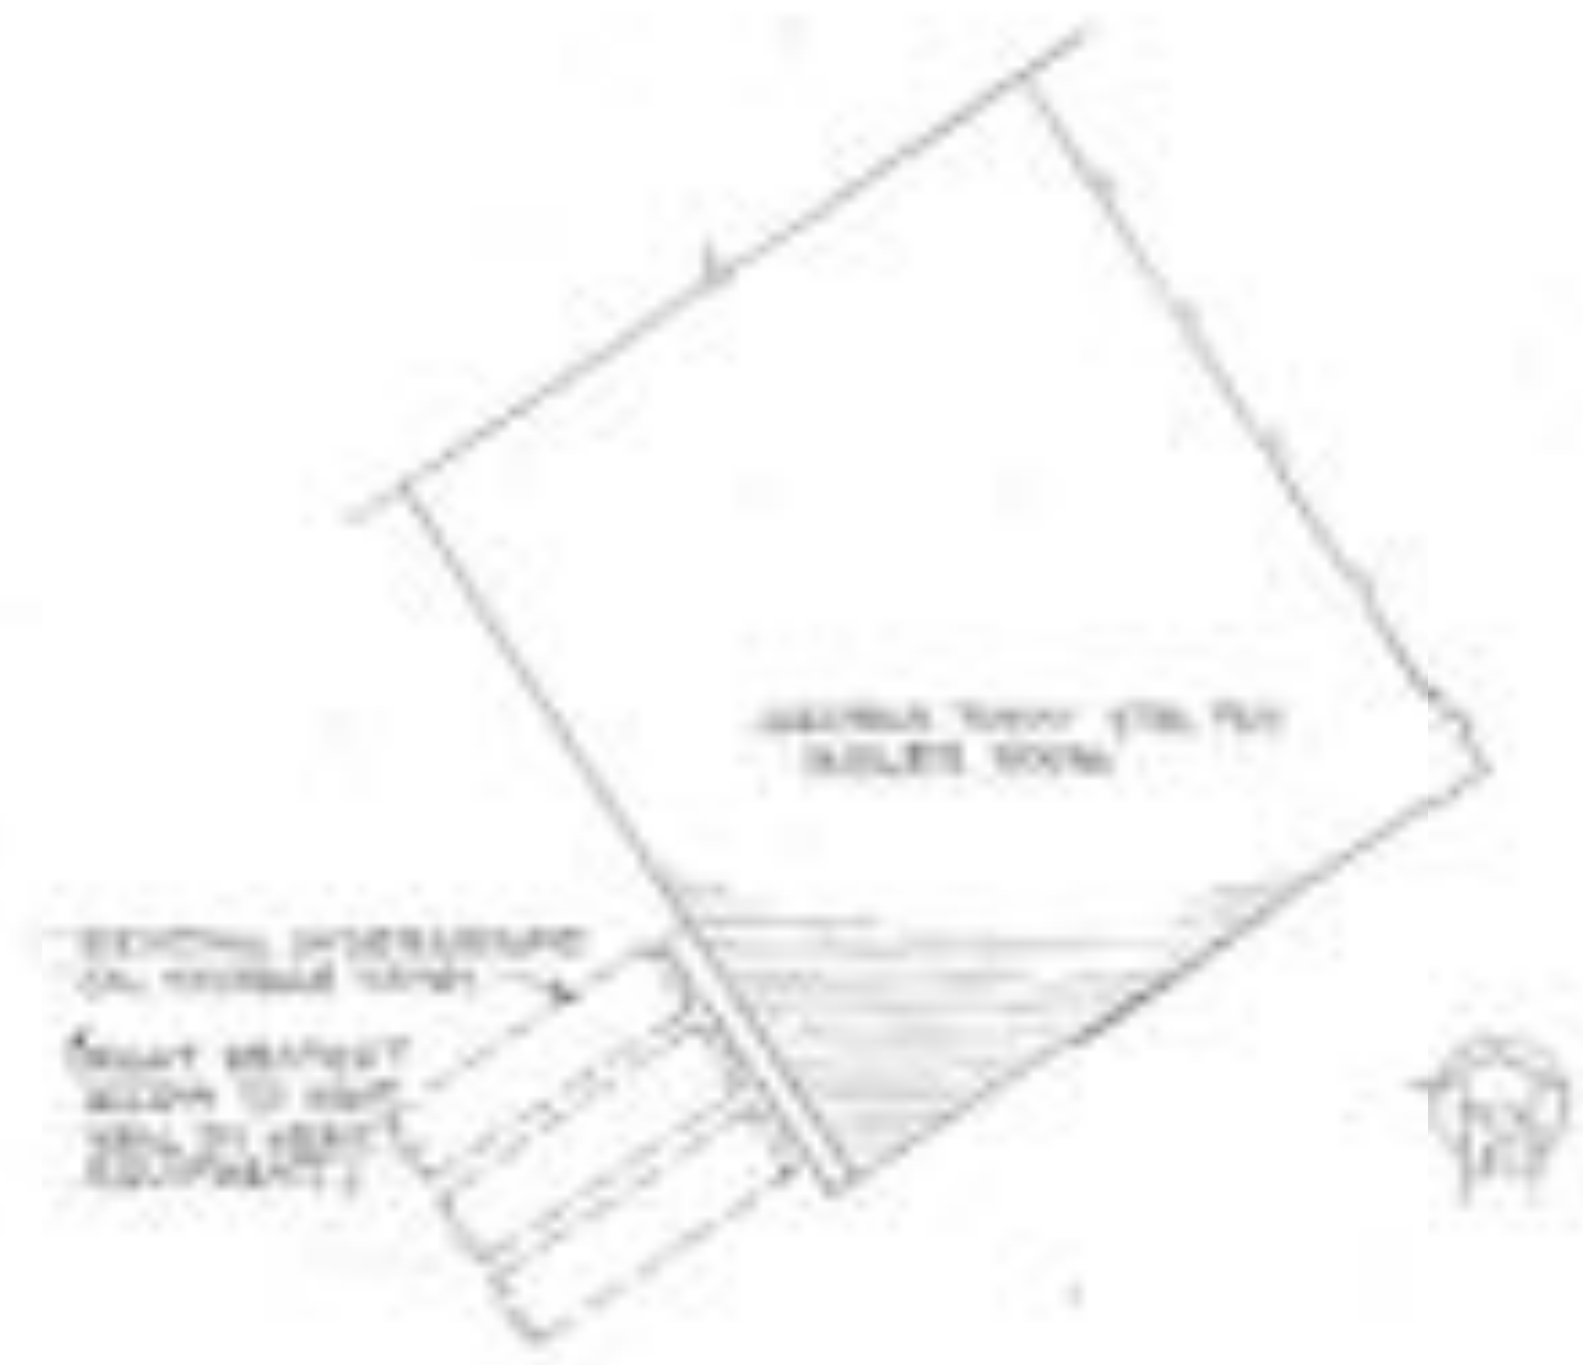
LOCATION OF BURIED TANKS
