GEORGETOWN STEAM PLANT
HISTORIC STRUCTURE & CULTURAL LANDSCAPE REPORT

OCTOBER 9, 2013

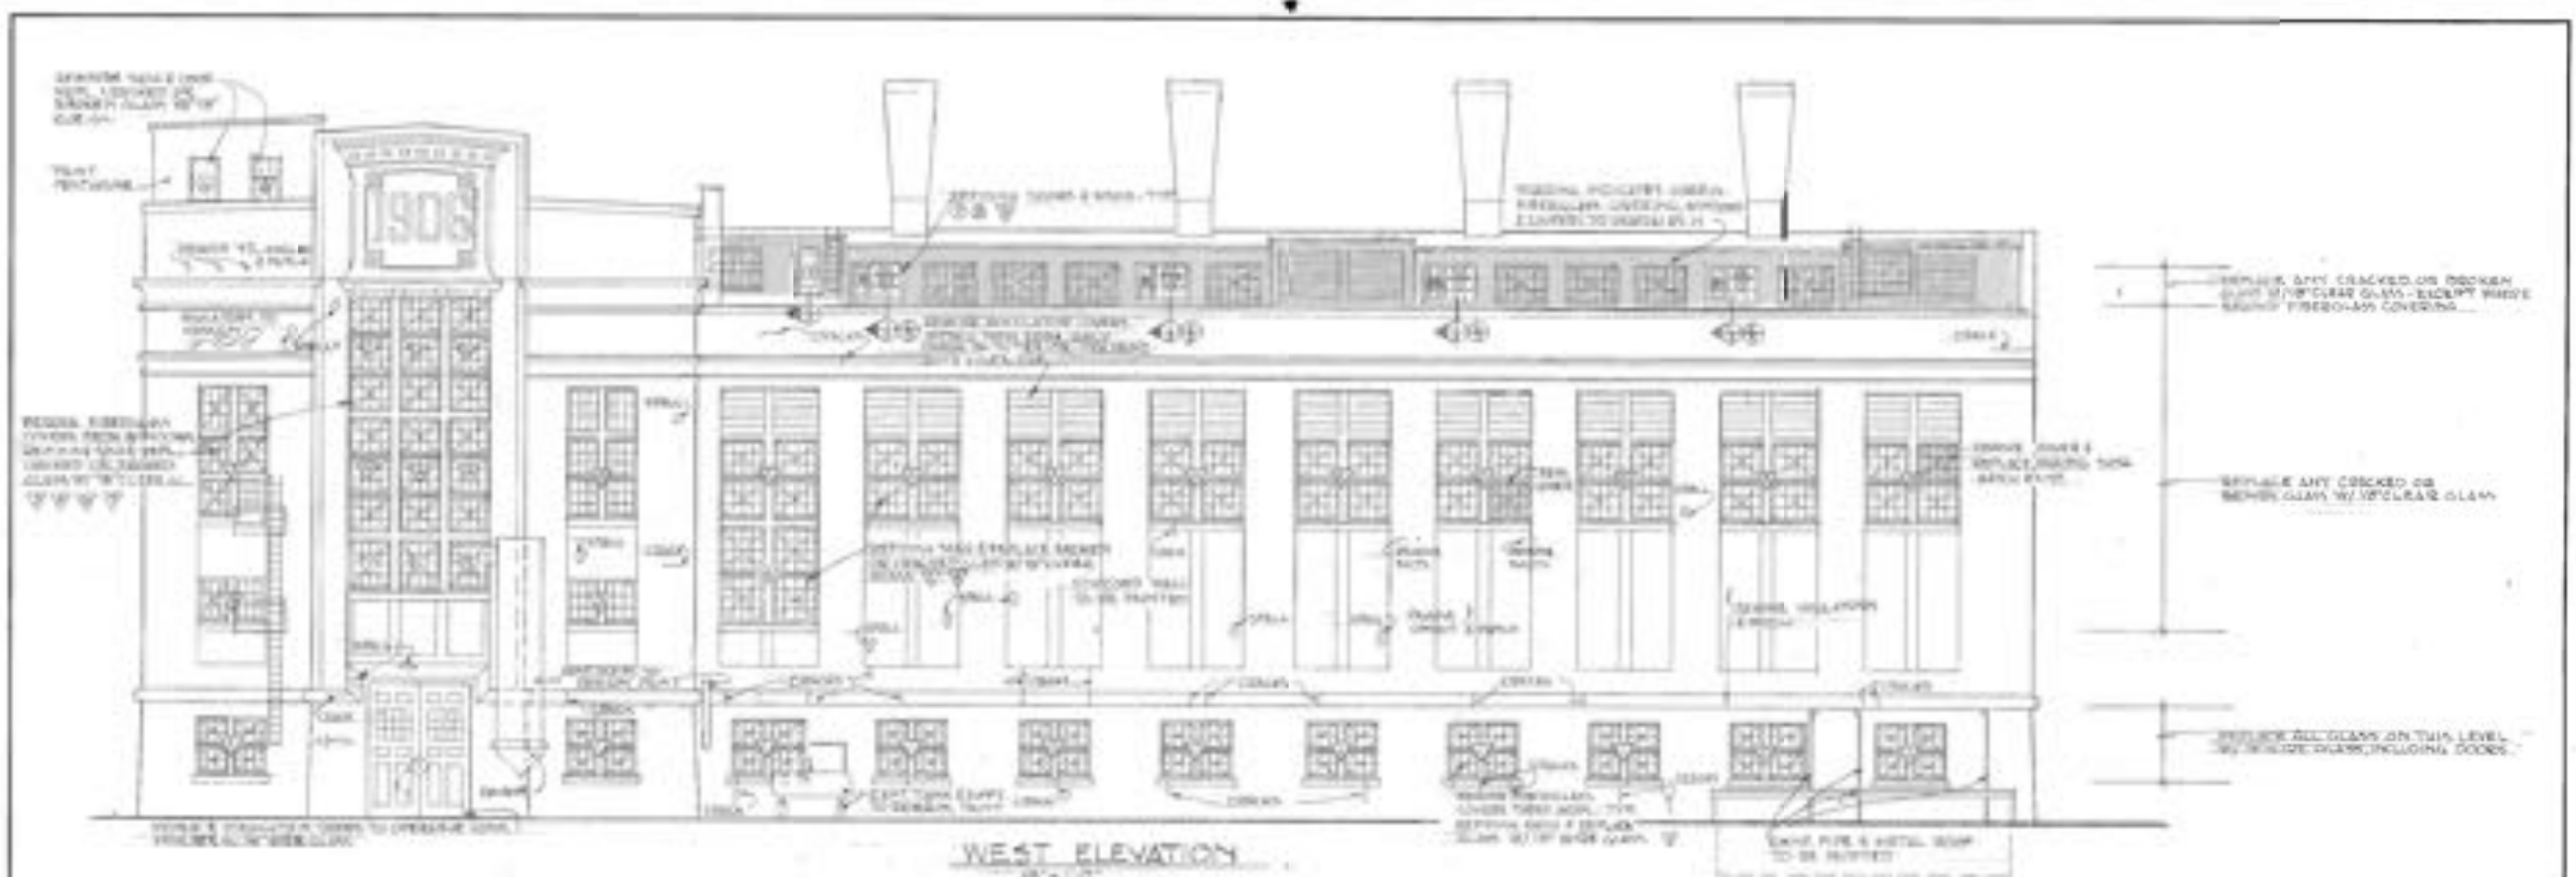
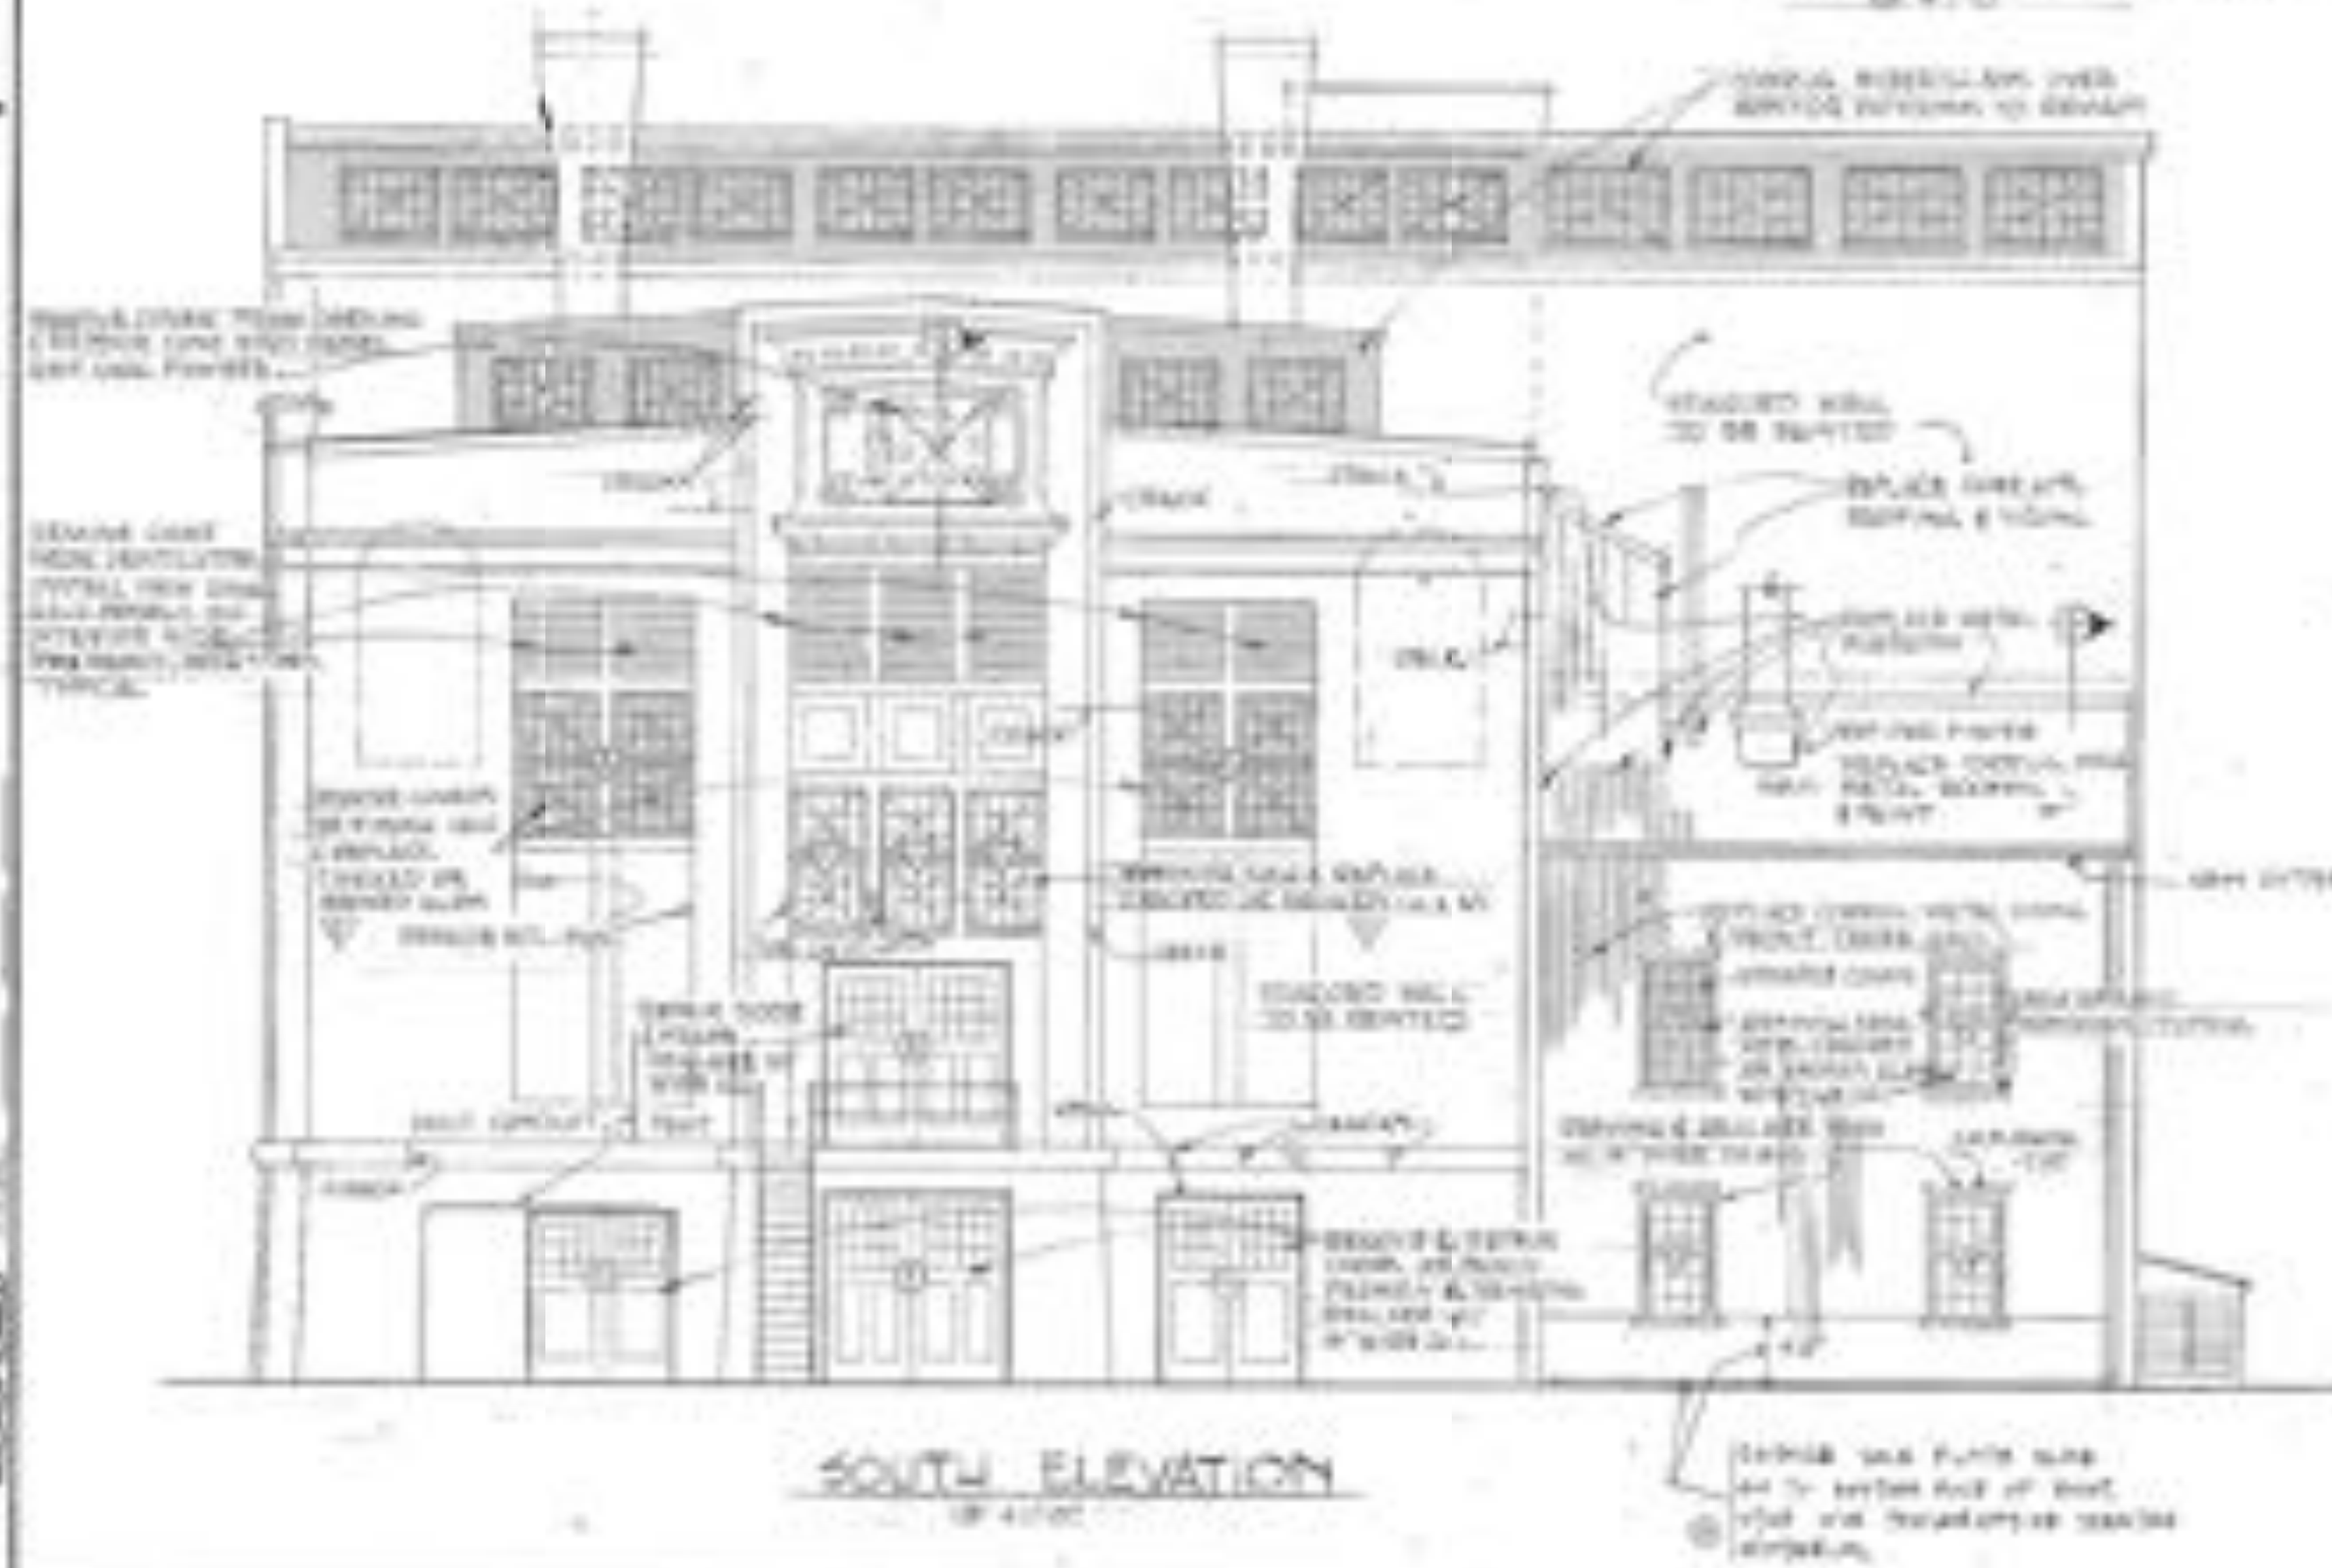
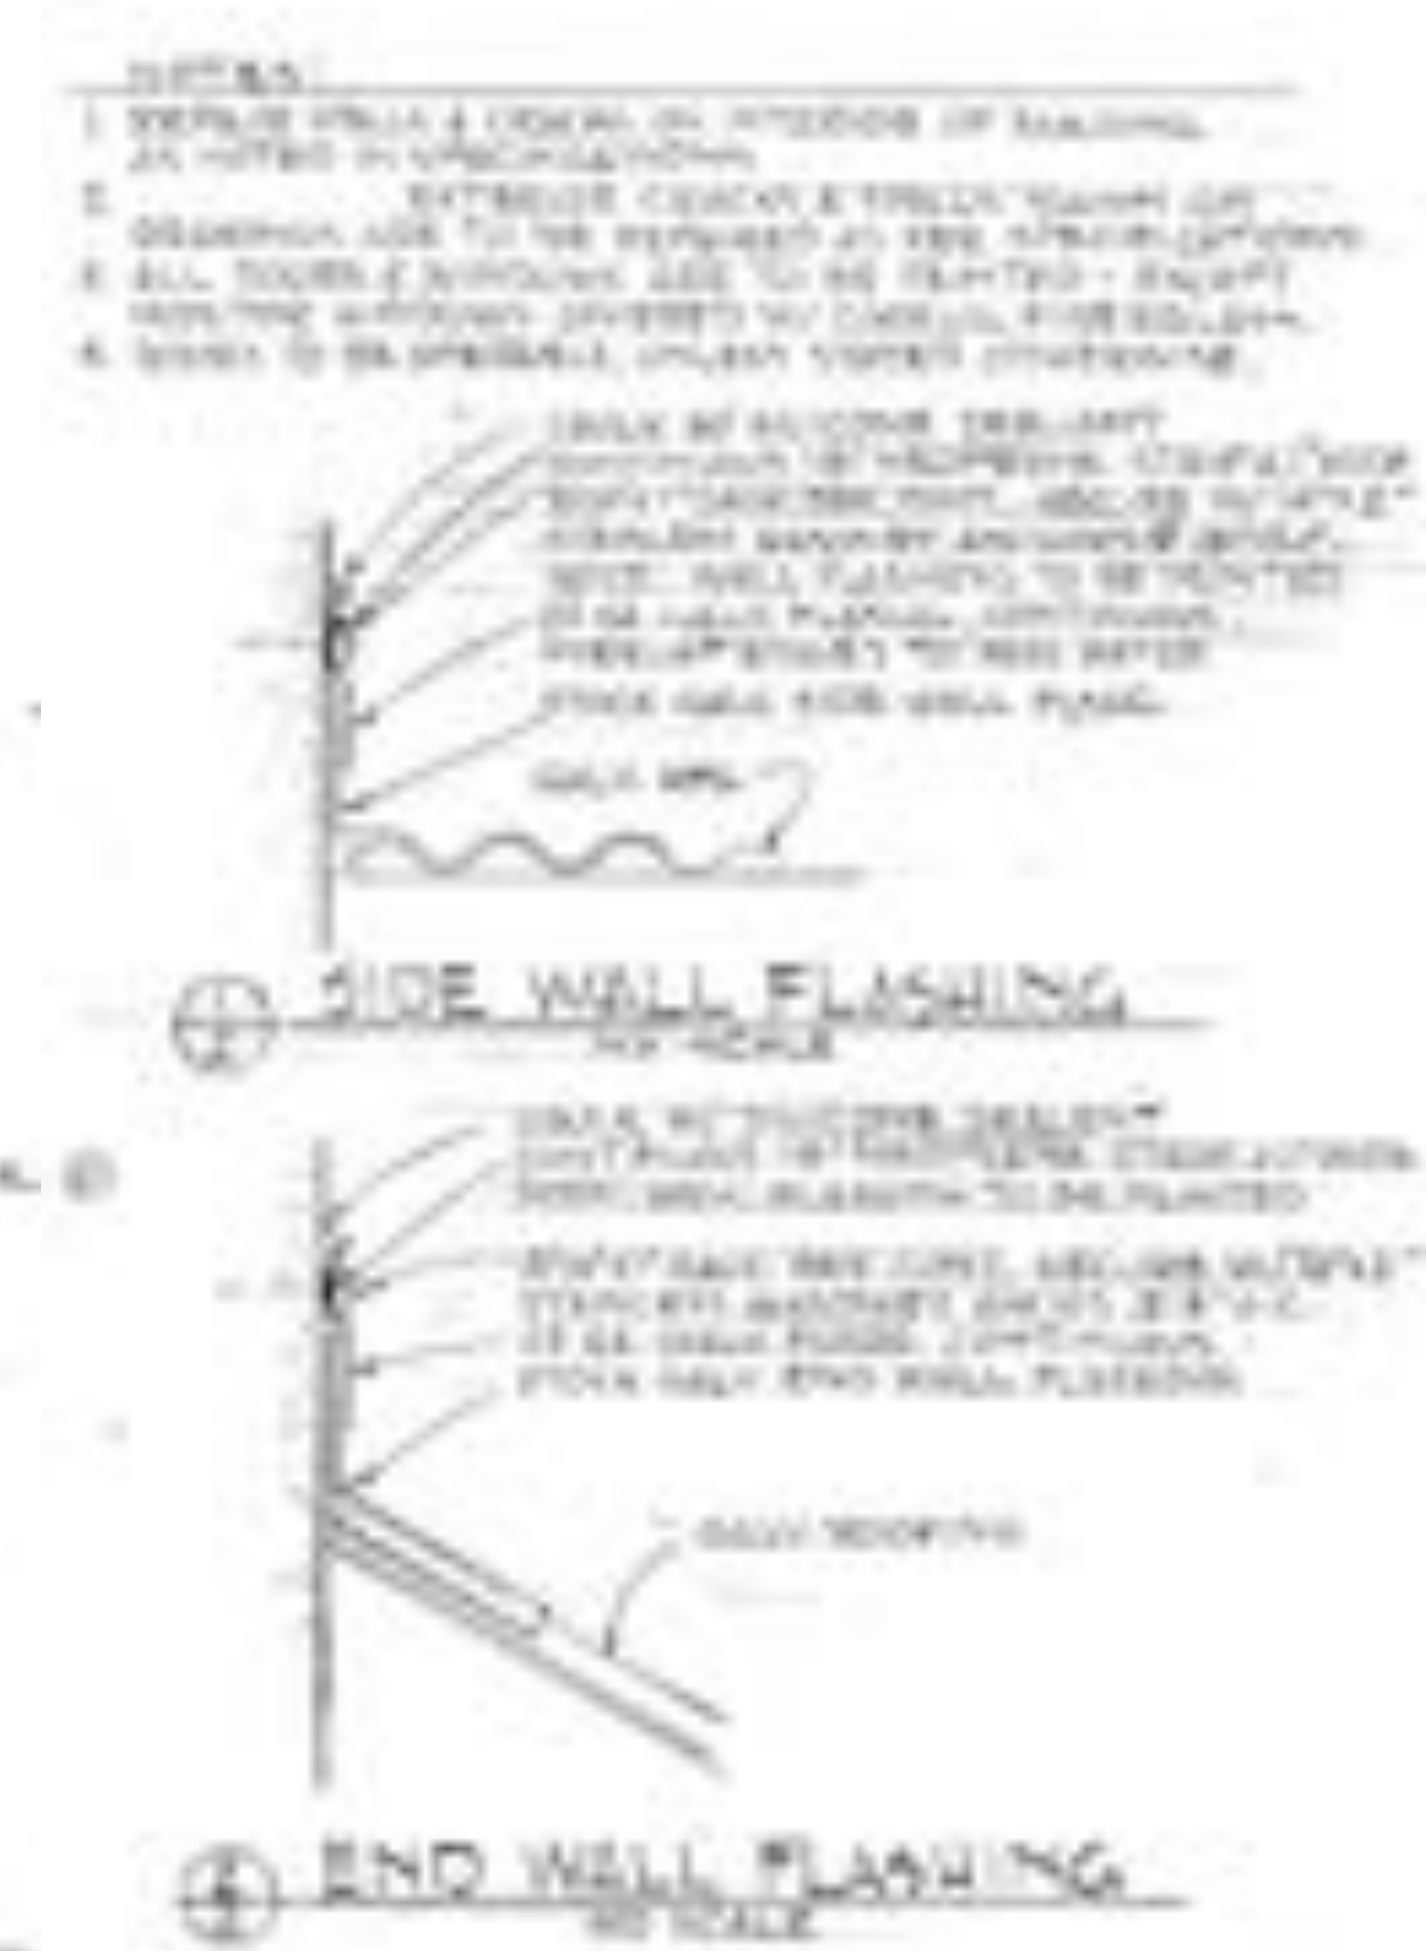
GEORGETOWN STEAM PLANT
 EXTERIOR RENOVATION
 NORTH AND EAST ELEVATIONS
 CLASS A-1
 NUMBER D-28772
 SCALE 1/8" = 1'-0"

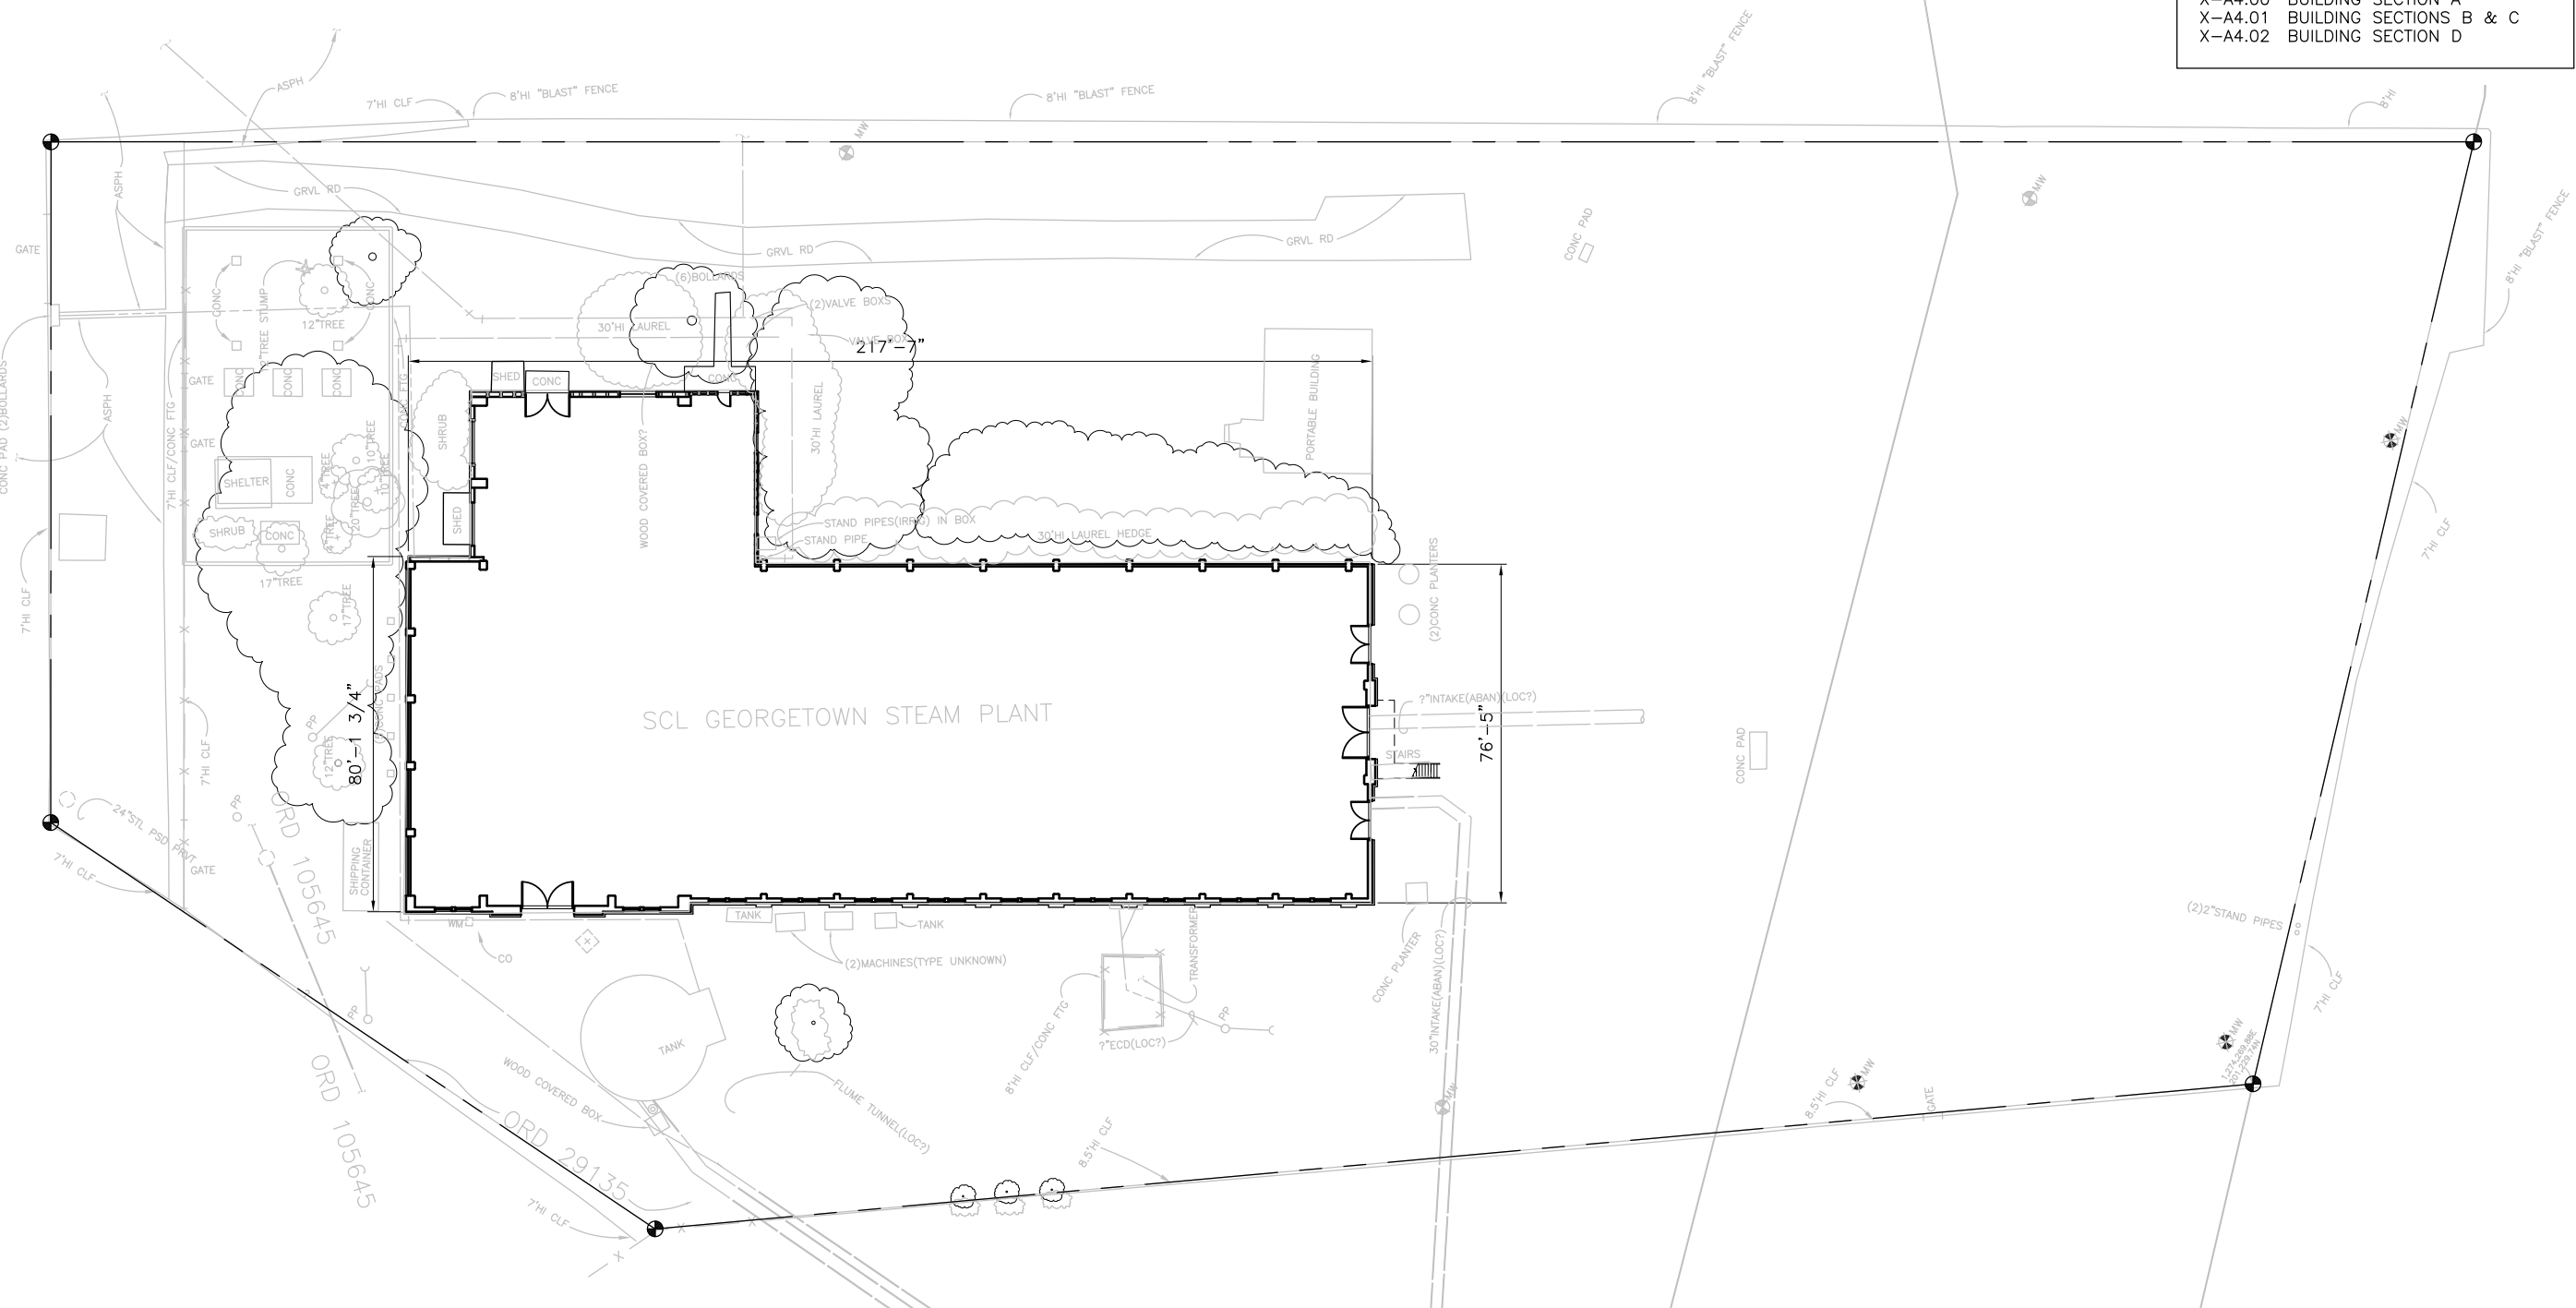
ARCHITECTURAL SITE PLAN
1" = 20'-0"

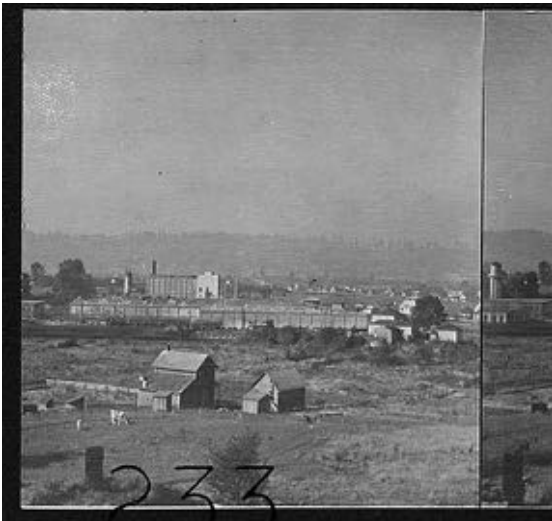
Top left: Looking southwest with the Georgetown Steam Plant visible in the distance,, showing the context in 1907. (MOHAI, image no. 1974.5868.233)

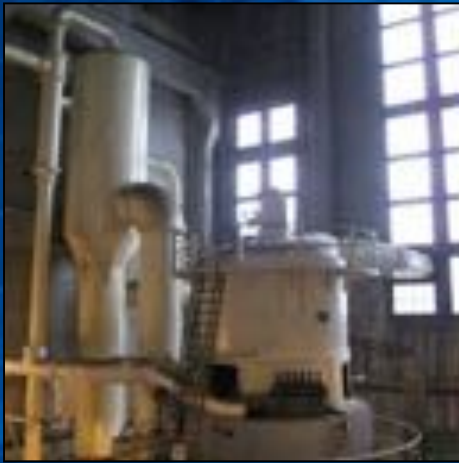
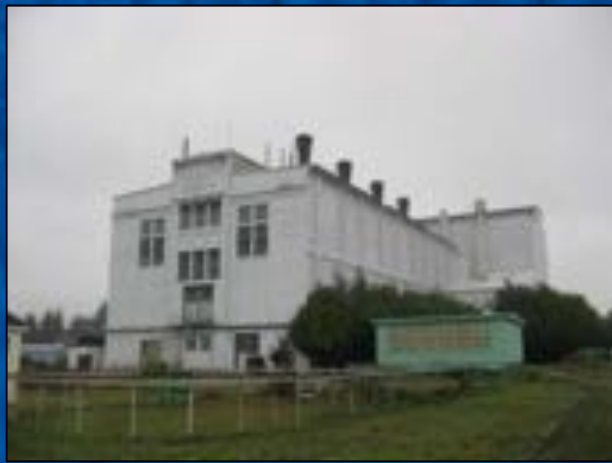
August 2012 | Final Report

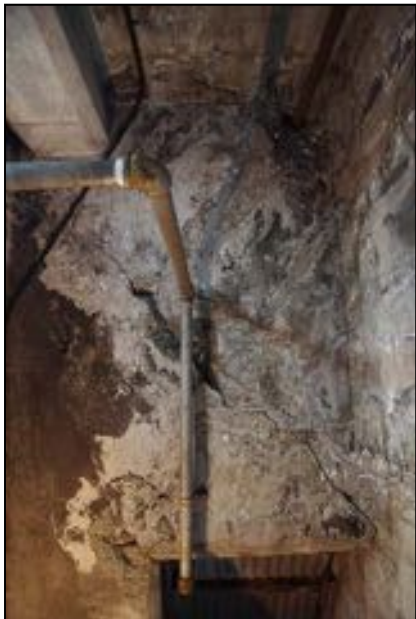
Figure 1-1: Possible Delaminated Concrete Slab Soffit over Stair

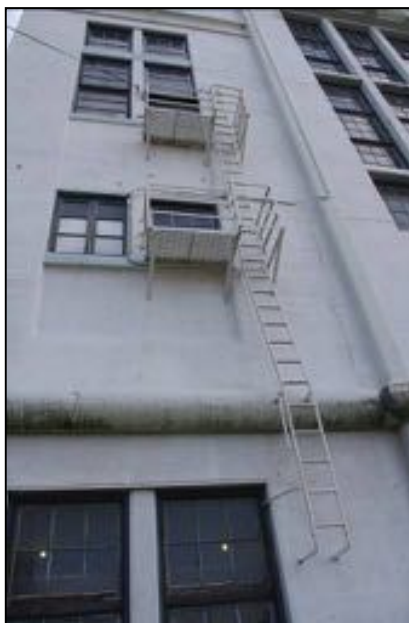
Figure 1-2: Northwest Fire Escape

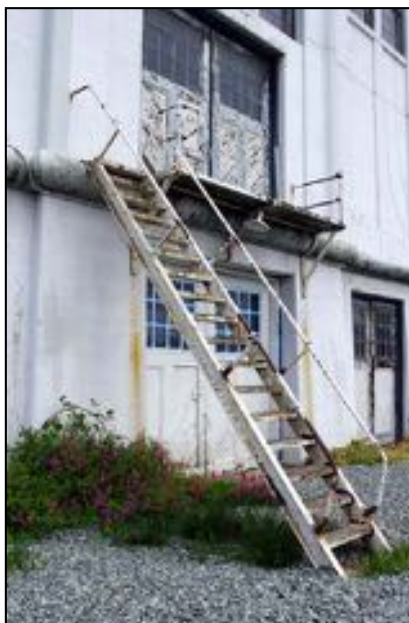
Figure 1-3: South Fire Escape

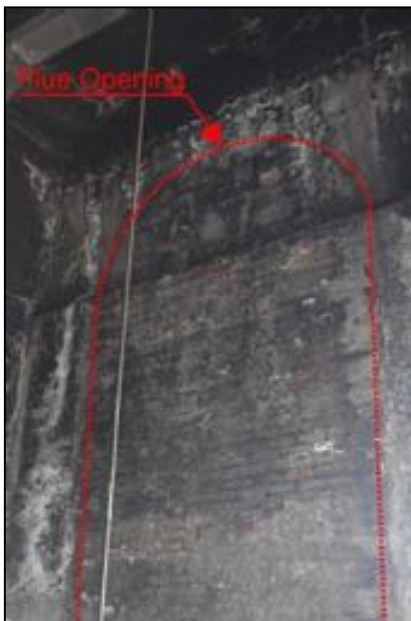
Figure 1-4: Masonry Infilled Flue Opening

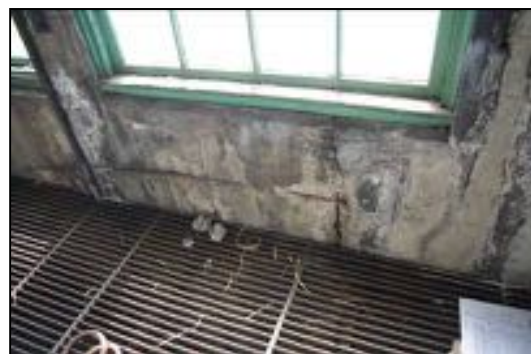
Figure 1-5: Concrete Deterioration below Window Sill

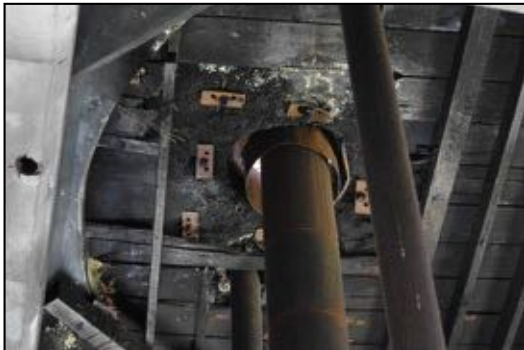
Figure 1-6: Wood infilled stack opening

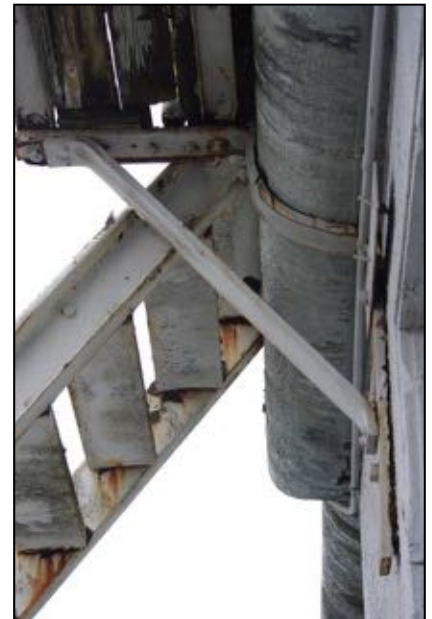
Figure 1-7: South Fire Escape, Detail

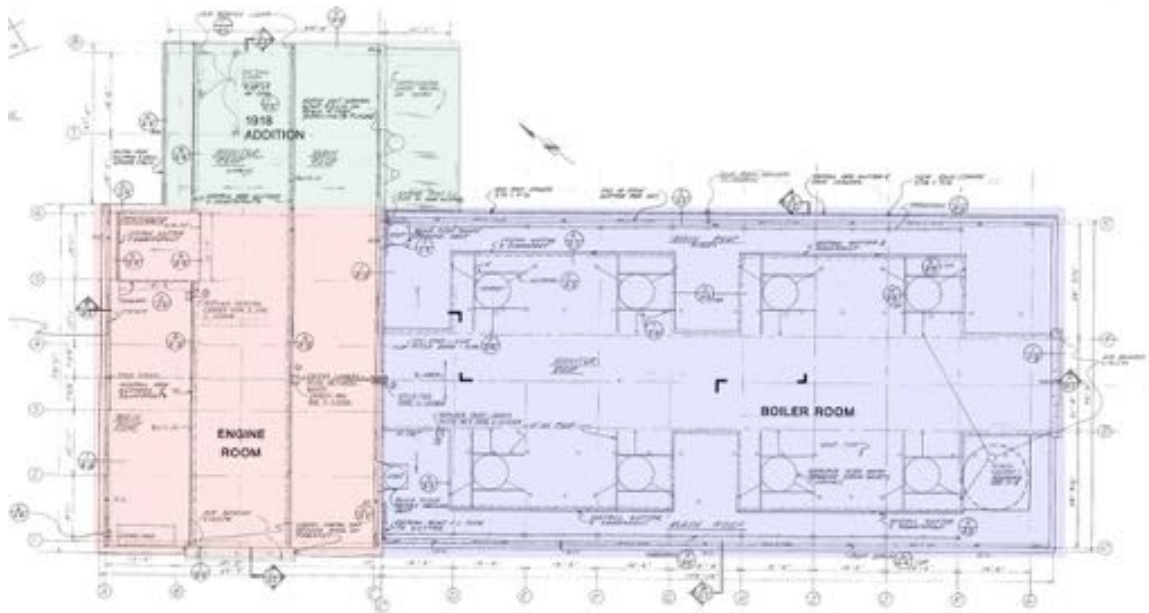
Figure 2-1: Plan view of Georgetown Steam Plant. Plan north is to the left.

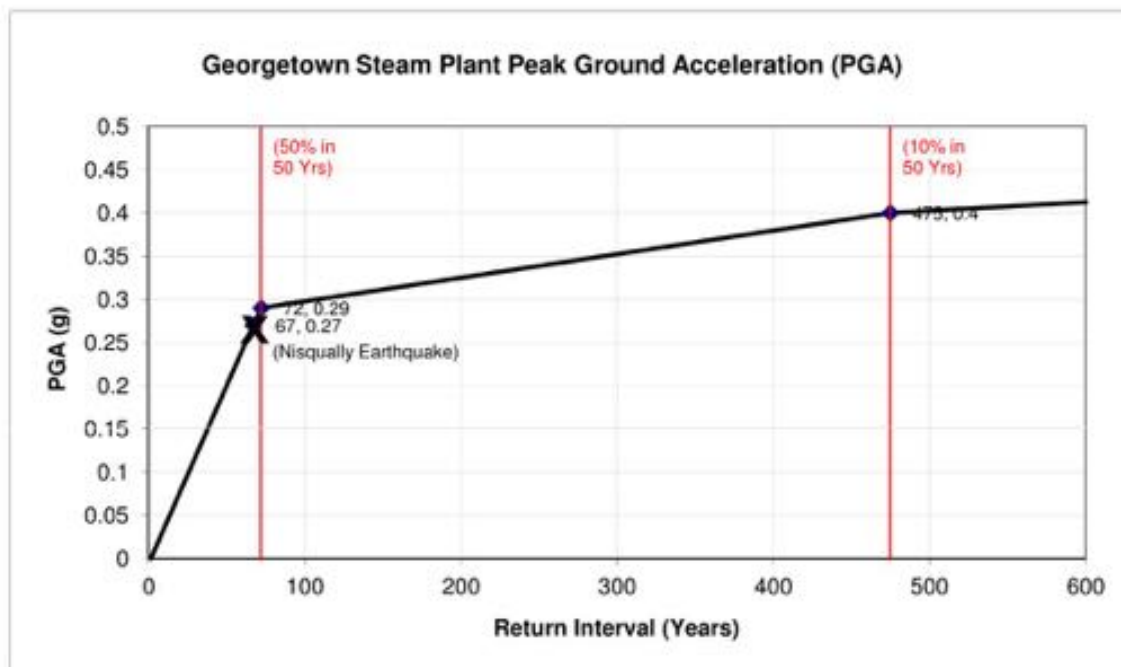
Figure 4-1: Estimated Peak Ground Accelerations at Steam Plant Site (based on 2002 USGS maps, Nisqually Earthquake records)

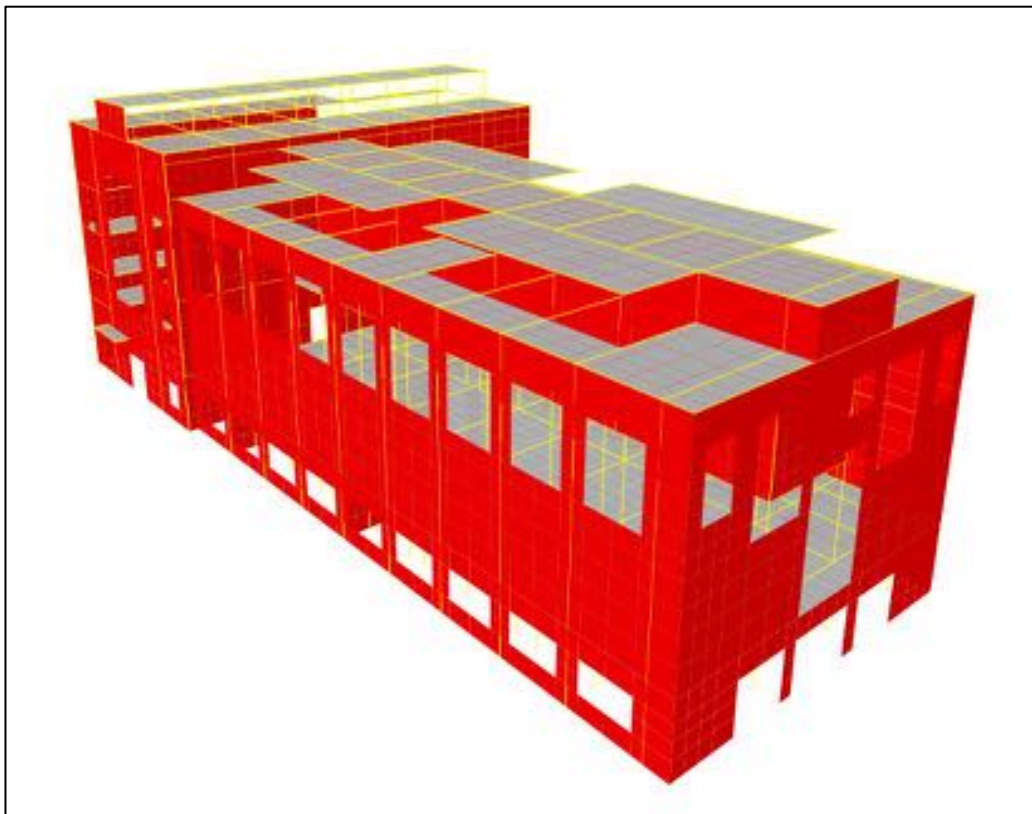
Figure 6-1: Analytical Model of Building

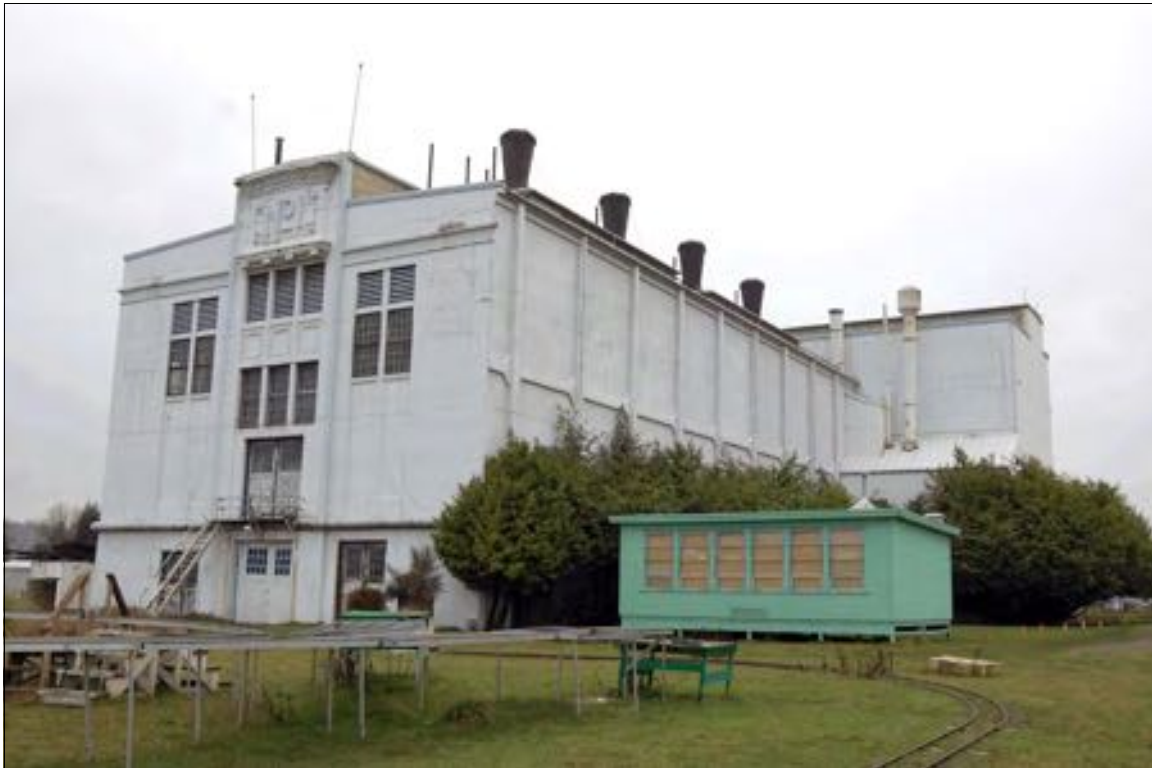
CONTAINS CONFIDENTIAL INFORMATION – NOT FOR GENERAL DISTRIBUTION

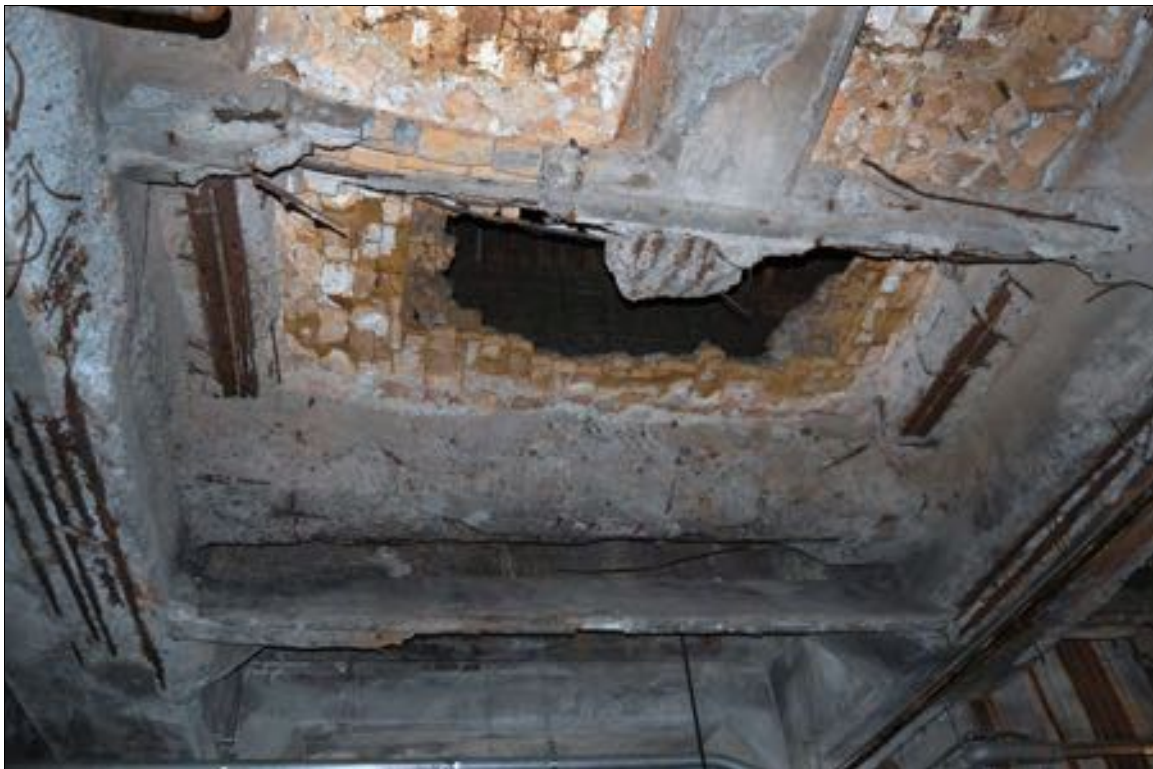
Figure 3. Damage resulting from demolition of ash hopper.

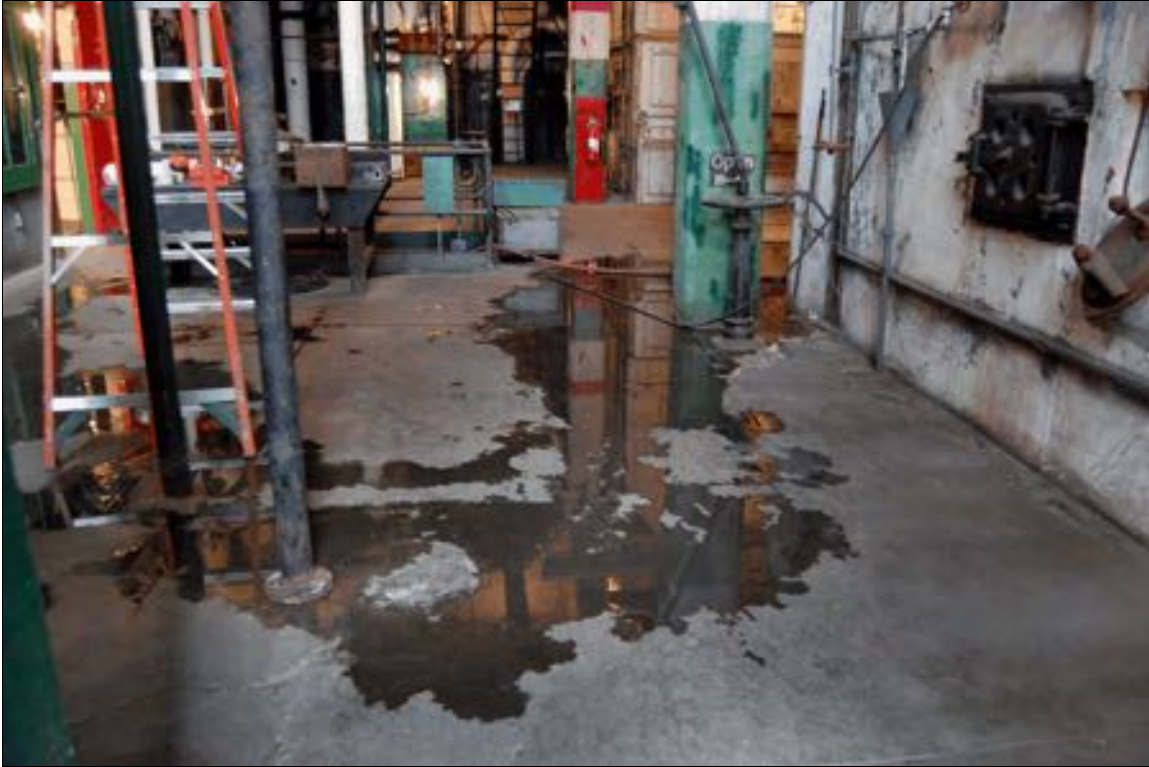
Figure 4. Water pooling at northwest end of boiler room due to roof drain leaks.

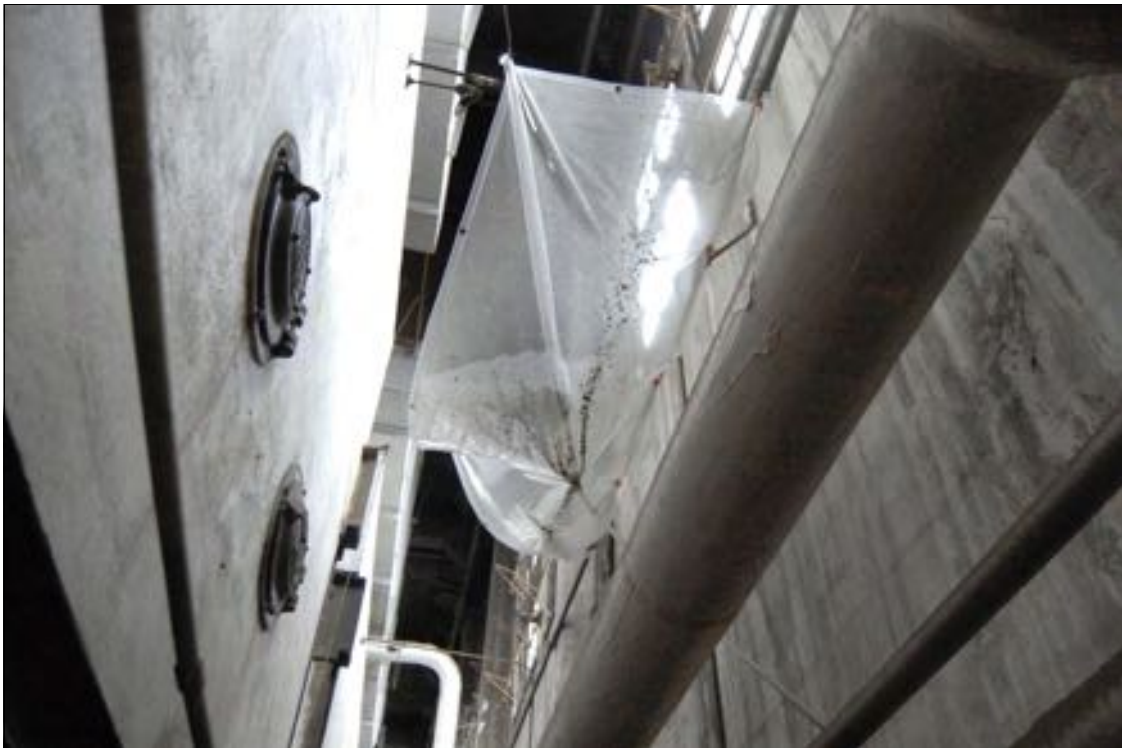
Figure 5. Plastic sheet and pipes used to redirect drain leaks.

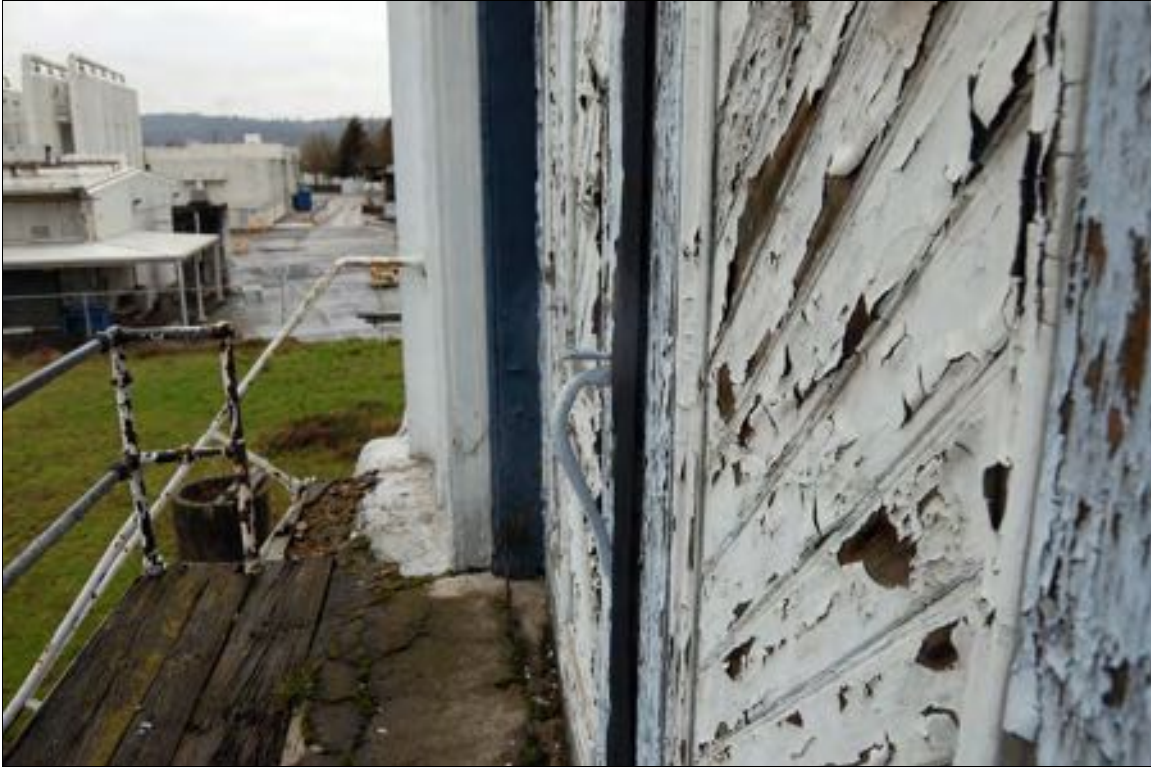
Figure 6. Detail of weathering and deterioration of exterior stair and second level door on southeast side, view to the southwest.

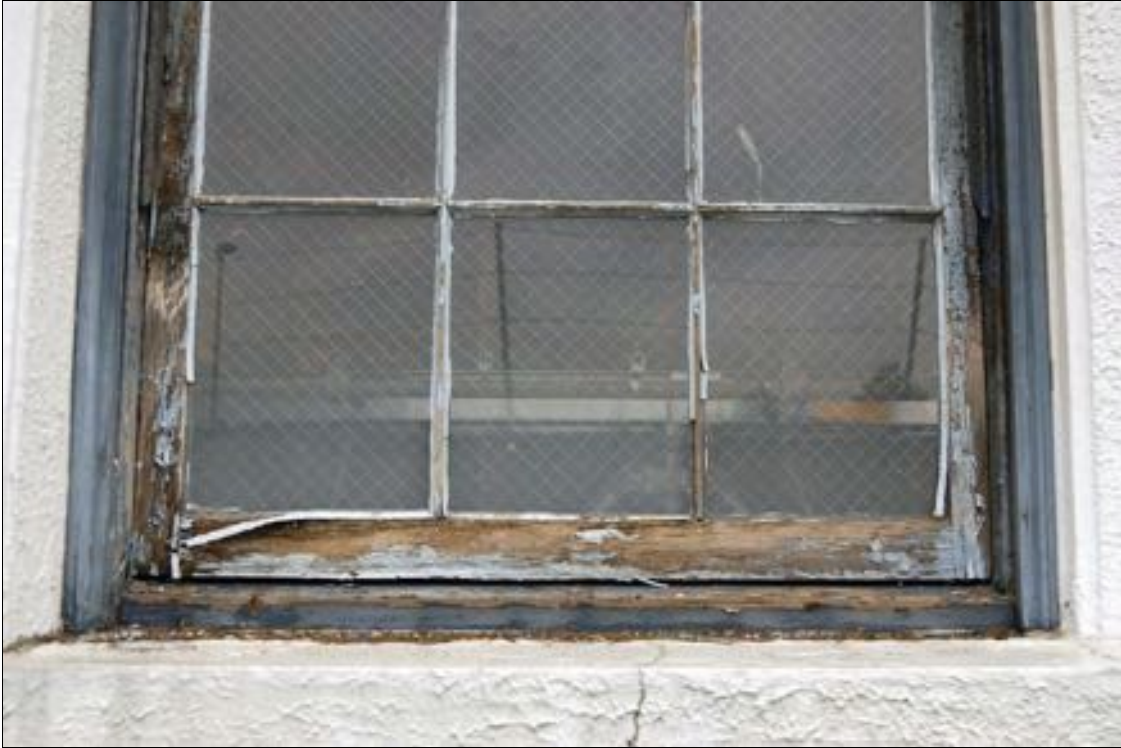
Figure 7. Detail of weathering and deterioration of southwest-facing window, view to the northeast.
