GEORGETOWN STEAM PLANT
HISTORIC STRUCTURE & CULTURAL LANDSCAPE REPORT

OCTOBER 9, 2013

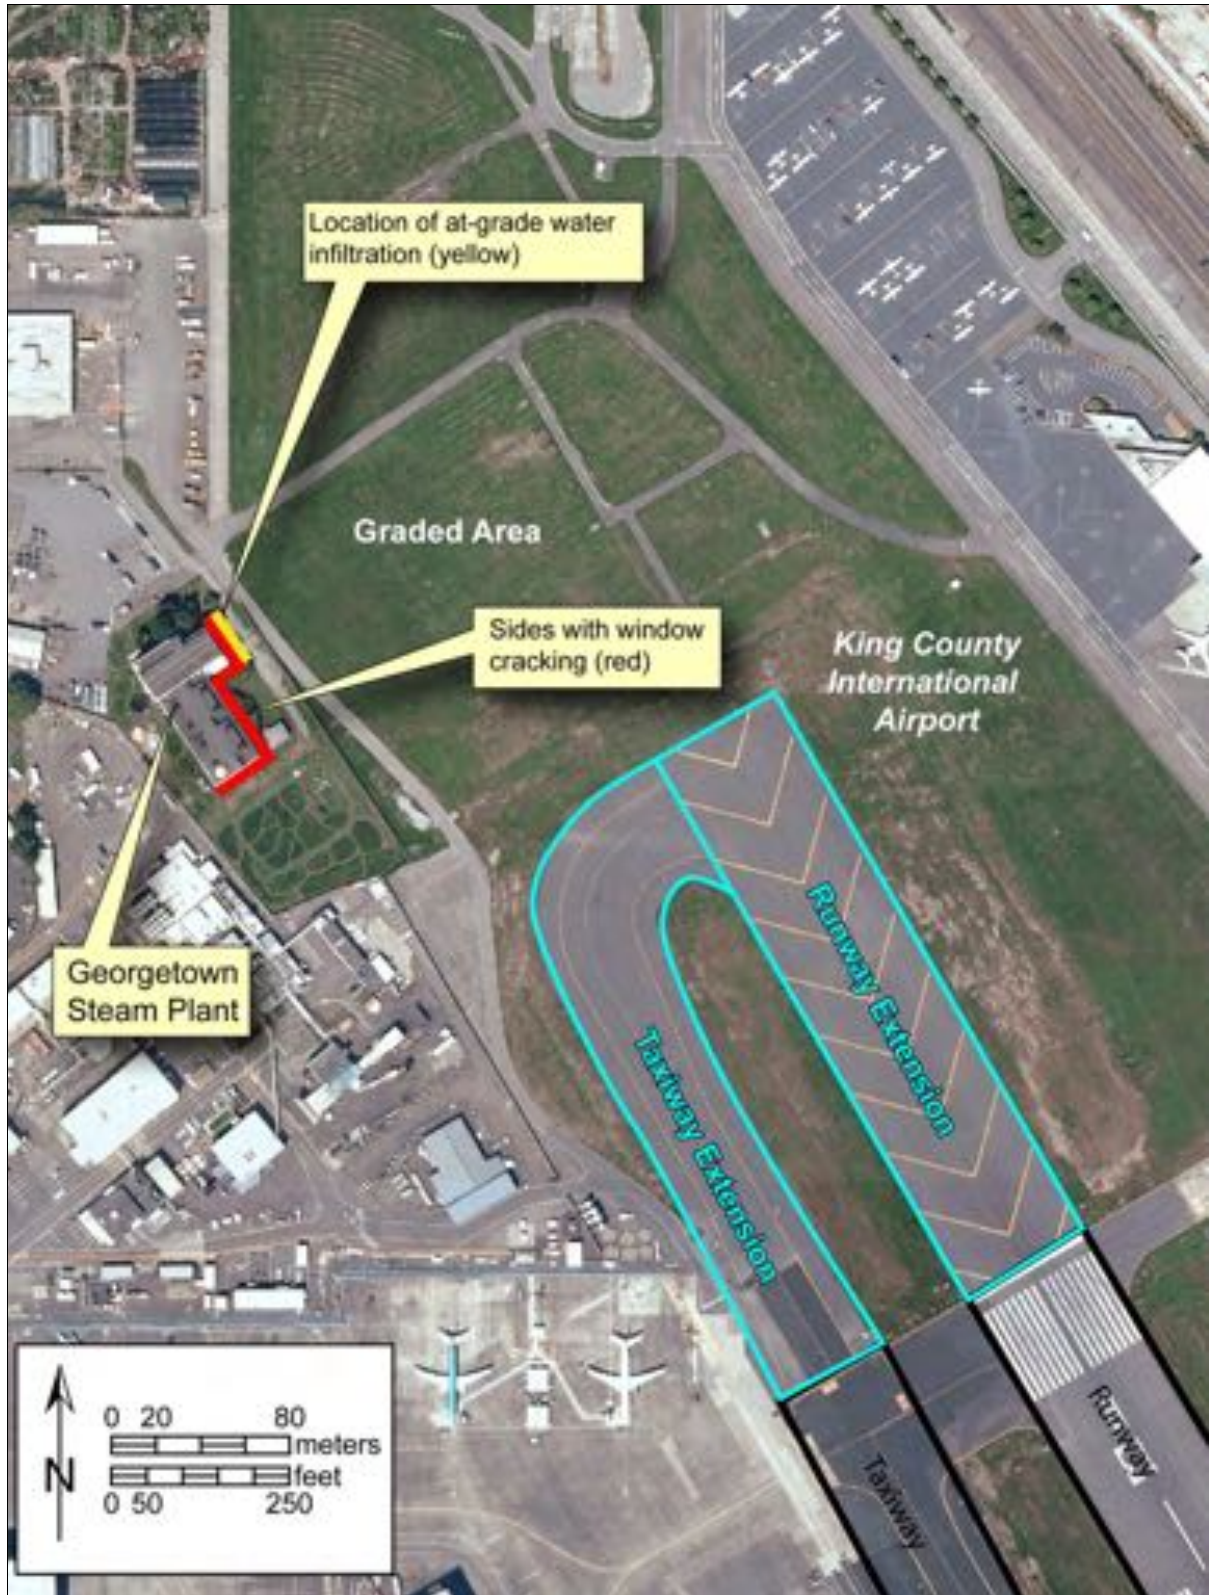
Figure 8. Proximity of airport to steam plant, showing problem areas on northeast and southeast sides of building.

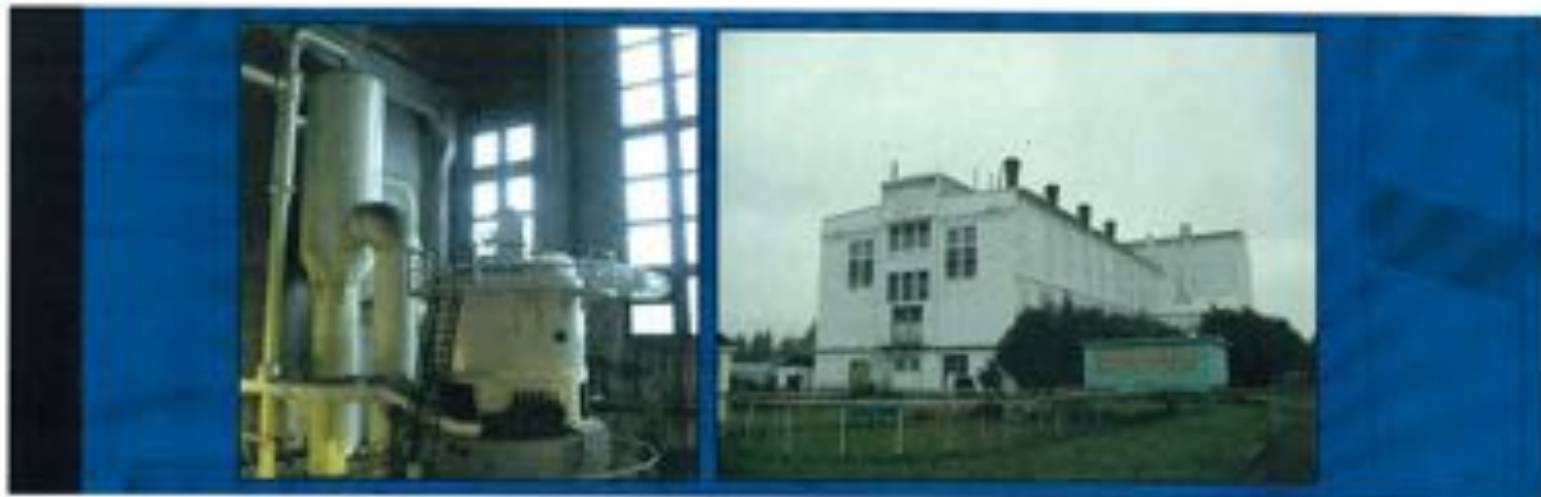
December 2010 | Final Report

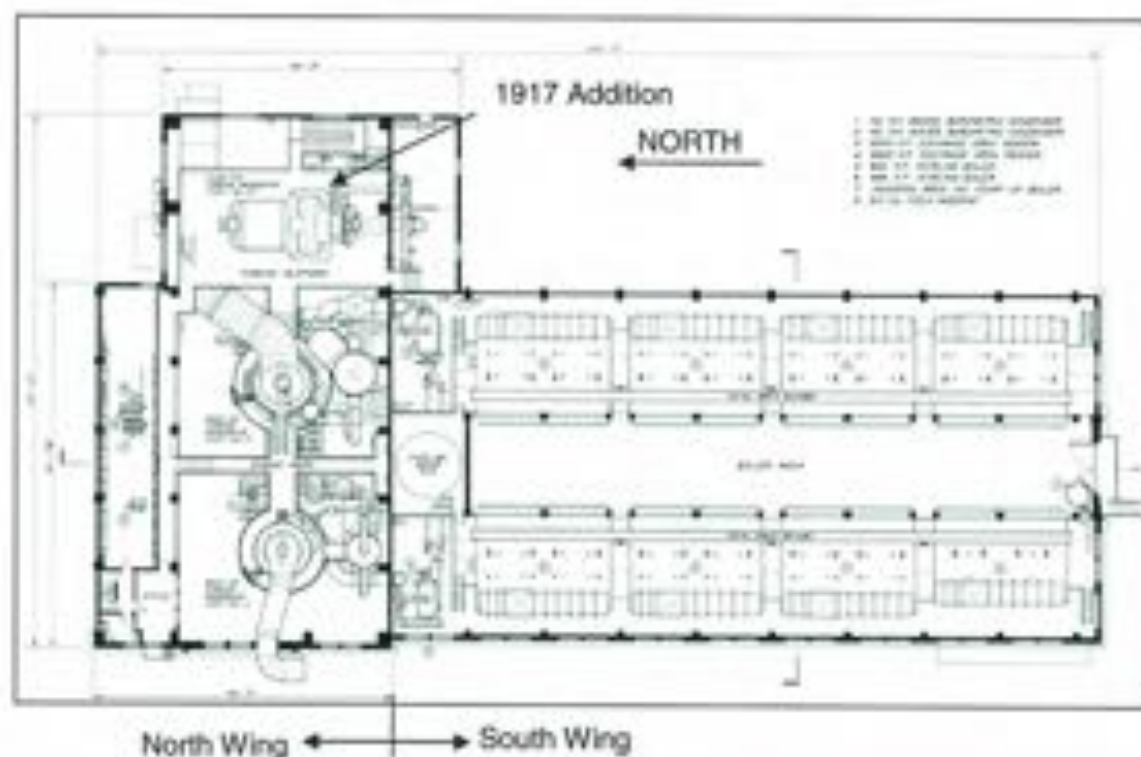
Figure 1-1: Second Floor Plan of Building (Per Historical American Engineering Record, Heritage Conservation & Recreation Service, Barry A. Richards & Yoshikado Koyama, 1982)

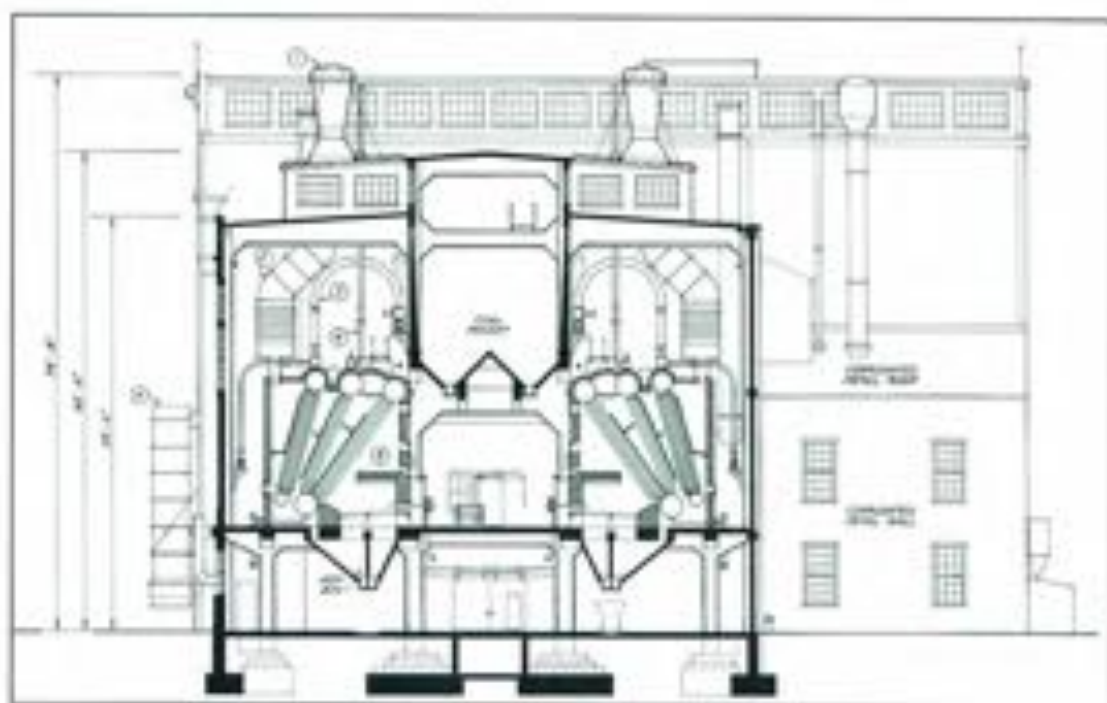
Figure 1-2: Building Section (Per Historical American Engineering Record, Heritage Conservation & Recreation Service, Barry A. Richards & Yoshitako Koyama, 1962)

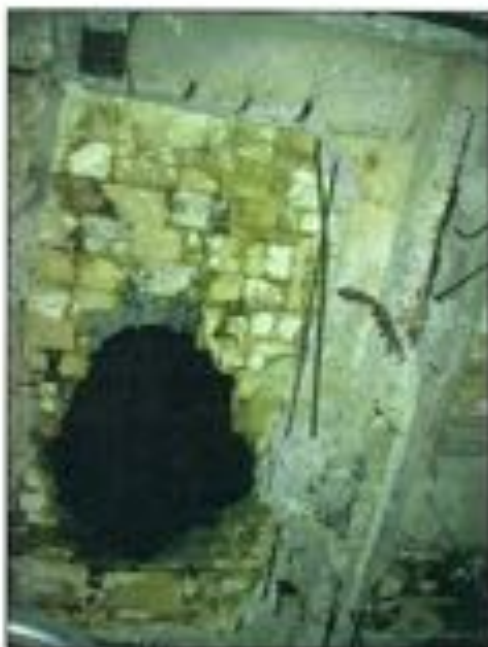
Figure 1-3: Partially demolished ash hopper viewed from below.

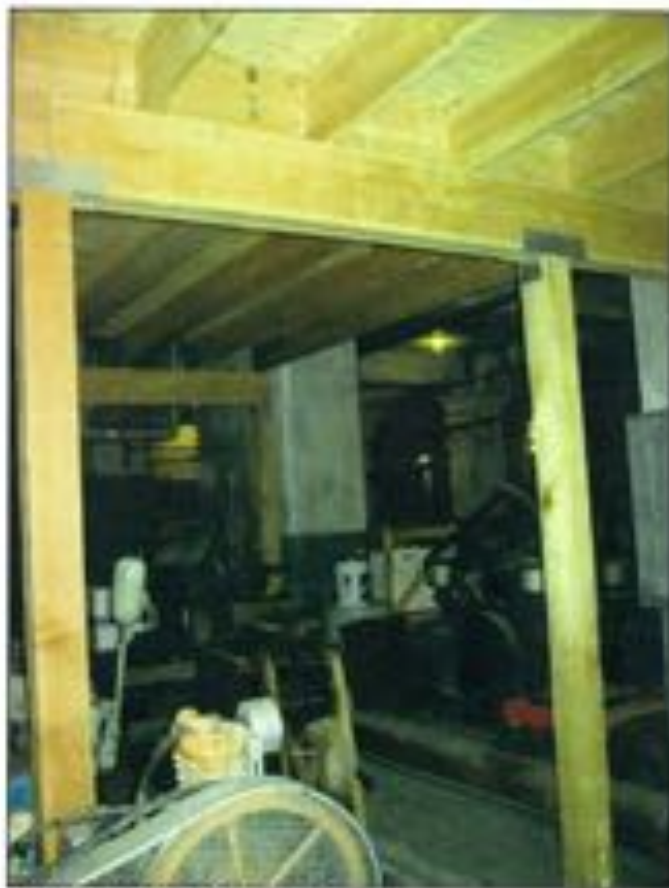
Figure 1-5: Wood platform on west bay.

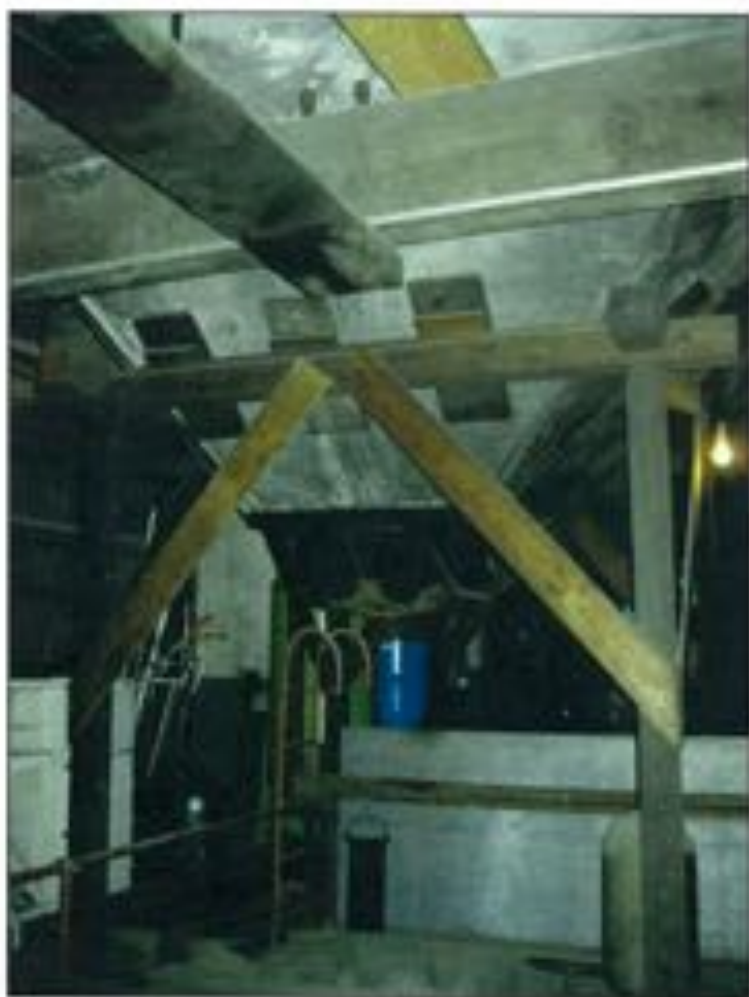
Figure 1-6: Timber shoring of intact ash hopper

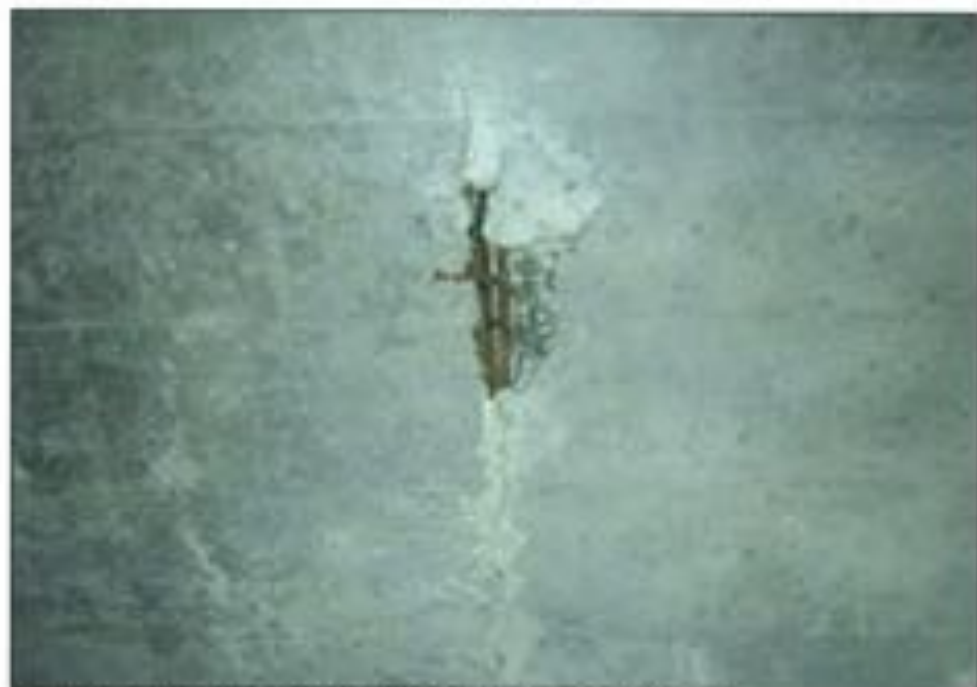
Figure 1-7: Concrete spalling and corrosion of embedded conduit or reinforcement.

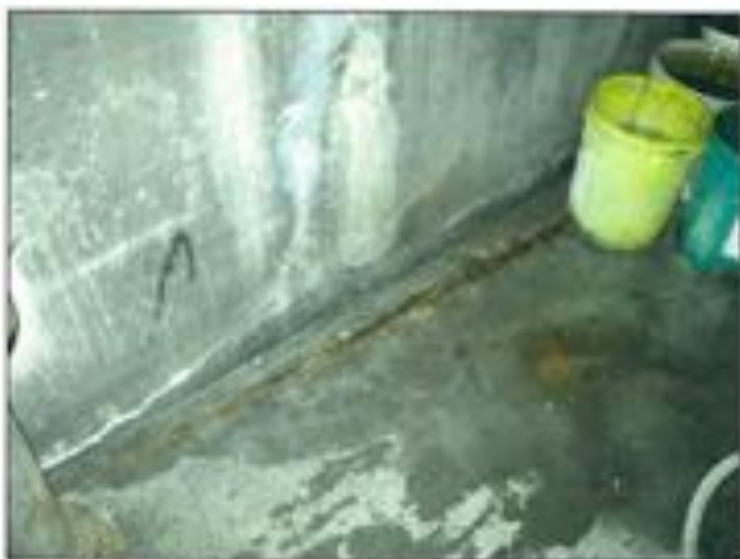
Figure 1-8: Top slab reinforcement corrosion at the second floor on the west street bay.

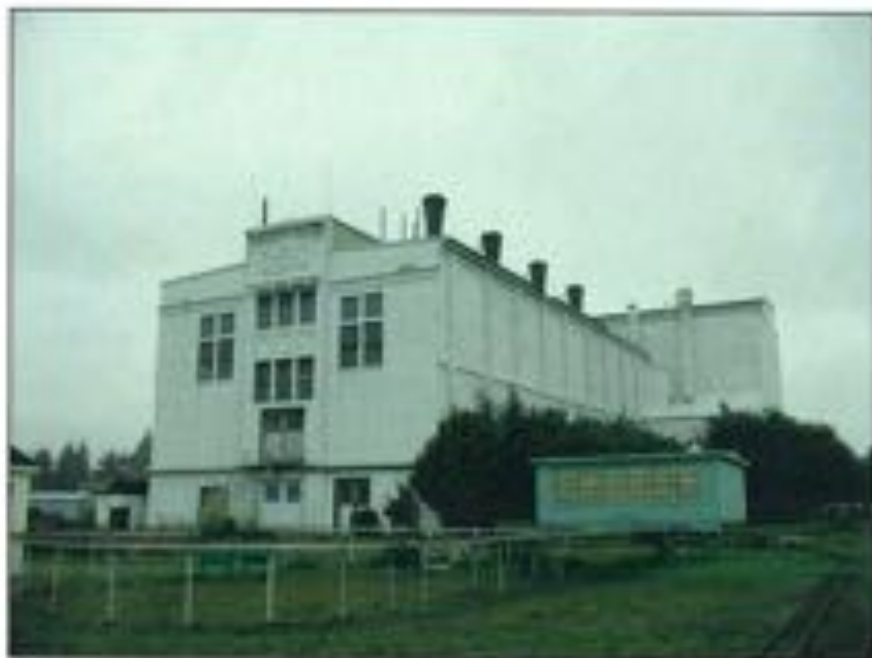
41	Base condition and framing of the east wall of the north addition	A-22
42	Overall framing of the interior of the east wall of the north addition	A-22

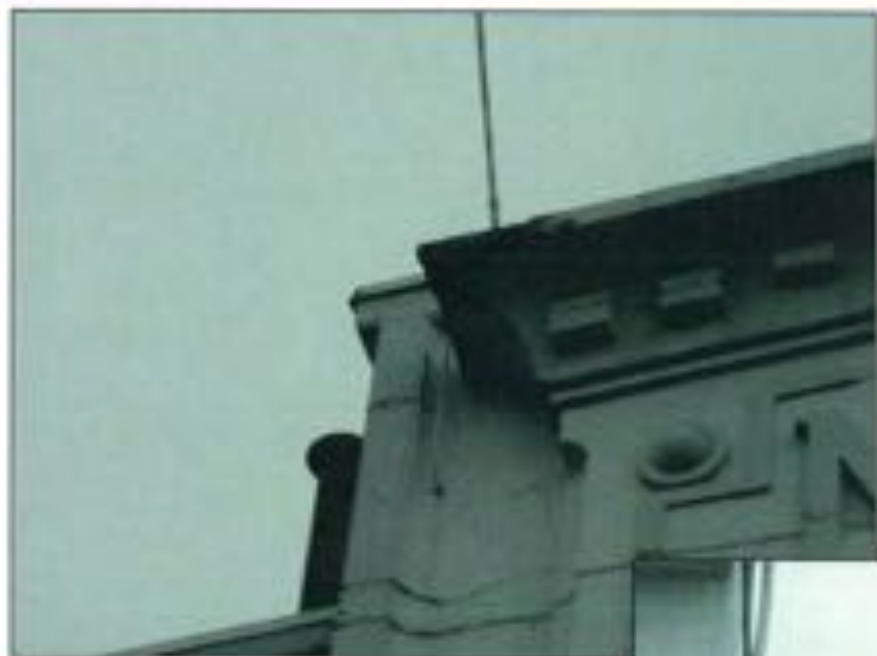
Photo 1 - Overall southeast elevation view of Georgetown Steam Plant.
Photo 2 - Top of south façade with cracks and exposure of concrete.

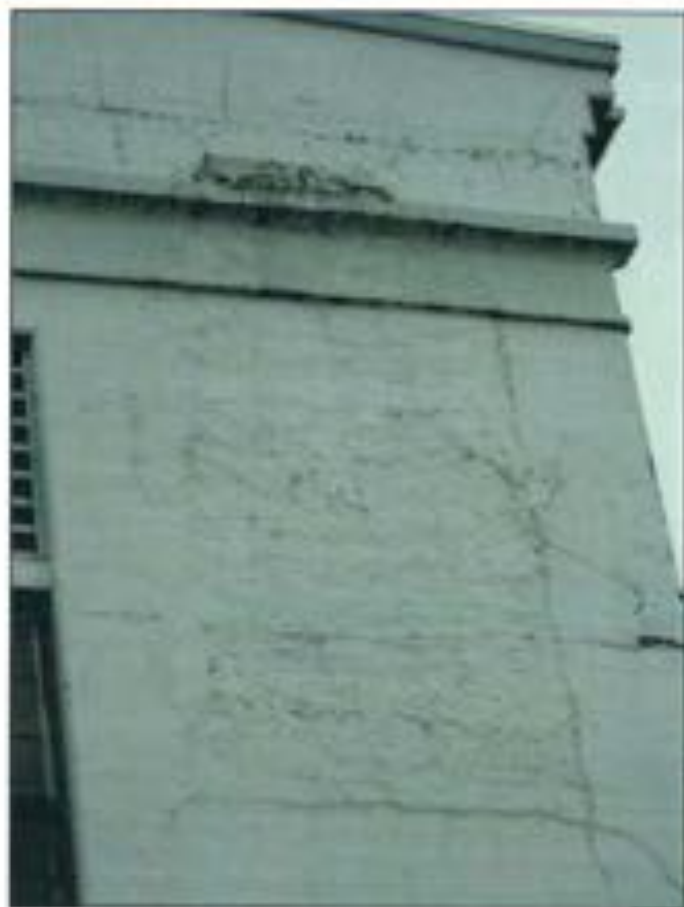
Photo 4 – Top of south façade at west ledge.

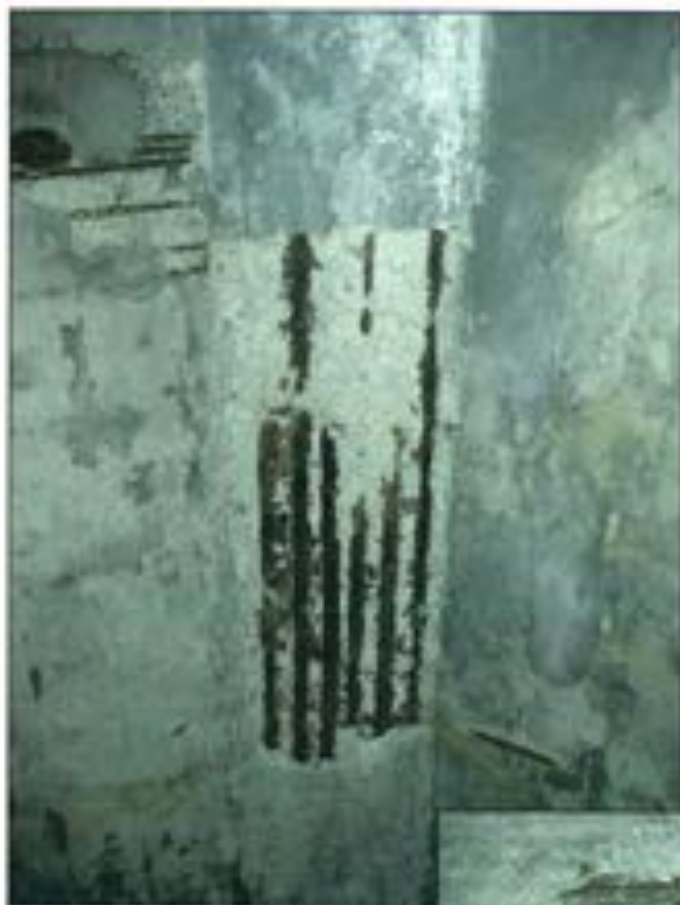
Photo 8 - Existing condition of the damaged ash hoppers.

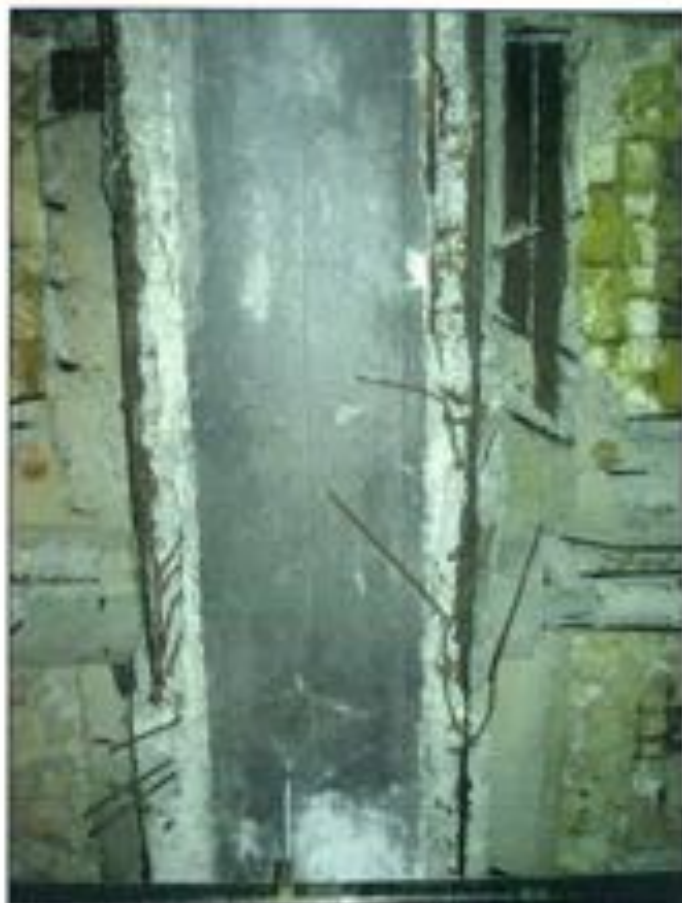
Photo 9 - Exposed beam reinforcement at the damaged ash hoppers.
Photo 10 - Existing condition of the damaged ash hoppers.

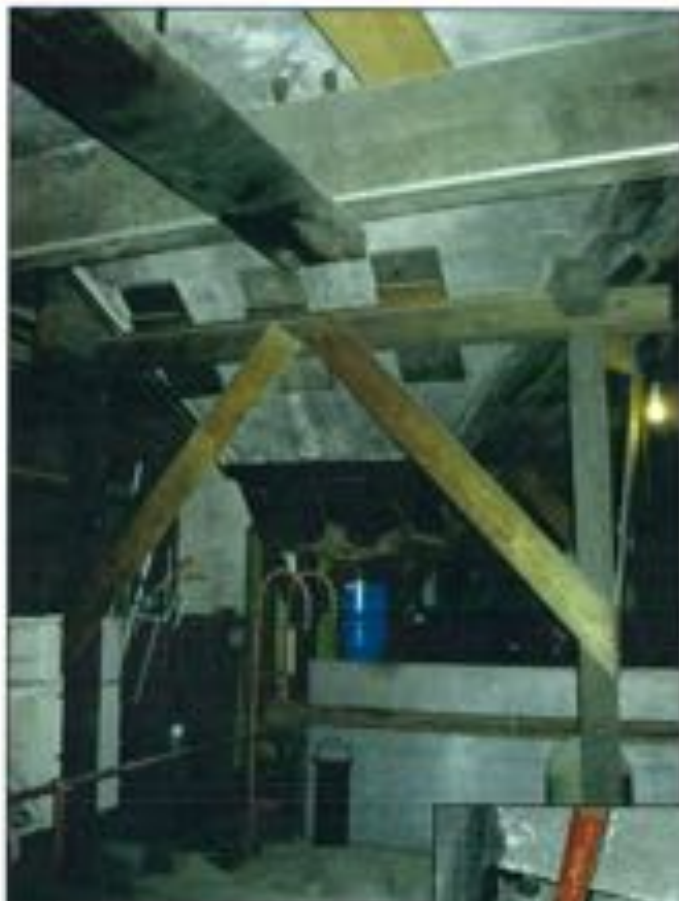
Photo 11 – Exposed beam reinforcement at the damaged ash hoppers,
Photo 12 – Added overhead shoring below damaged ash hoppers in the east bay.

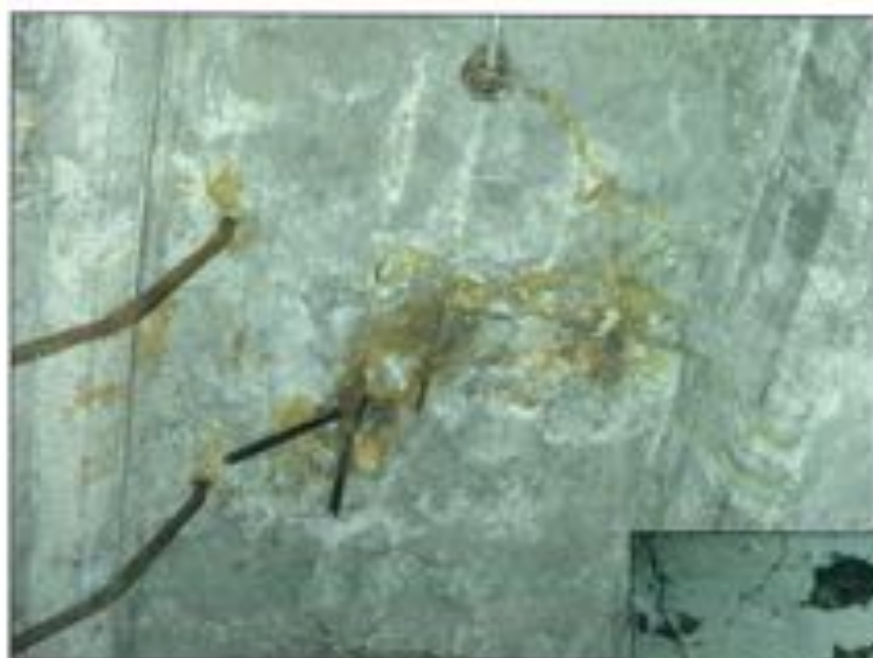
Photo 16 - Concrete damage and concrete staining of the intact ash hoppers.

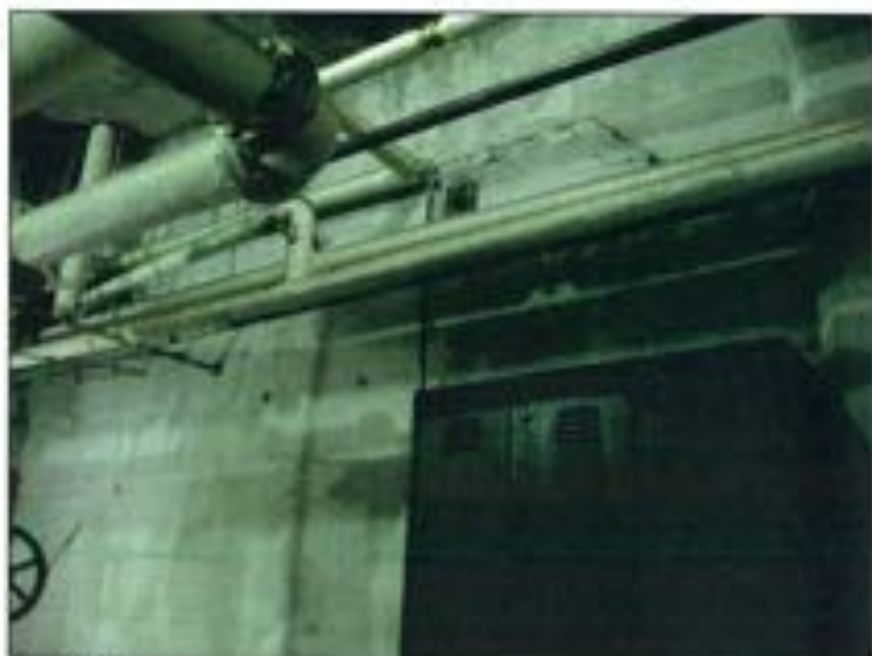
Photo 17 - Corrosion of original supports and concrete damage of the intact ash hoppers.
Photo 18 - Overhead concrete spalling at the second vertical generator foundation.

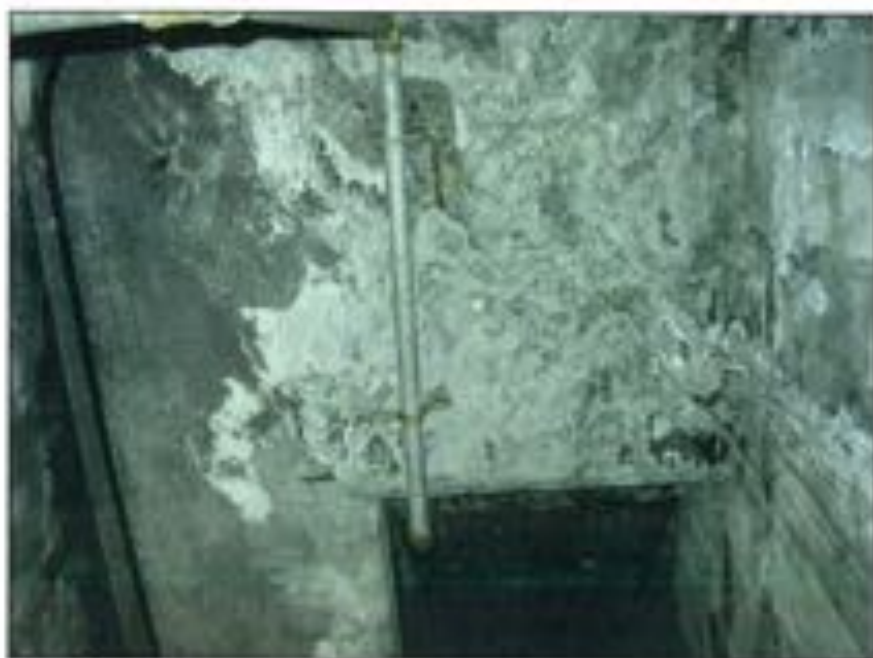
Photo 20 - Exposed wall reinforcement at the southwest corner.

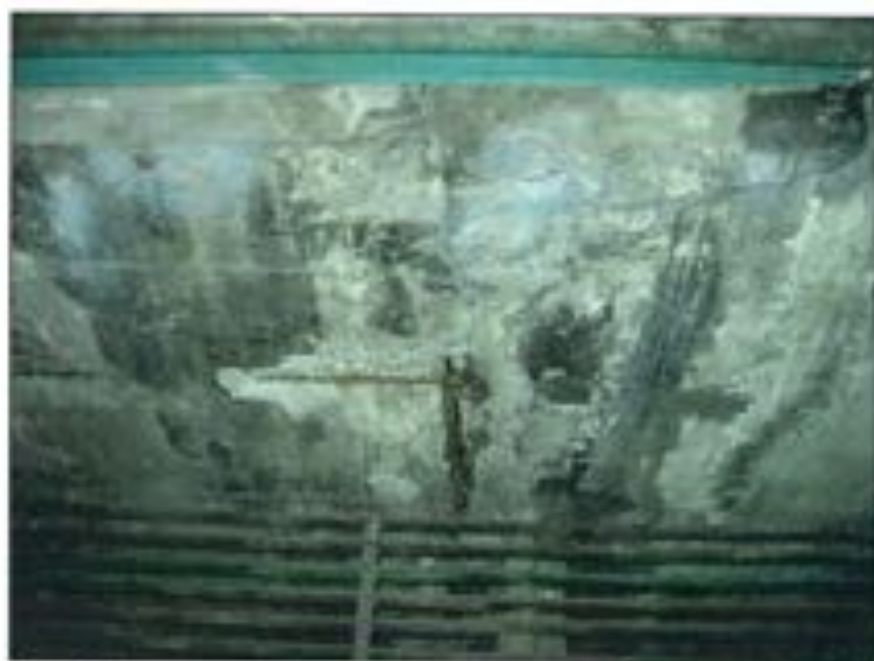
Photo 21 – Water staining and concrete spalling at the southwest corner of the second floor.
Photo 22 – Steel corrosion at the top of slab on the second floor below observed exterior leak.

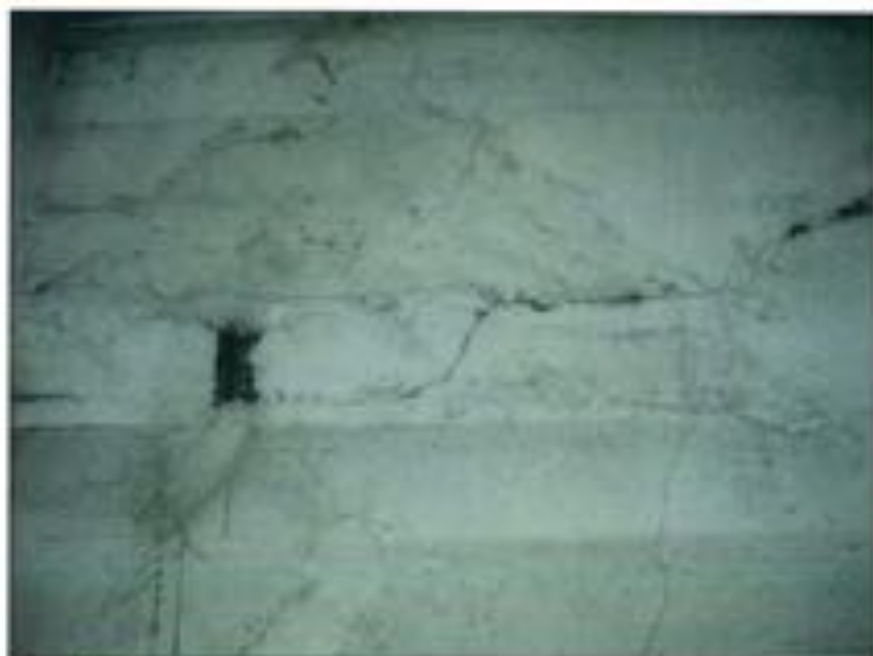
Photo 24 - Concrete spalling at roof in middle bay of south portion.

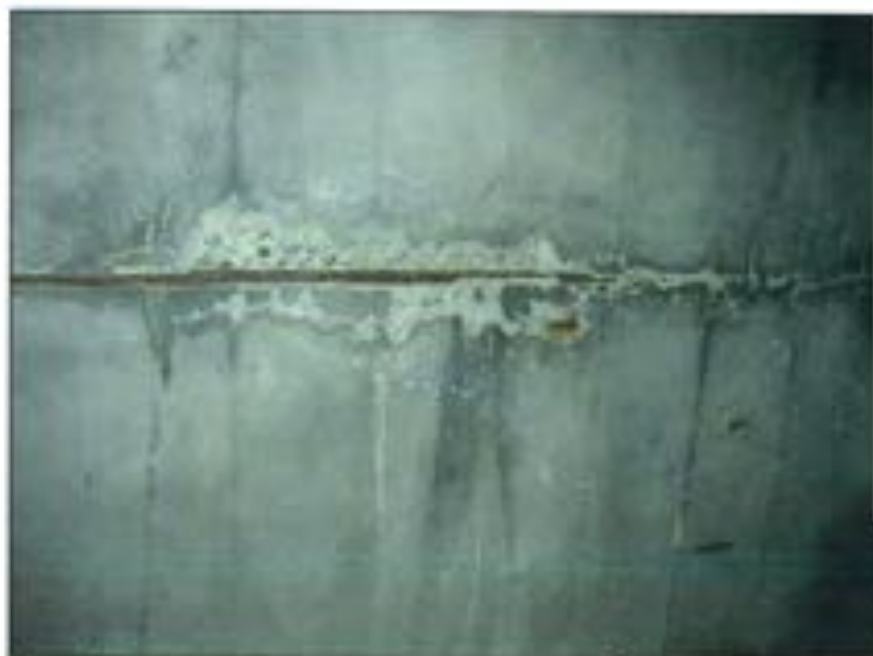
Photo 25 - Concrete cracking in exterior east wall middle pay of south portion.
Photo 26 - Water staining of concrete below the window.

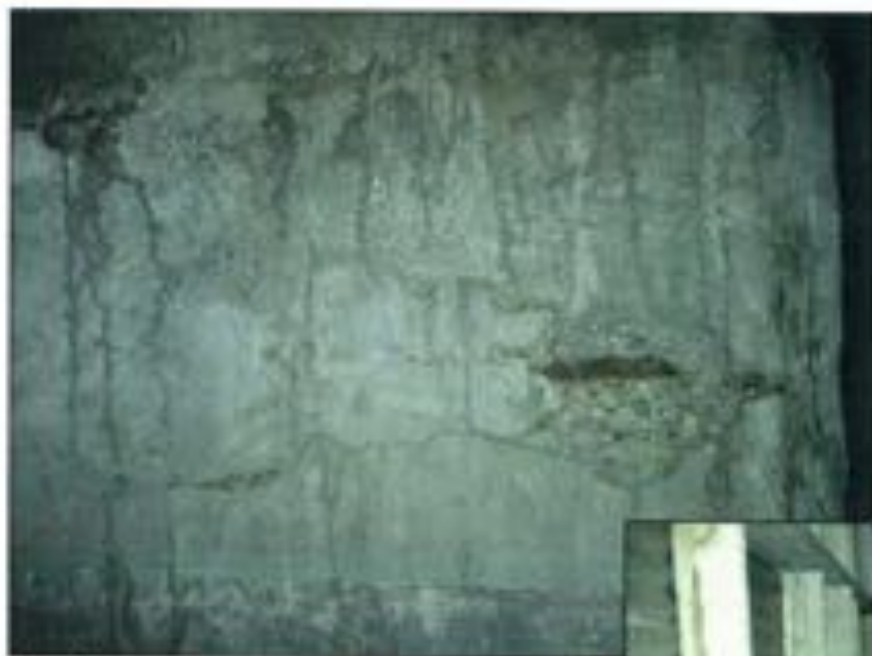
Photo 28 - Concrete staining and reinforcement corrosion at the east addition at the second floor.

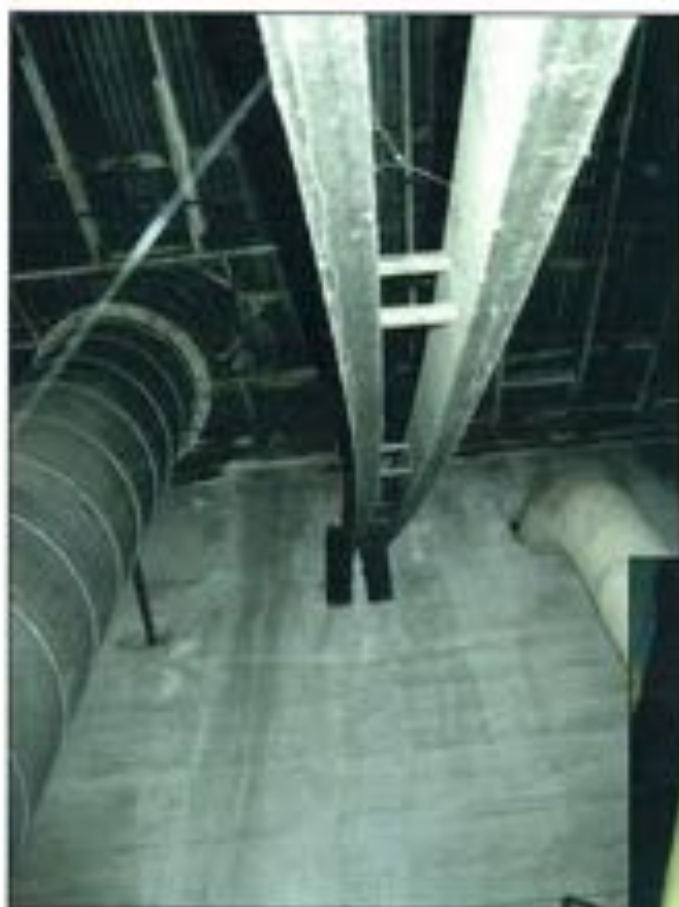
Photo 29 - Concrete staining and reinforcement corrosion at the east addition at the second floor.
Photo 30 - Out of plane buckling of double channel braces at the east addition at the second floor.

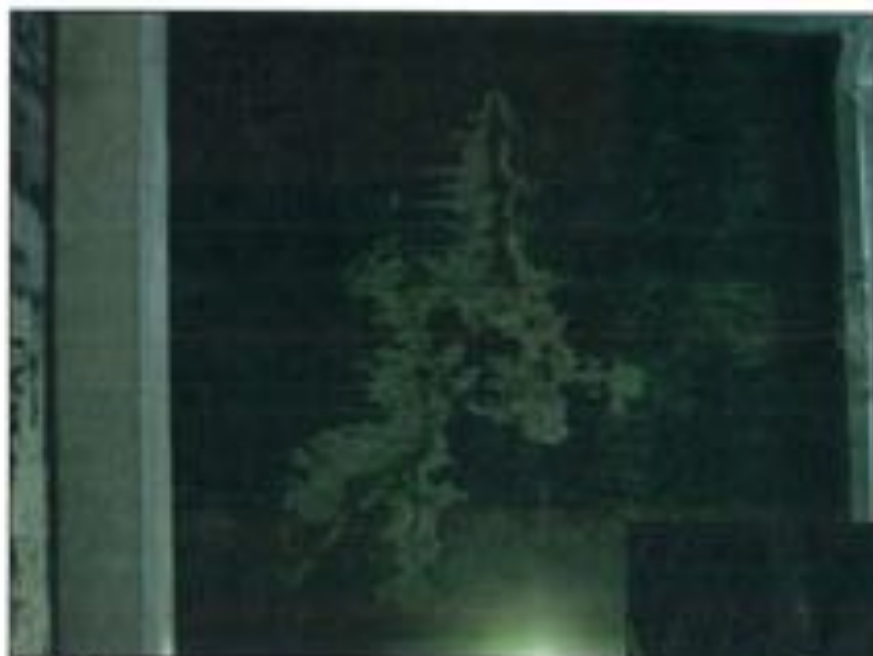
Photo 33 - Typical construction for the roof and the north portion of the building.
Photo 34 - Water staining of the roof of the north portion of the building.

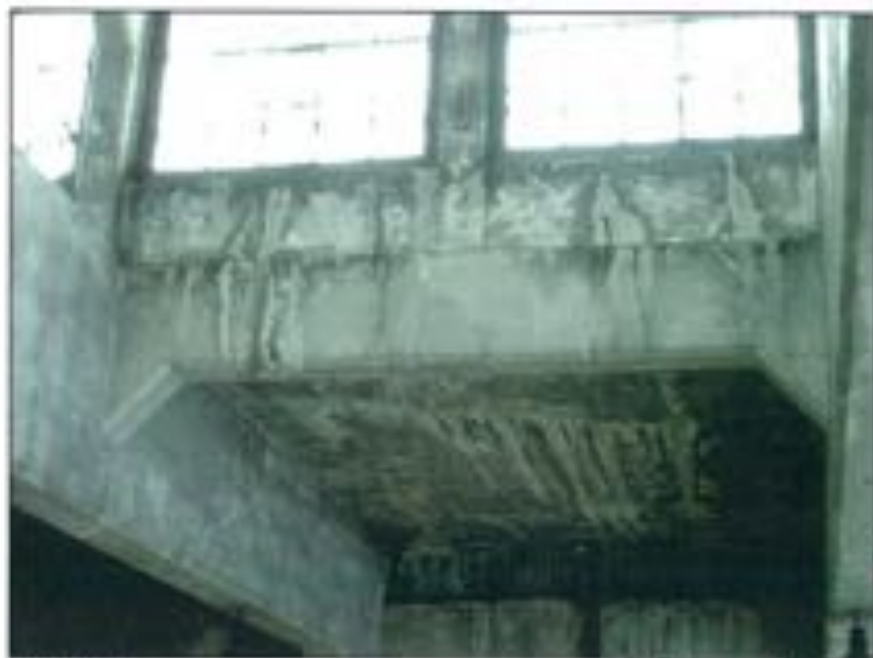
Photo 36 - Water staining of the southeast wall of the north portion of the building.

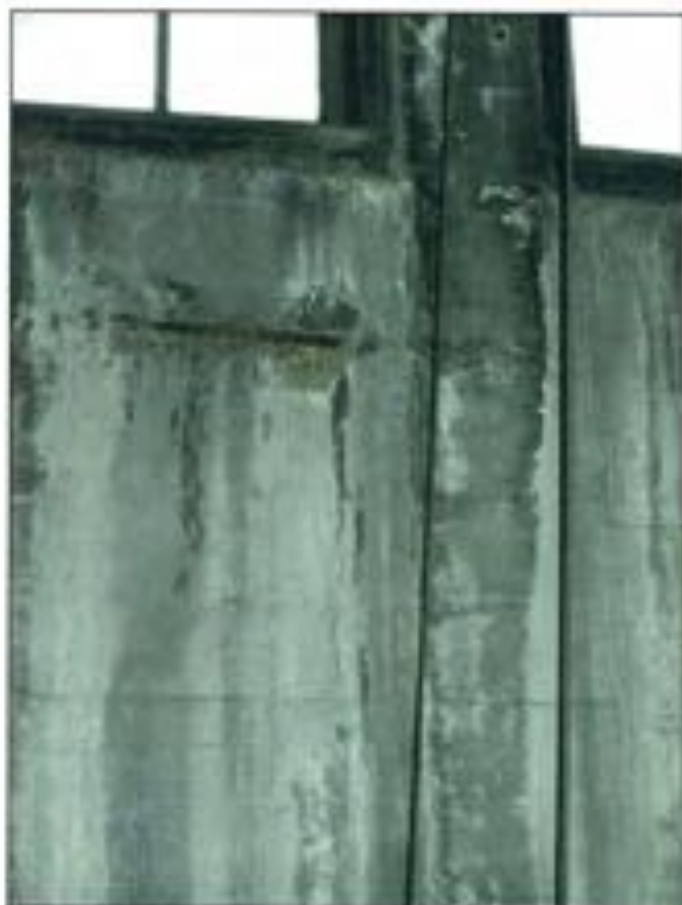
Photo 37 - Water staining of the roof at the southwest corner of the north portion of the building.
Photo 38 - Water staining and corrosion at the windowsill on the west side.

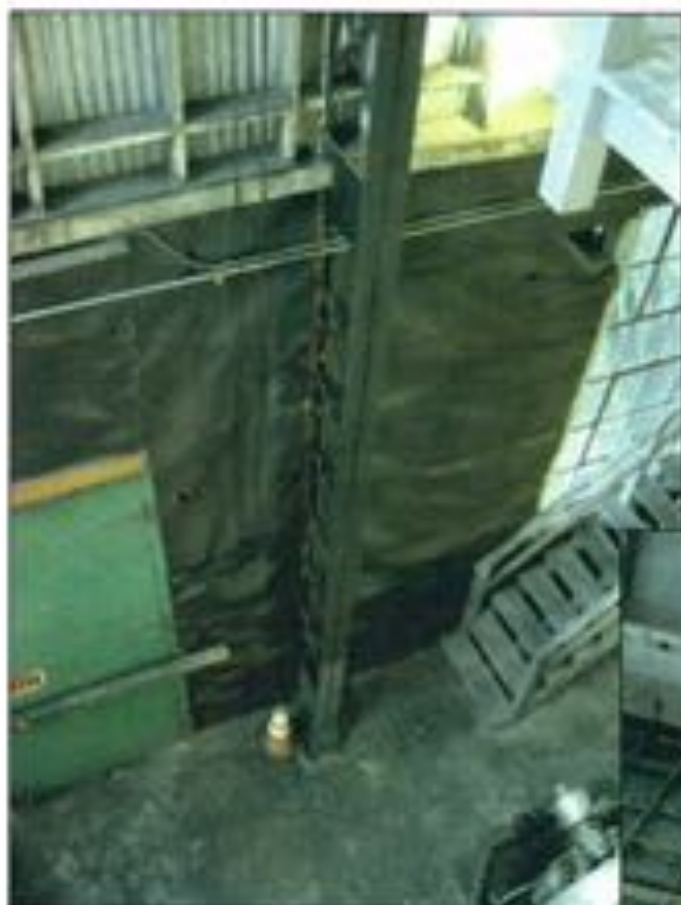
Photo 40 – Overall elevation of the interior of the east wall of the north addition.

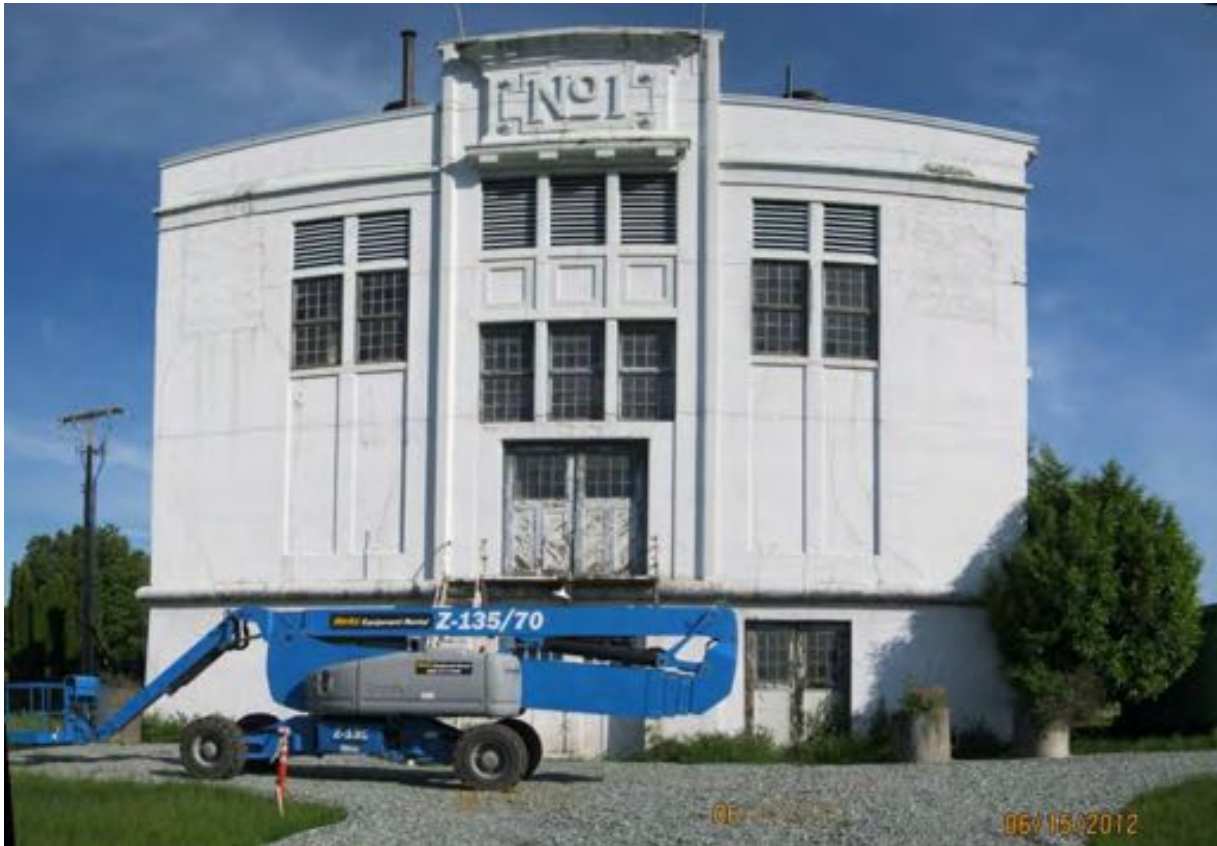
BOLA Architecture & Planning
159 Western Ave West, Ste 486
Seattle, WA 98119

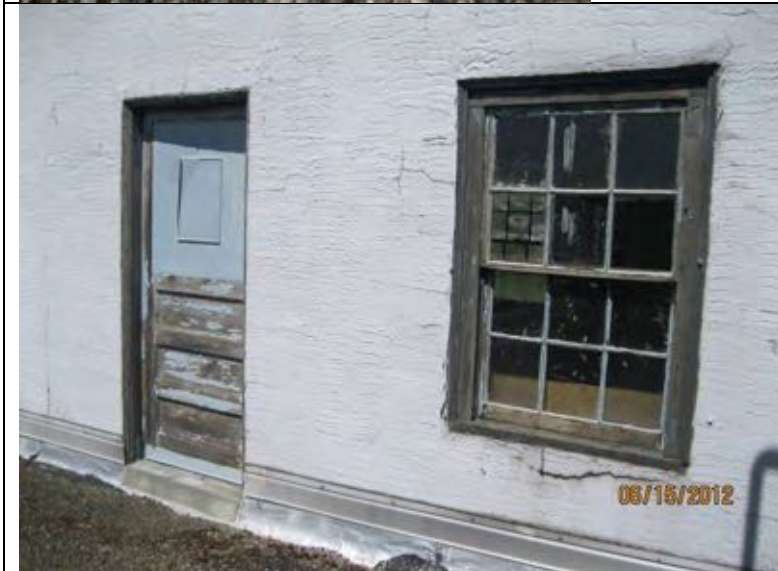
Photograph 7:
East end of NW roof with access
door. Note parge coat over hollow
clay tile is cracked and spalling
around the window.

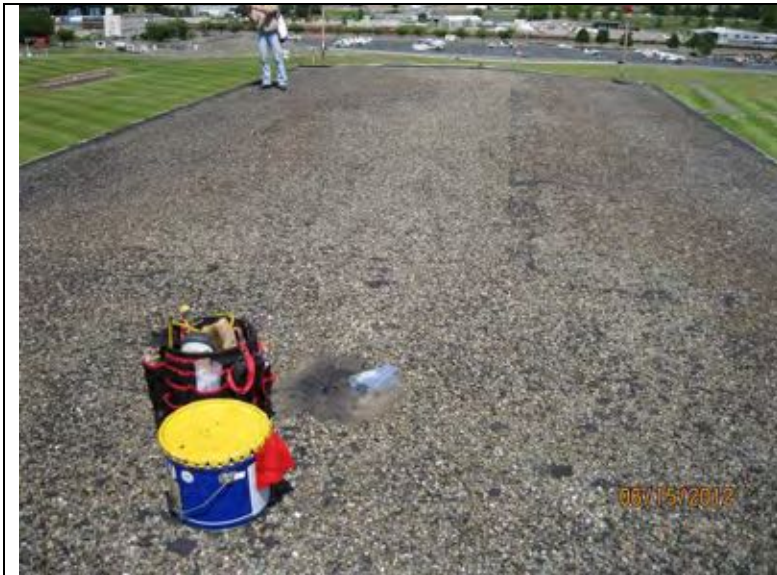
Photograph 8:
Upper north roof looking east over
the 1918 addition. Test cut in
foreground.

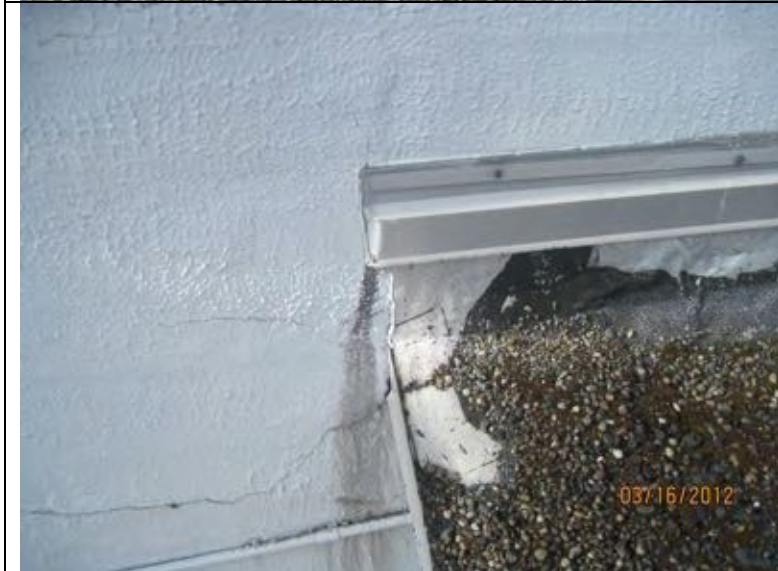
Photograph 24:
Typical transition where embedded edge metal meets rising wall is improperly detailed. There needs to be a soldered flashing to receive the cant strip and the counterflashing needs to extend beyond the edge of the roof.

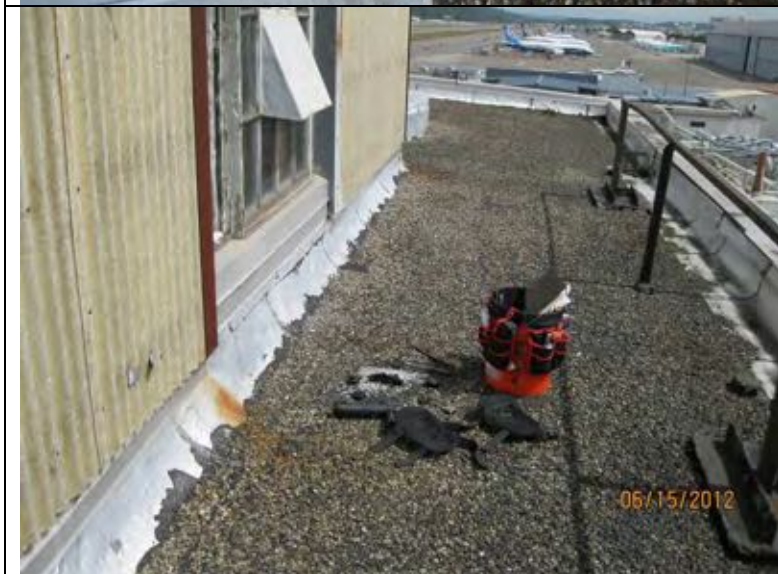
Photograph 25:
Test cut at south end of south roof, west side. Similar to previous test cuts.

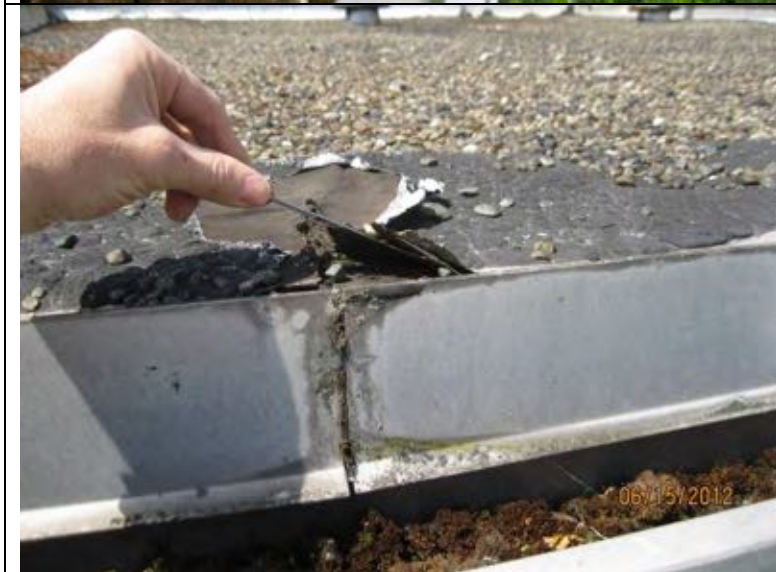
Photo 28:
Membrane unadhered at sheet
metal lap joint; typical condition.

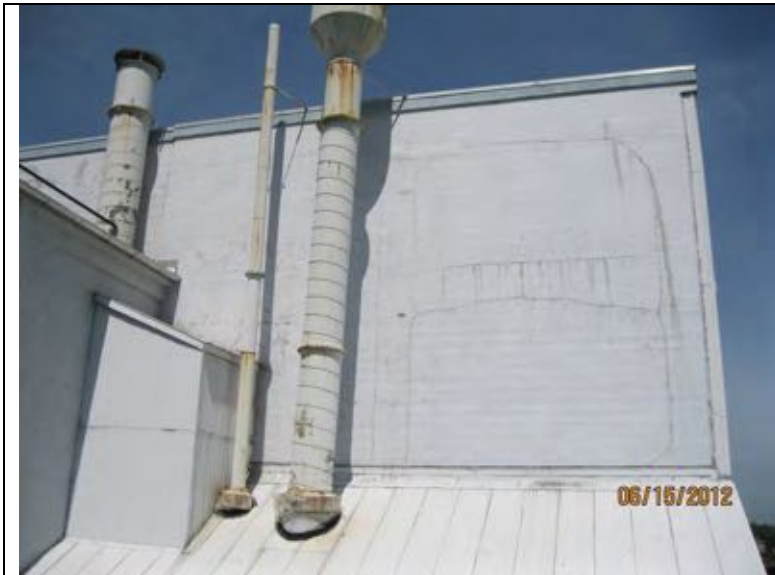
Photo 29:
South facing wall at engine room addition. Corrugated metal roofing below.

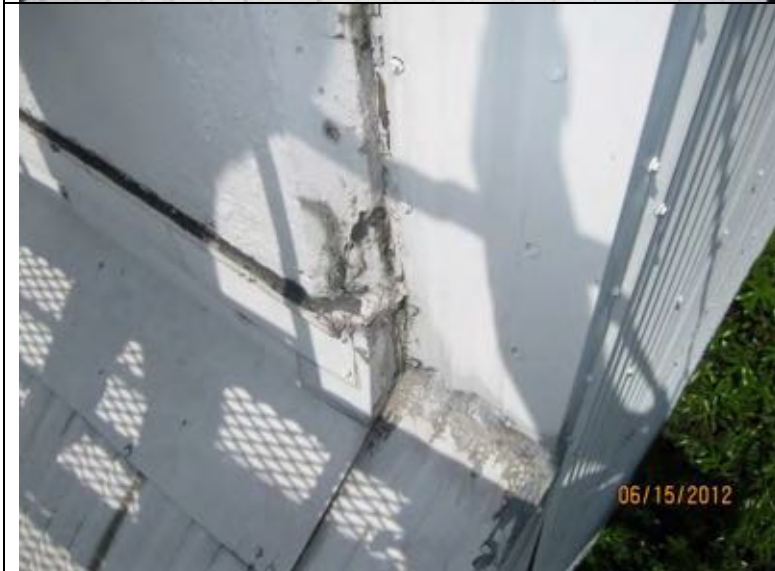
Photo 30:
Corner of corrugated metal roof is not well flashed. Flashing should extend beyond corner. Sealant joint needs to be replaced or covered with sheet metal..
