GEORGETOWN STEAM PLANT
HISTORIC STRUCTURE & CULTURAL LANDSCAPE REPORT

OCTOBER 9, 2013

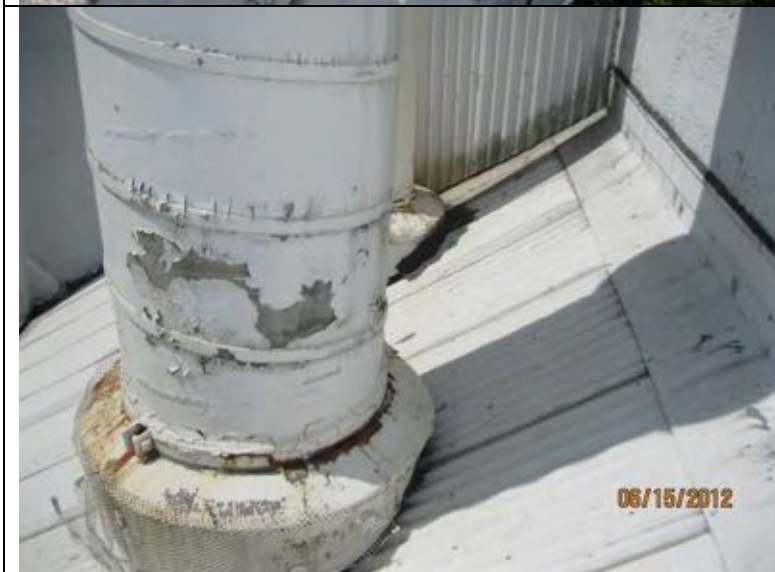
Photo 31:
Stack penetrations through corrugated metal roof need to be reflashed and sealed, as the metal flashing is rusted through in locations.

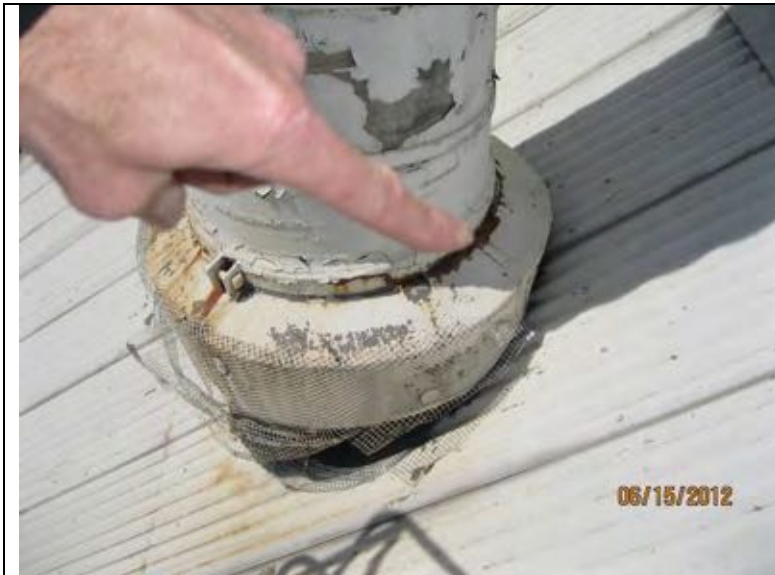
Photo 32:
Pointing out where flashing is rusted through.

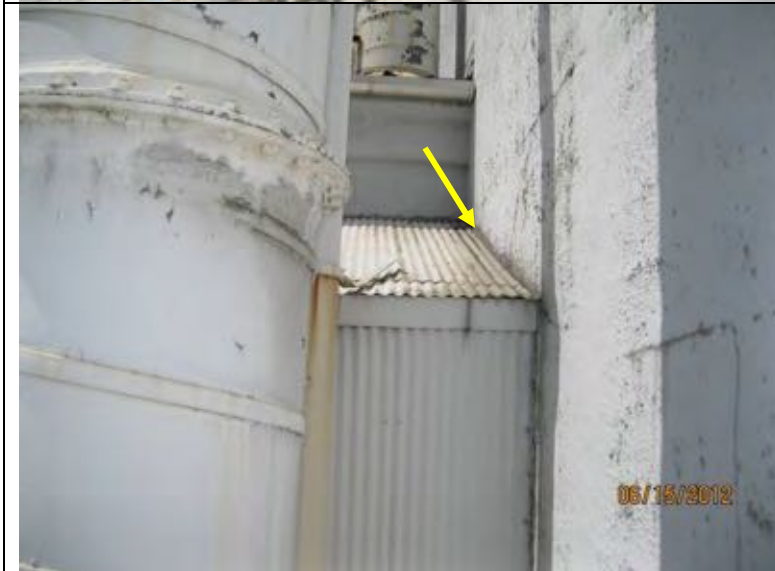
Photo 33:
Upper corrugated metal roof drains to lower metal roof. There is no counterflashing along the rake edge of the upper roof. It appears the roofing butts to the wall.

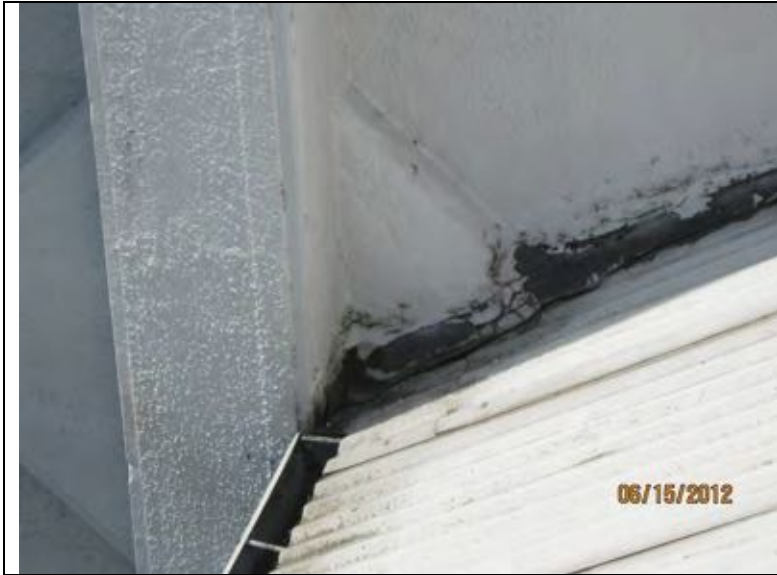
Photo 35:
Close-up of previous photo at bottom edge (SW corner of roof). This is a built in leak where the roofing runs into a concrete column. There needs to be a custom soldered cricket/diverter installed with counterflashing on the wall.

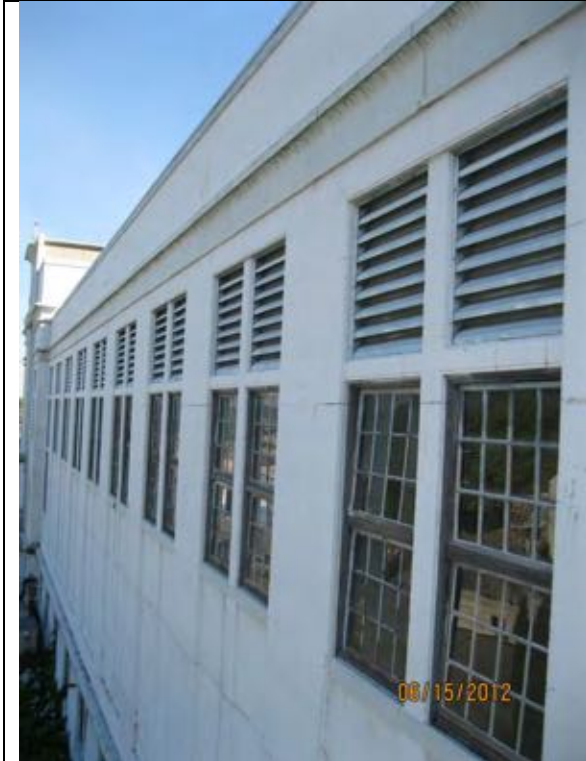
Photo 36: Overview of the west elevation looking north.

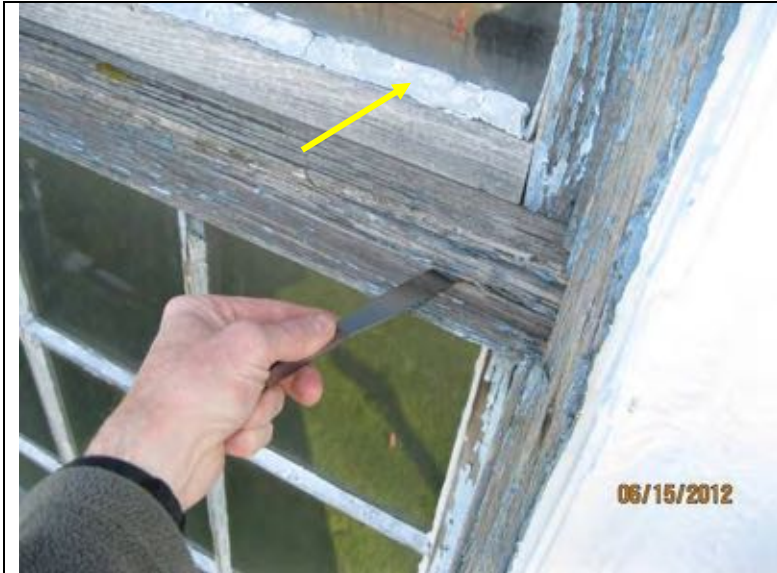
Photo 37:
Wood window frames are deteriorated to varying degrees, worst at west and south elevations. Note glazing putty holding the glazing in place where the arrow points.

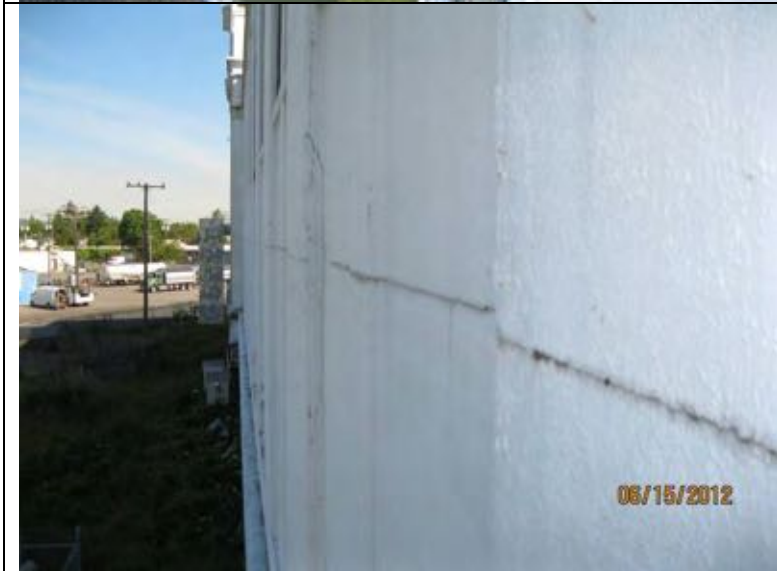
Photo 38:
Horizontal crack in what appears to be a cold joint in the concrete at the west elevation.

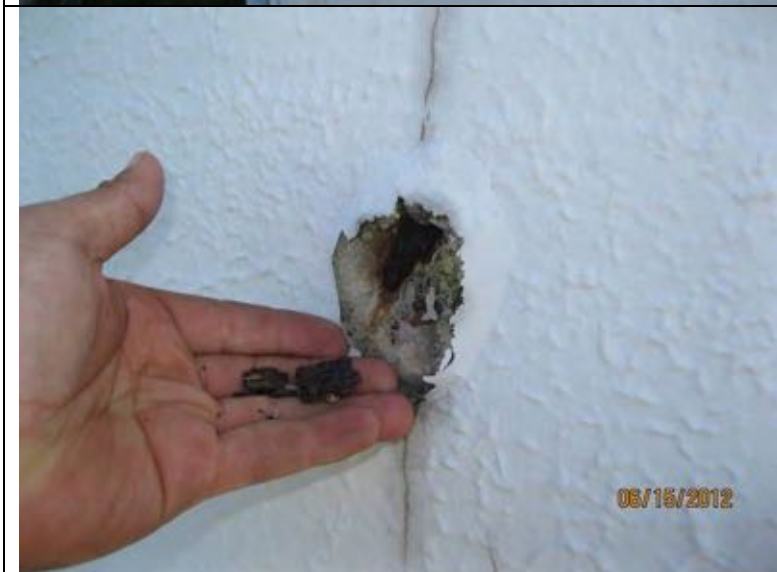
Photo 38:
Spalled concrete on west wall, towards the south end, with rusted reinforcing steel in hand.

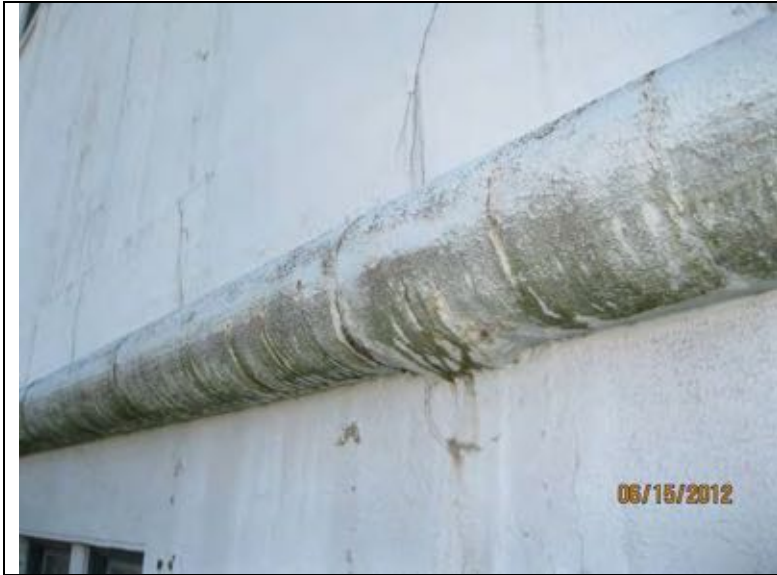
Photo 39:
½ round cornice at west elevation
with cracks and spalls at
underside.

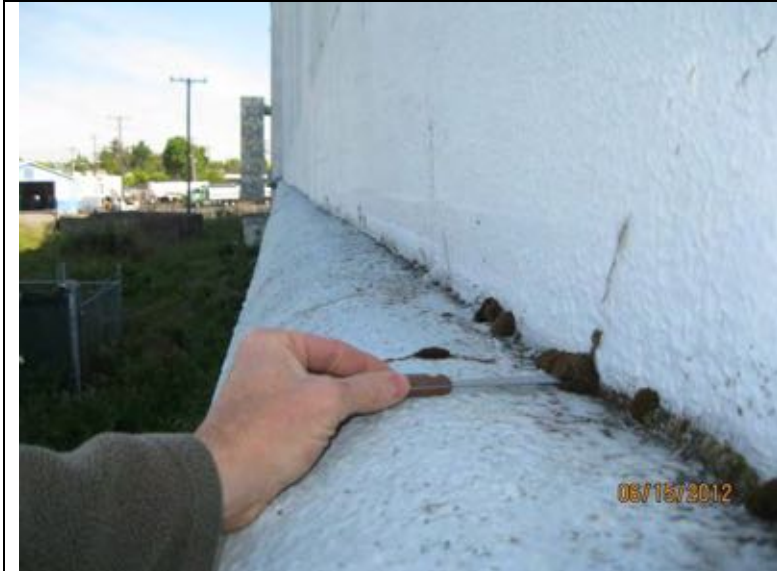
Photo 40:
Moss growth at top of ½ round
cornice. It appears the top holds
moisture.

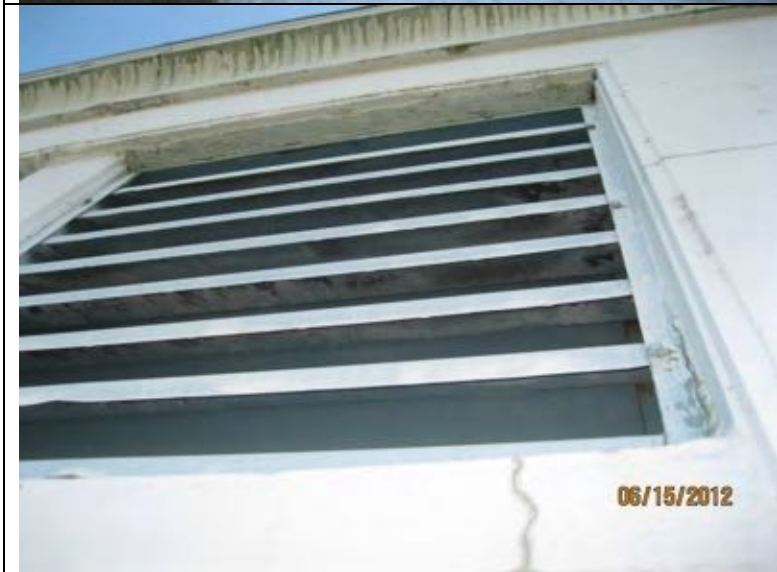
Photo 41:
Steel louvers at top of west
elevation appear to be in
serviceable condition, other than
surface preparation and paint.

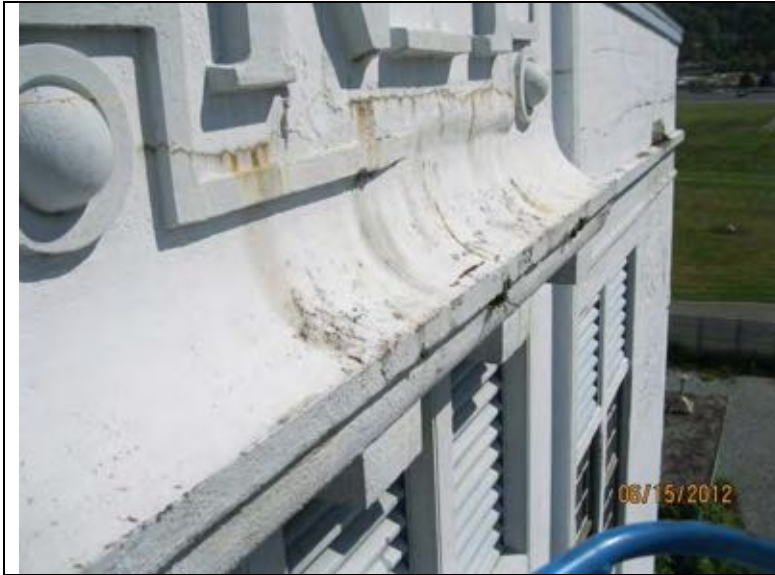
Photo 42:
South elevation with station label.
Note inaccurate patching at wall
and cracks/spalls where water has
caused plant growth at drip edge.

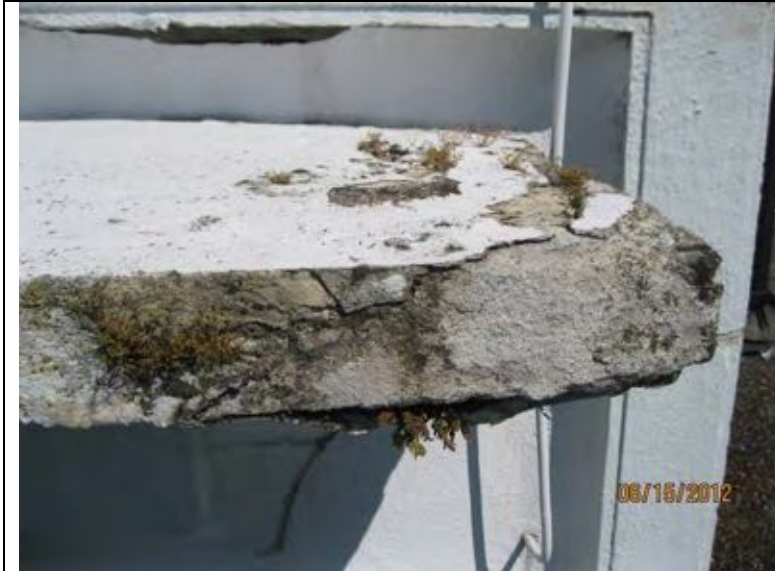
Photo 43:
Spalled and delaminated concrete
at corner of cornice, south
elevation top of wall.

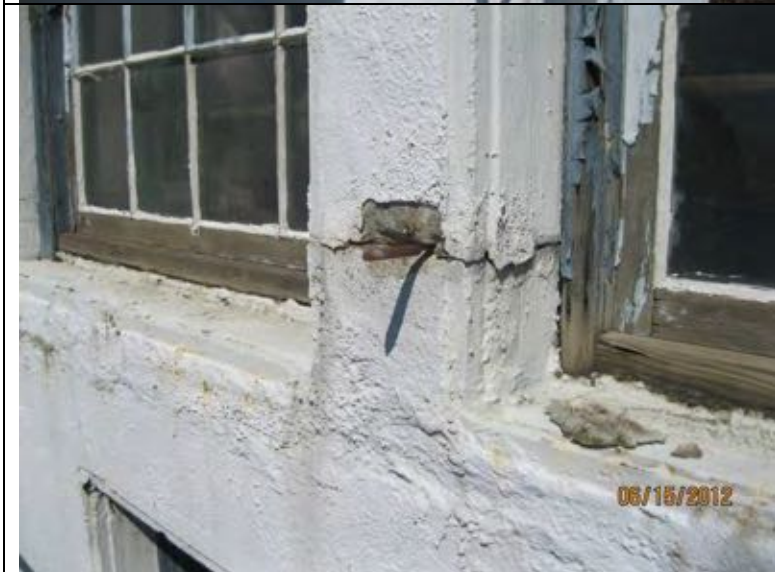
Photo 44:
Sealant knife inserted into what
appears to be an open cold joint in
the concrete between windows,
south elevation.

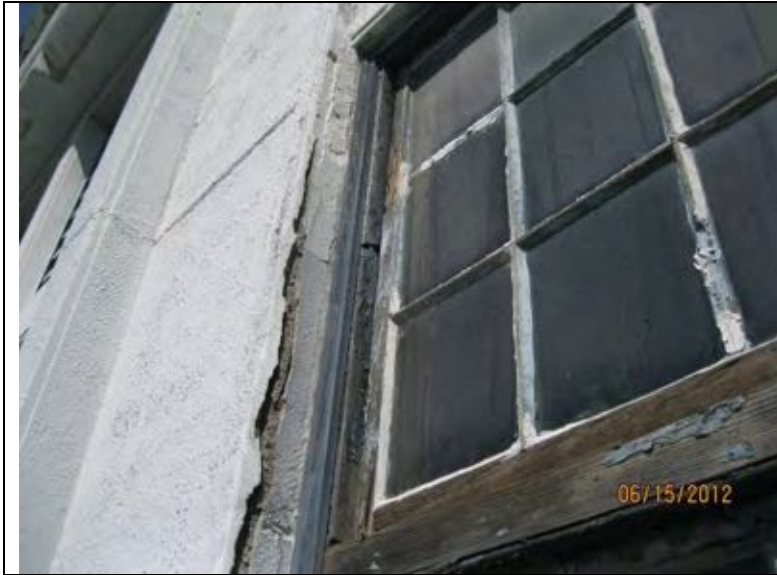
Photo 45:
Spalled concrete at jamb of
window, south elevation.

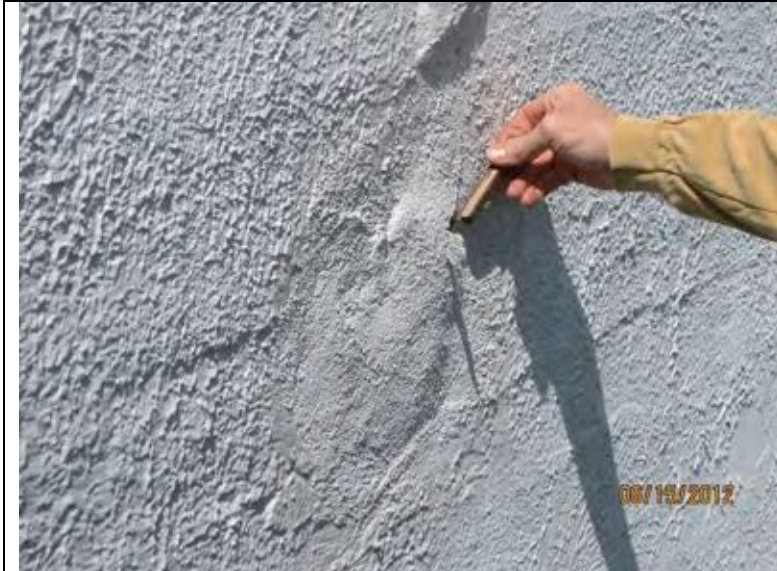
Photo 46:
East wall; sealant knife inserted
behind delaminated patch material.

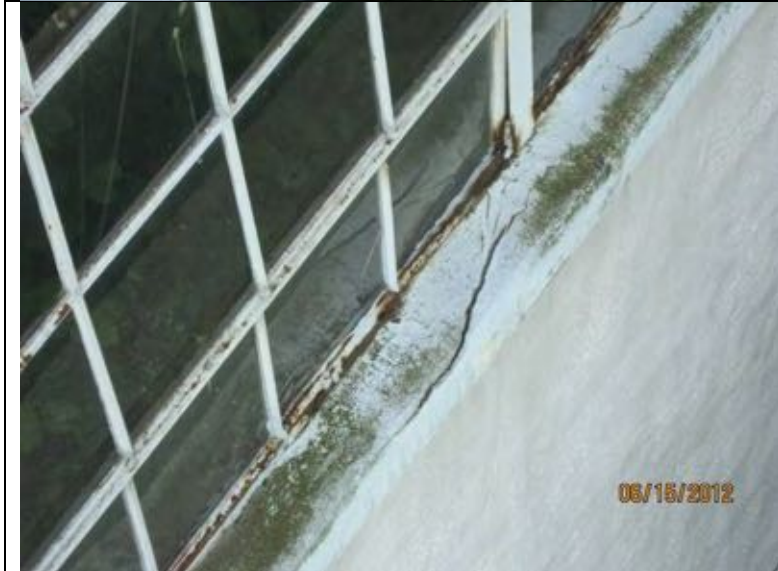
Photo 55:
Rusted steel framed window and
spalled concrete sill material.

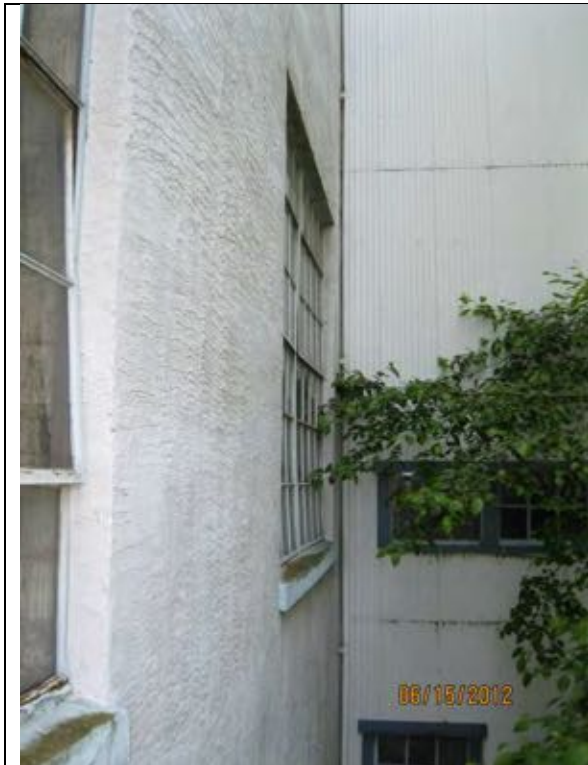
Photo 56:
Steel windows are deflected inward at north wall of 1918 addition.

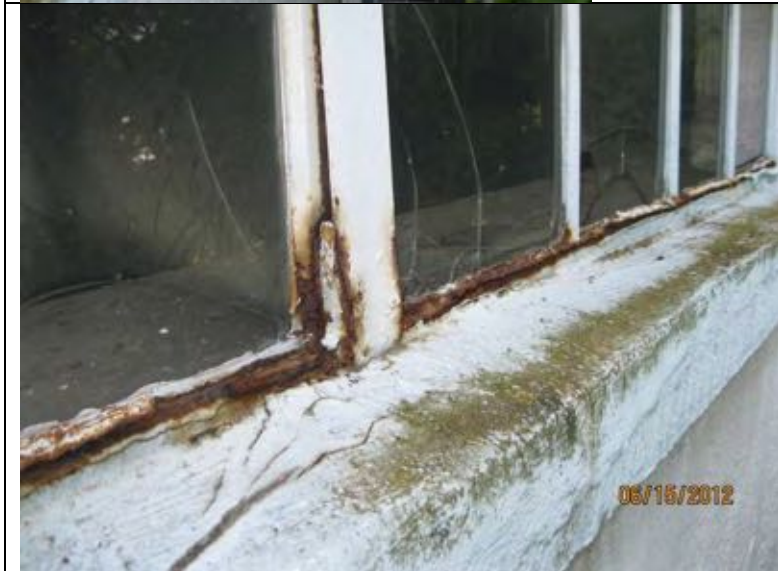
Photo 57:
Rusted steel window at north elevation of 1918 addition.

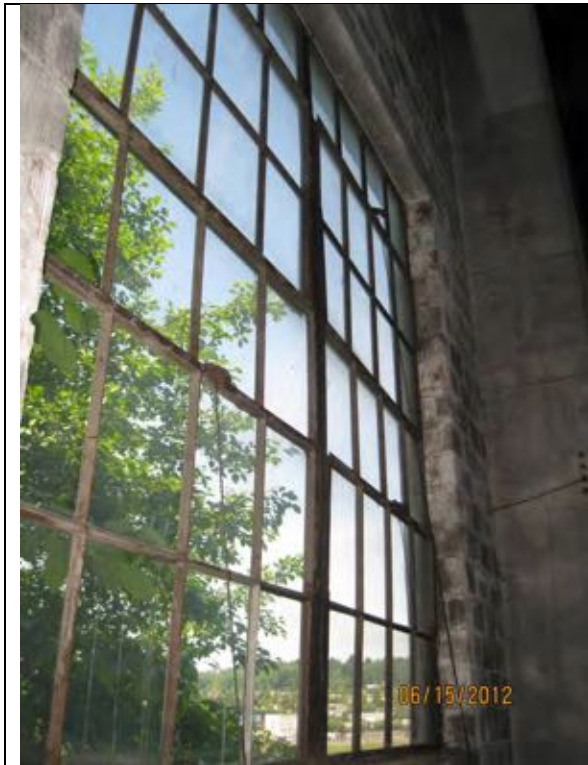
Photo 58:
Window deflecting inward at north elevation of addition. Note hollow clay tile at interior wall.

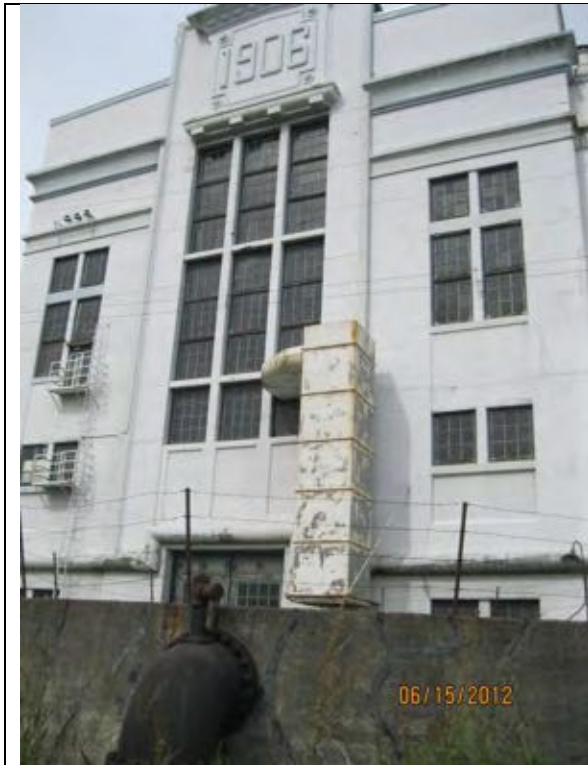
Photo 60:
Overview of west elevation at
north end. Note spalls and cracks
in concrete walls.

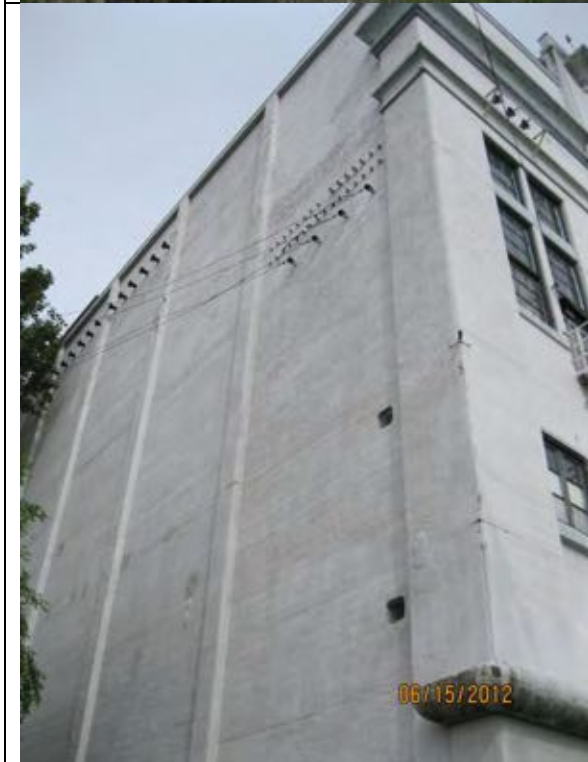
Photo 61:
Overview of north wall at NW
corner.

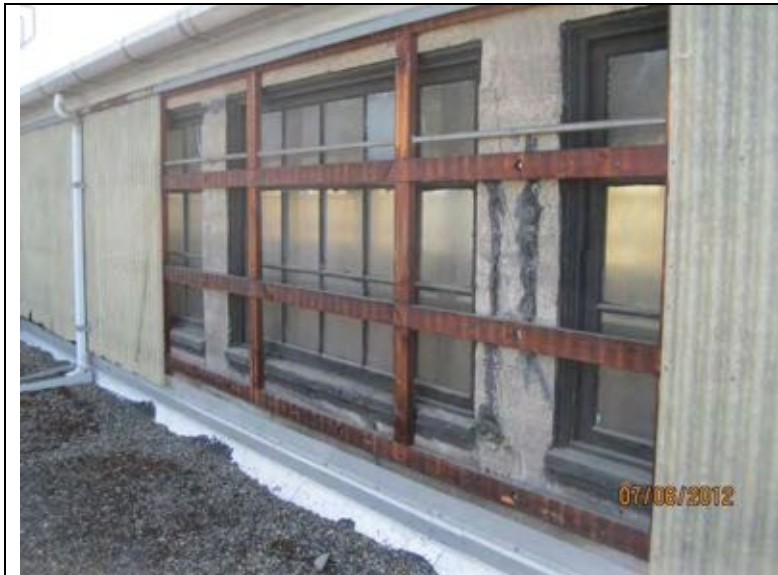
Photo 62:
Clerestory wood framed windows at roof. Uncovered for condition evaluation. Note wood framing to support corrugated fiberglass is bolted to concrete. Wood sills notched in order to fit framing overlay. Wood window frames are deteriorated.

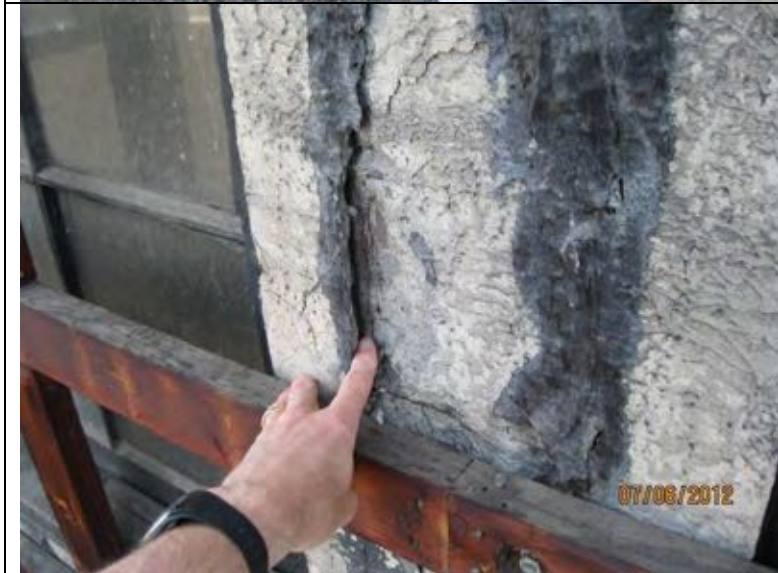
Photo 63:
Severely spalled concrete and exposed/rusted reinforcing steel.

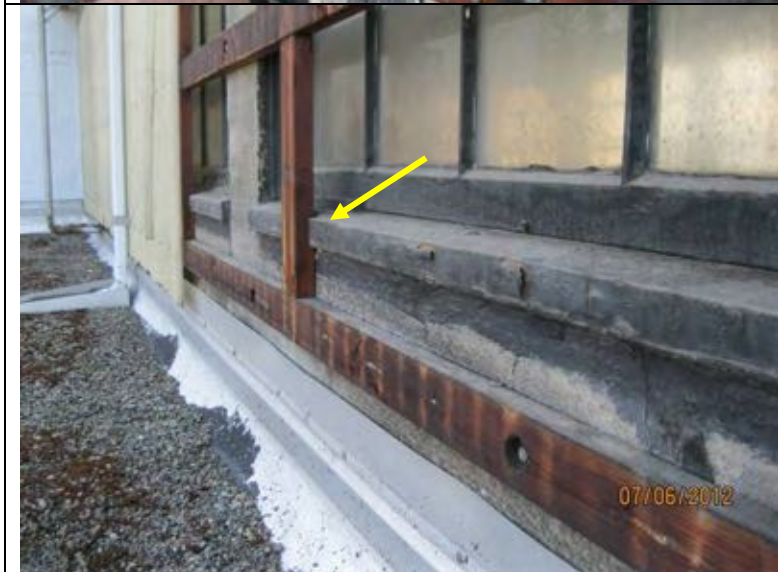
Photo 64:
Notched windowsill at clerestory windows for wood framing fit.

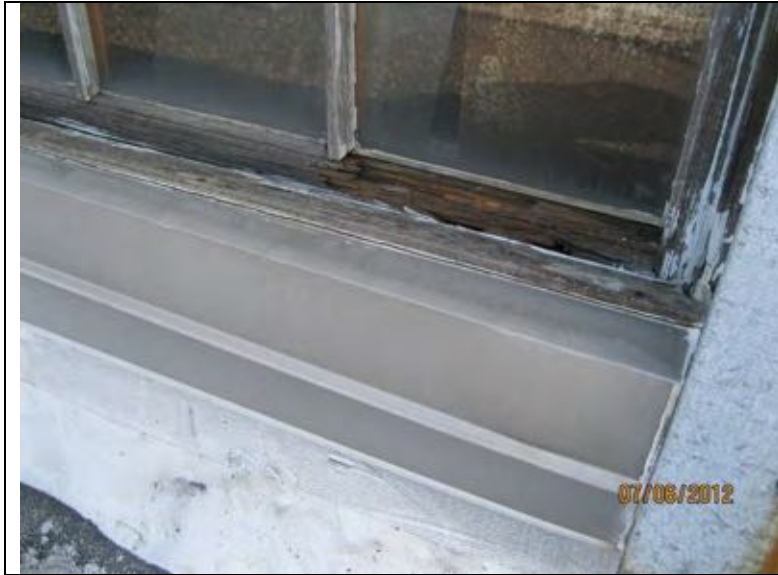
Photo 65:
Typical deteriorated wood window
frame.

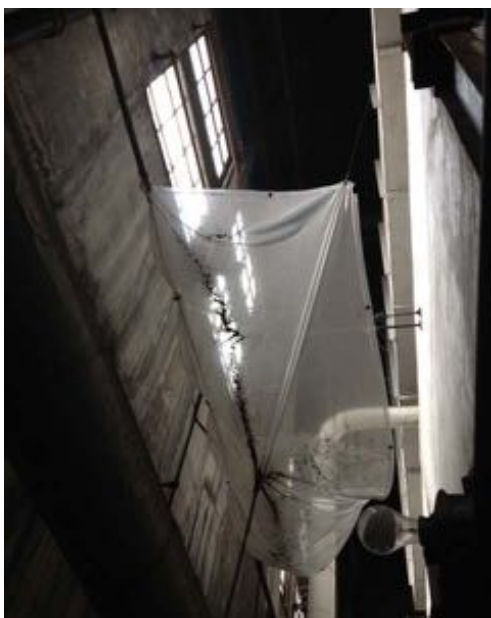
Image 5: West side Boiler Room leak

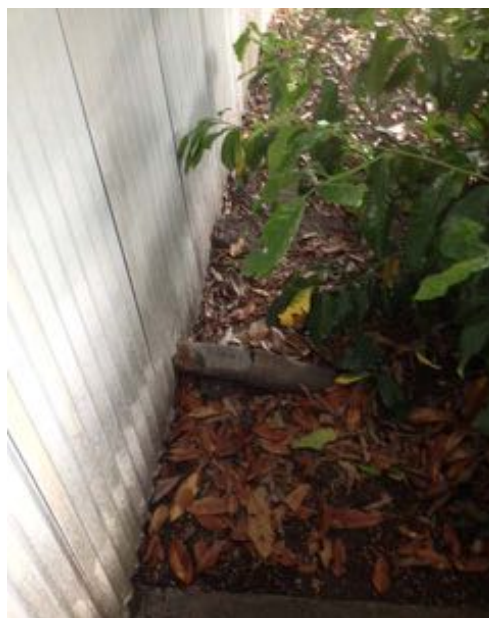
Image 6: East side Boiler Rm drain pipe

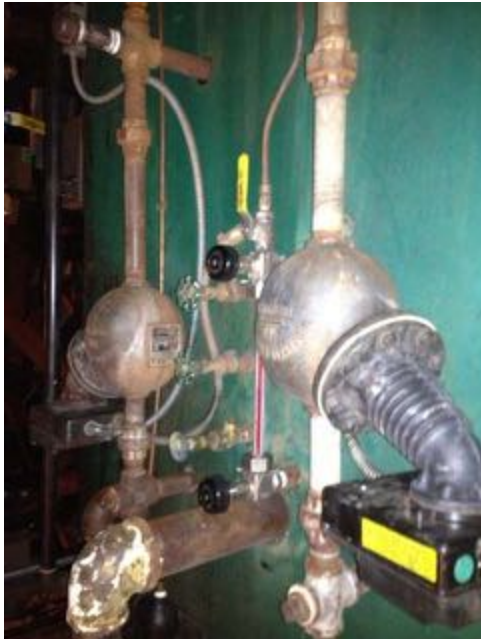
Image 11: Corrosion on boiler, piping

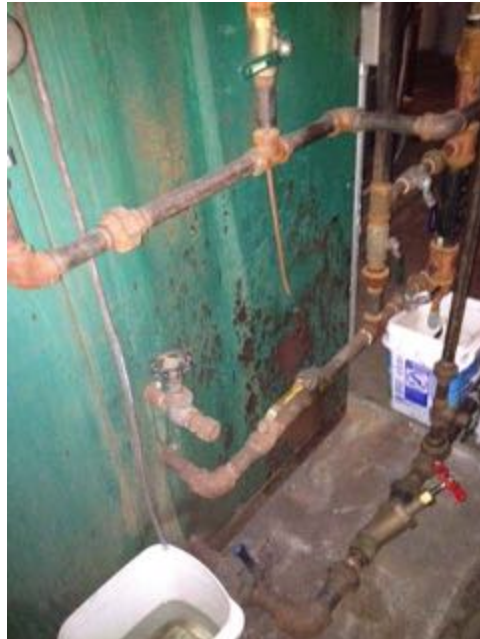
Image 12: Corrosion on boiler, piping

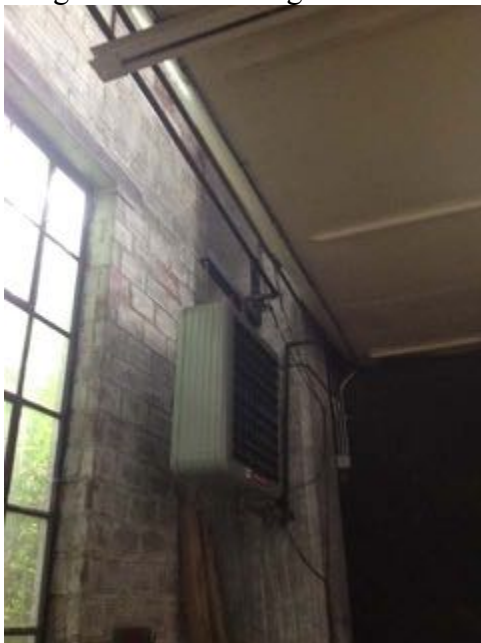
Images 13-16: Existing steam unit heaters, distribution piping and condensate pumps

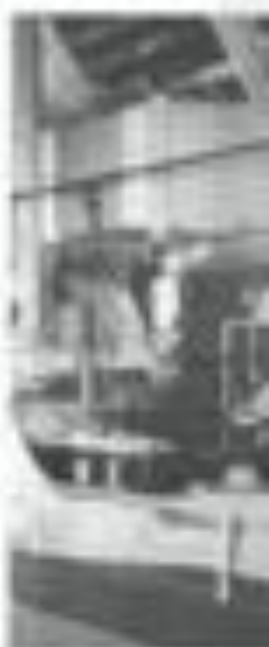
1917 storage for coal (foreground) and 1917 storage for coal (background) for work.

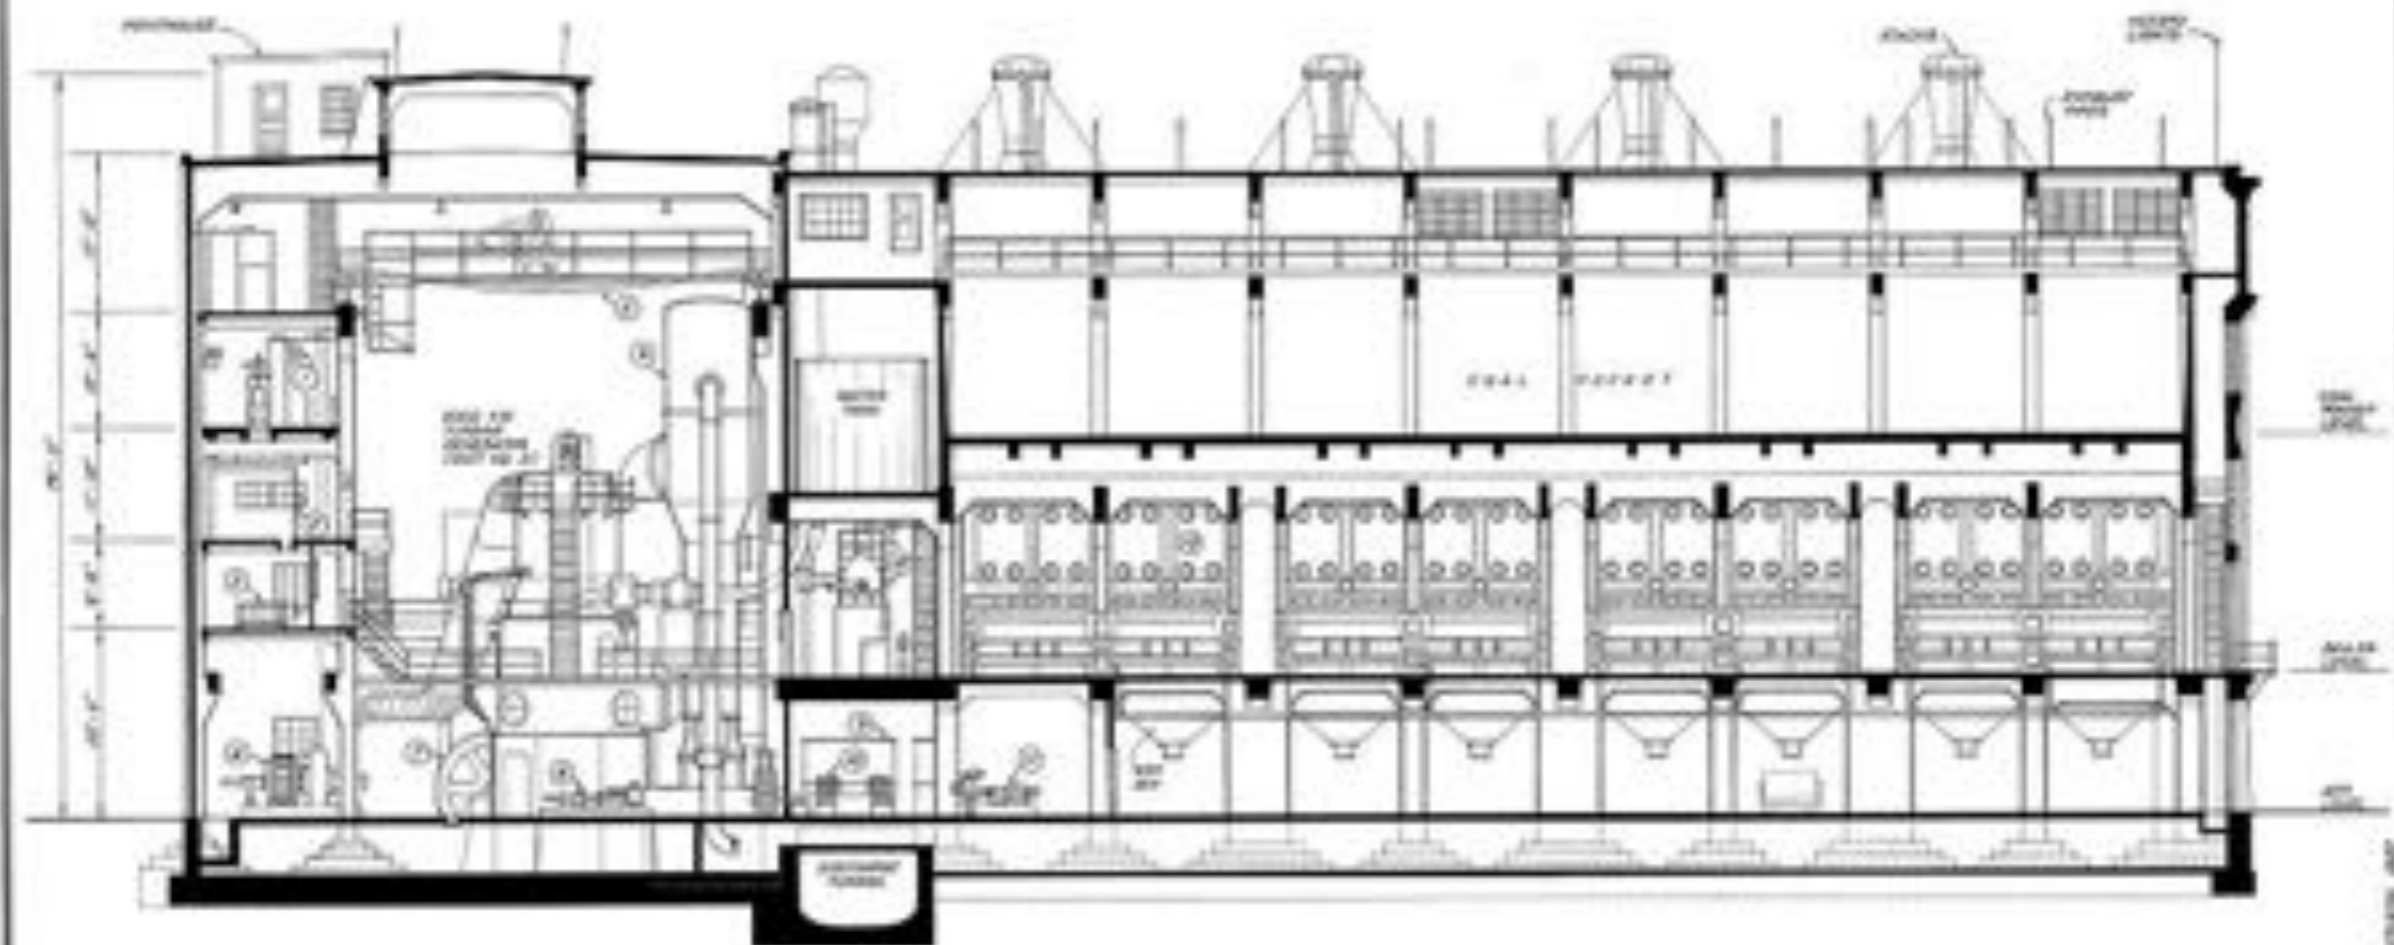
- 1 OIL SWITCH
- 2 SWITCHBOARD
- 3 8" P. CO. FUEL AIRGASSET
- 4 600 H.P. OIL CO. MOTOR GENERATOR
- 5 20 TON CRANE
- 6 40 HP ACID BATTERY CHARGER
- 7 17" BUSHING 7 1/2" CO. DRY VACUUM PUMP
- 8 WORTHINGTON DUPLEX 2000 AMP. MOTOR PUMP
- 9 TURNER OIL FILTER
- 10 WORTHINGTON DUPLEX OIL PUMP
- 11 40 H.P. 30 LAMB STEAM TURBINE MOTOR PUMP
- 12 4000 H.P. GEORGE OREN MOTOR
- 13 557 H.P. STEAM ENGINE

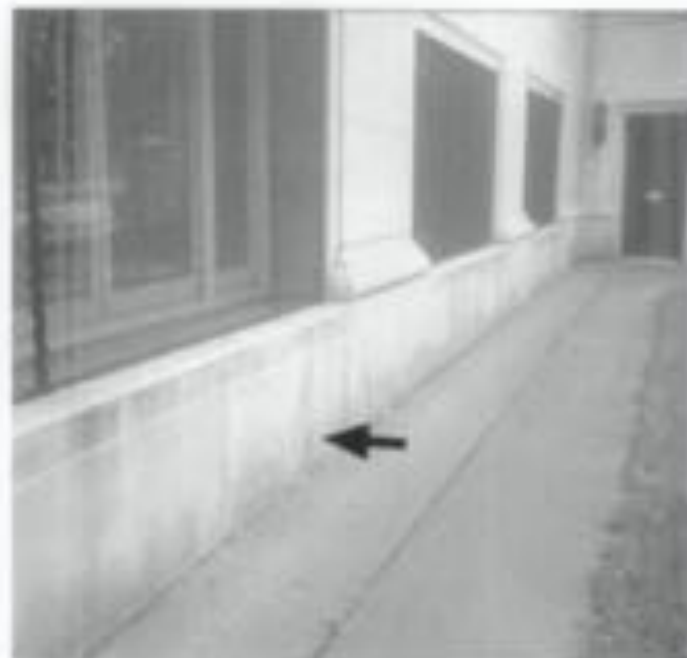
Figure 2. Biological growth as shown on this marble foundation can usually be removed using a low-pressure water wash, possibly with a non-ionic detergent added to it, and scrubbing with a natural or synthetic bristle brush.

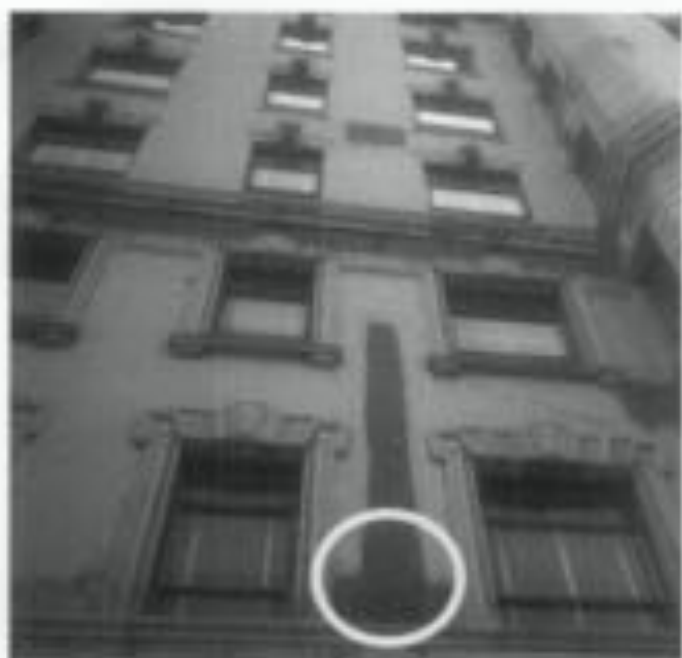
Figure 3. This small test area has revealed a red brick patch that does not match the original large brick. This may explain why the building was painted, and may suggest to the owner that it may be preferable to keep it painted.

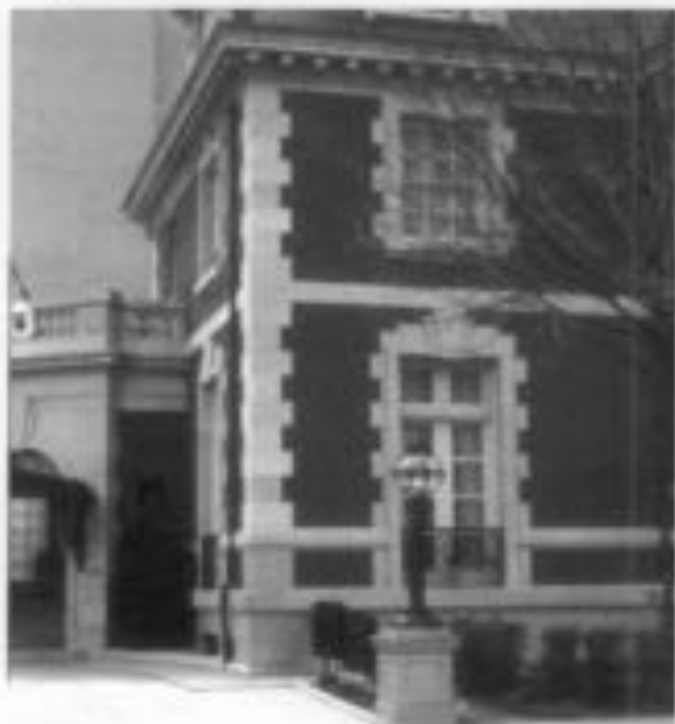
Figure 4. The foundation of this brick building is limestone, but the decorative trim above is architectural terra cotta intended to simulate stone.

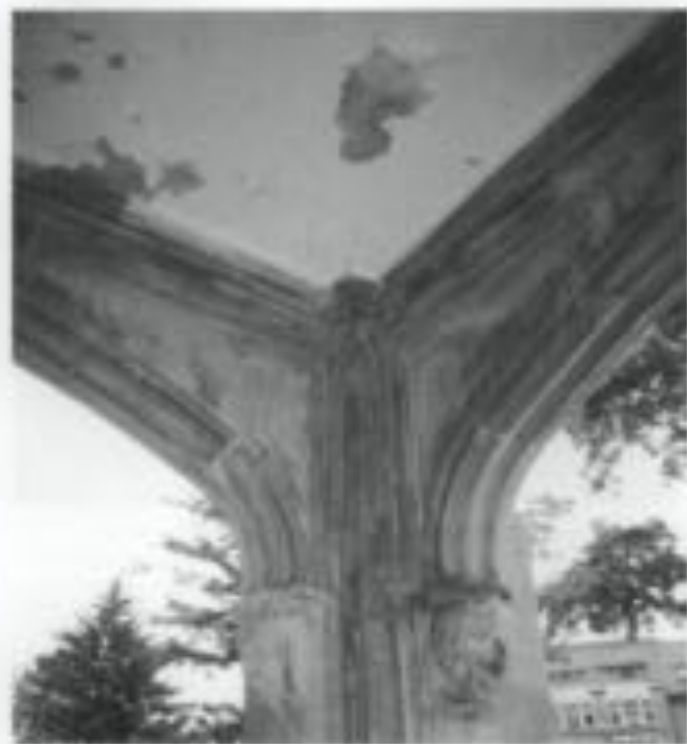
Figure 5. Repeated water washing did not remove the staining inside this limestone porte cochere. Upon closer examination, it was determined to be a water-repellent coating that had been applied many years earlier. An alkaline cleaner may be effective in removing it.

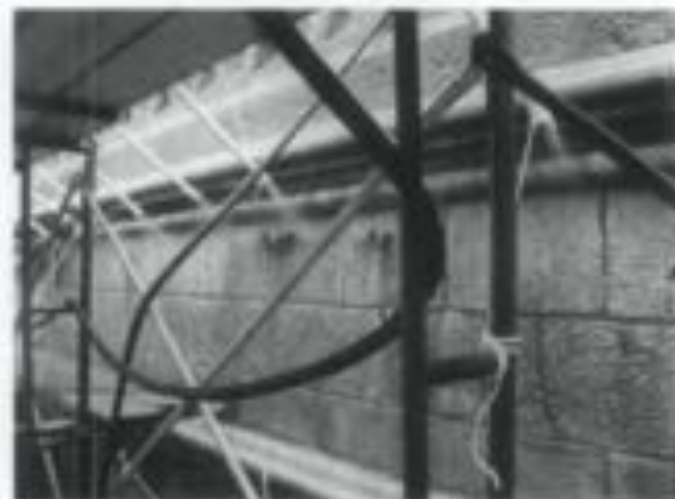
Figure 6. Timed water soaking can be very effective for cleaning limestone and marble as shown here at the Marble Collegiate Church in New York City. In this case, a twelve-hour water soak using a multi-nozzle manifold was followed by a final water rinse. Photo: Hans T. Eason, Wm. Jannoy, Ebers Associates, Inc., N.Y., N.Y.

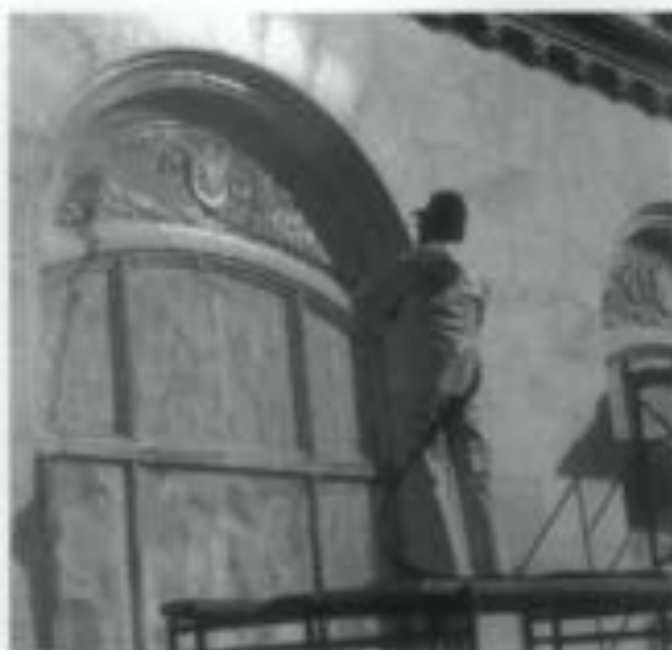
Figure 7. Glazed architectural terra cotta often may be cleaned successfully with a low-pressure water wash and hand scrubbing supplemented, if necessary, with a non-ionic detergent. Photo: National Park Service Files.

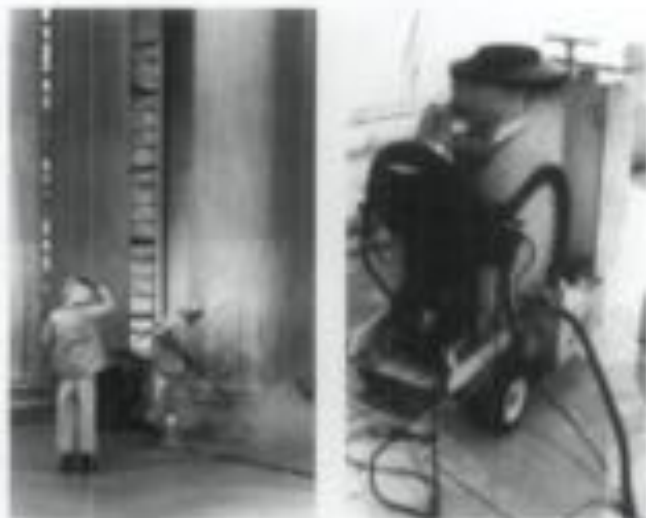
Figure 8. (Left) Low-pressure (under 100 psi) steam cleaning (hot pressurized water washing), is part of the regular maintenance program at the Jefferson Memorial, Washington, D.C. The white marble interior of this open structure is subject to constant soiling by birds, insects and visitors. (Right) This portable steam cleaner enables prompt cleanup when necessary. Photos: National Park Service files.

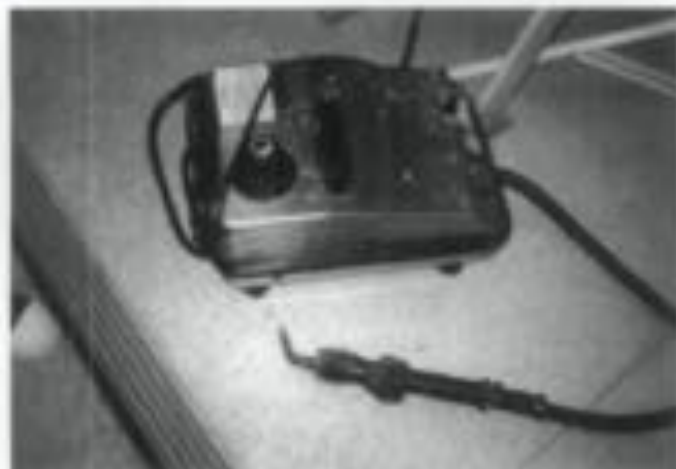
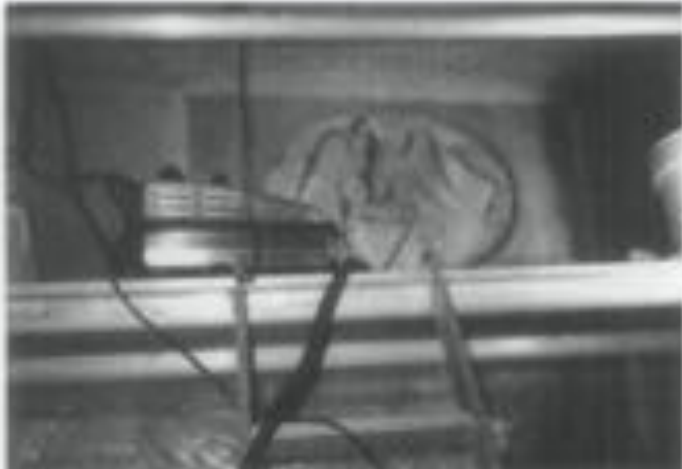
Figure 9. (Left) This small steam cleaner—the size of a vacuum cleaner—offers a very controlled and gentle means of cleaning limited, or hard-to-reach areas or carved stone details. (Right) It is particularly useful for interiors where it is important to keep moisture to a minimum, such as inside the Washington Monument, Washington, D.C., where it was used to clean the commemorative stones. Photos: Audrey T. Trepper.

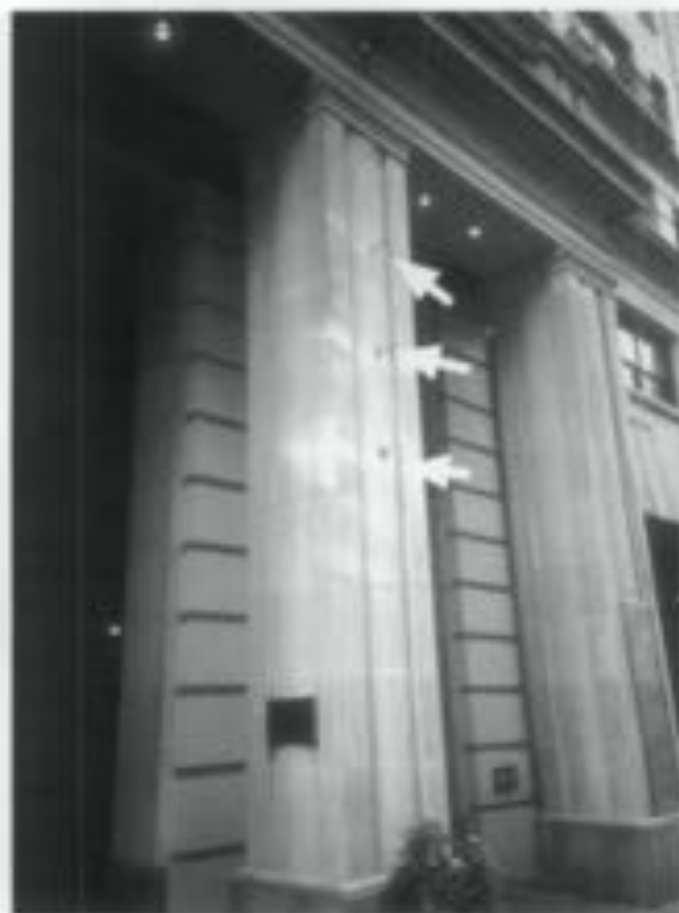
Figure 10. High-pressure water washing too close to the surface has abraded and, consequently, marred the limestone on this early-20th century building.

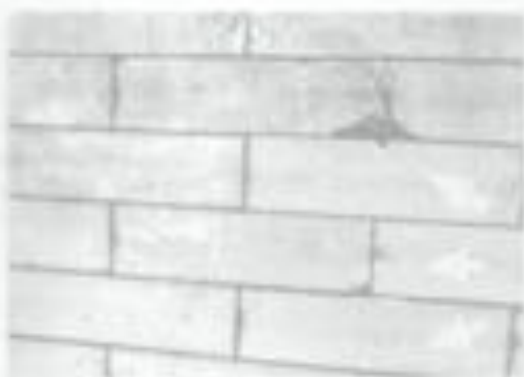
Figure 11. Rinsing with high-pressure water following chemical cleaning has left a horizontal line of abrasion across the bricks on this late-19th century row house.

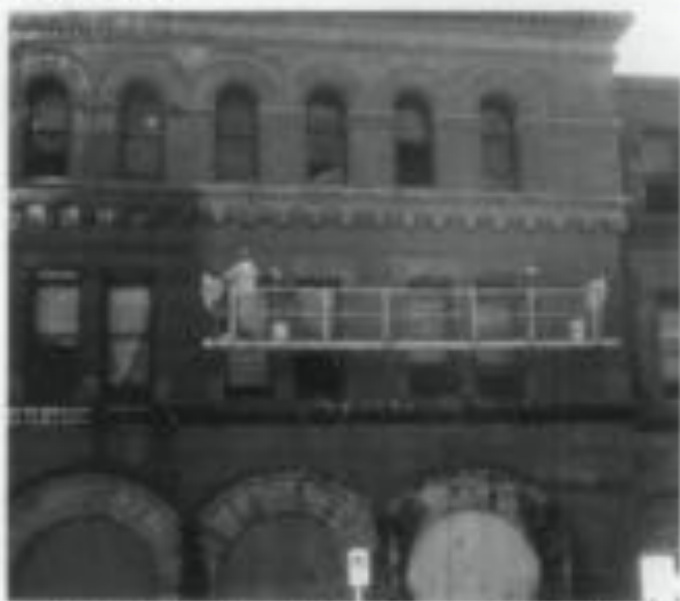
Figure 12. A mild acidic cleaning agent is being used to clean this heavily soiled brick and granite building. Additional applications of the cleaner and hand scrubbing, and even sandblasting, may be necessary to remove the dark stains on the granite arches below. Photo: Sharon C. Park, ILLA.

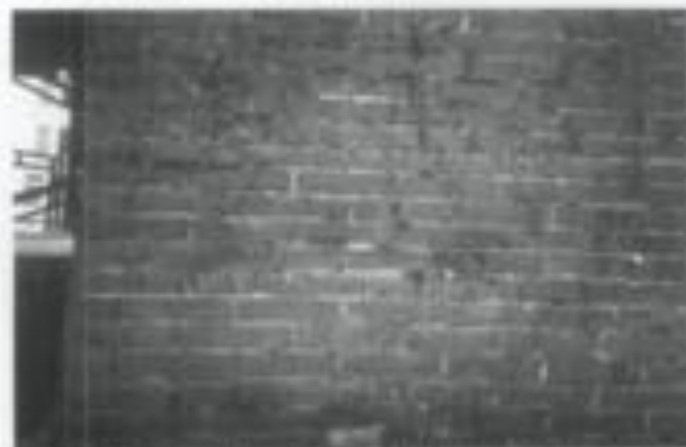
Figure 13. Sometimes it may be preferable to paint over a thick asphalt coating rather than try to remove it, because it can be difficult to remove completely. However, in this case, many layers of asphaltic coating were removed through multiple applications of a heavy duty chemical cleaner. Each application of the cleaner was left to dwell following the manufacturer's recommendations, and then rinsed thoroughly. (As much as possible of the asphalt was first removed with wooden scrapers.) Although not all the asphalt was removed, this was determined to be an acceptable level of cleanliness for the project.

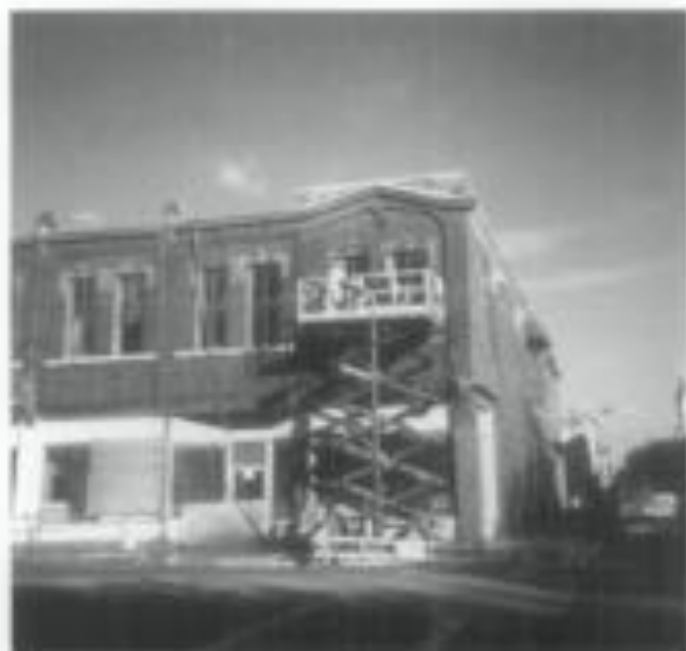
Figure 14. Chemical removal of paint from this brick building has revealed that the cornice and window heads are metal rather than masonry.
