GEORGETOWN STEAM PLANT
HISTORIC STRUCTURE & CULTURAL LANDSCAPE REPORT

OCTOBER 9, 2013

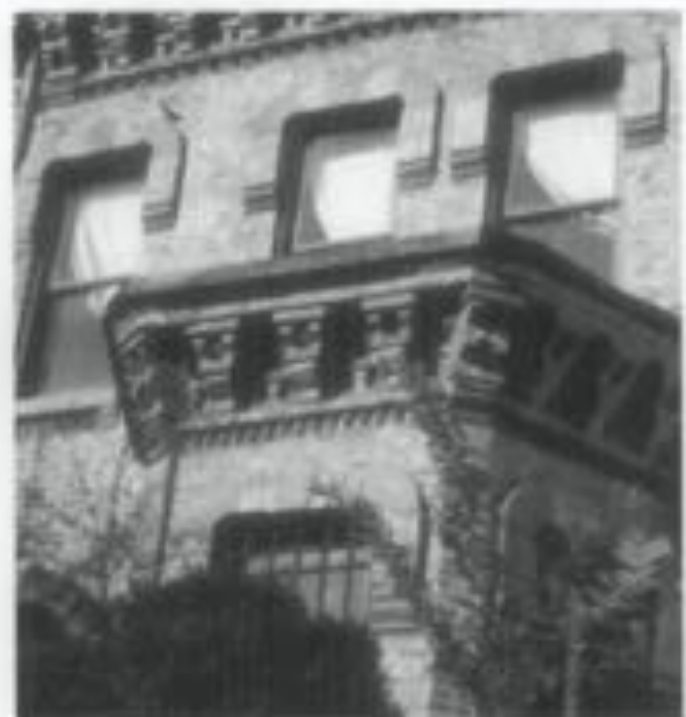
Figure 15. The whitish deposits left on the brick by a chemical paint remover may have resulted from inadequate rinsing or from the chemical being left on the surface too long and may be impossible to remove.

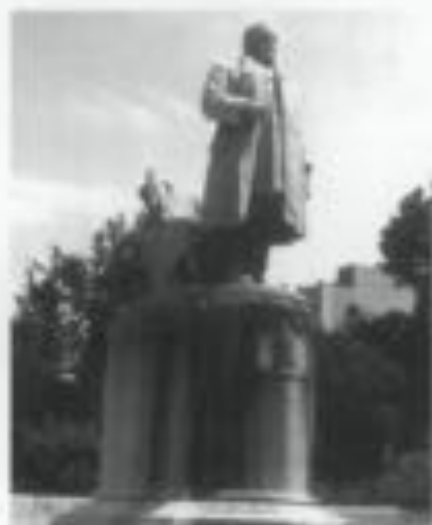
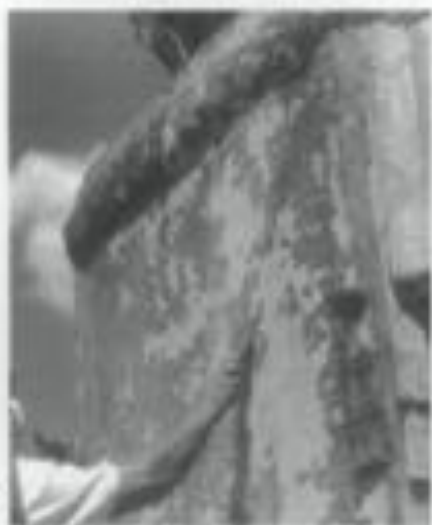
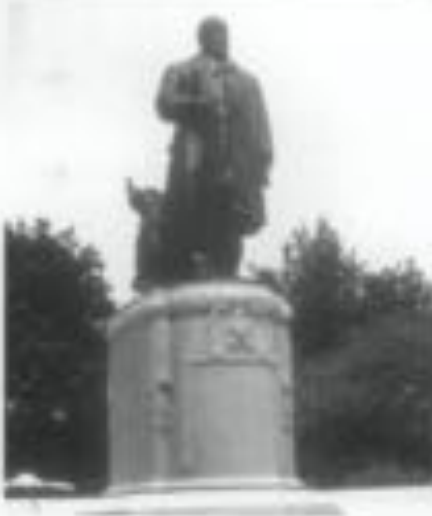
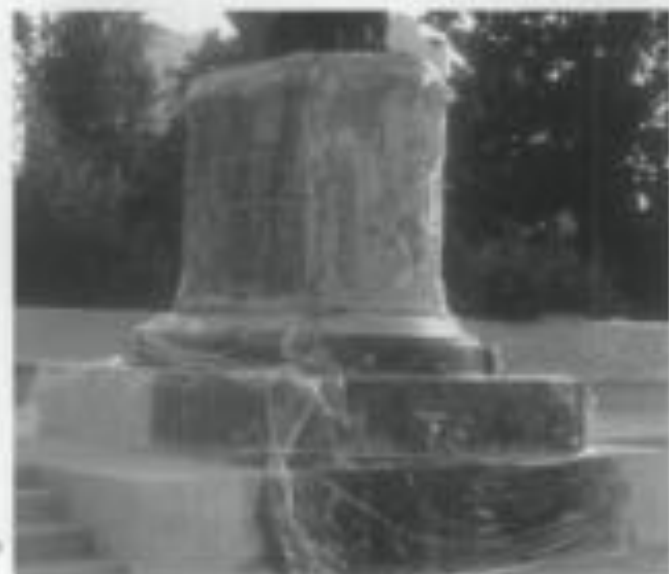
Poulticing to Remove Stains and Graffiti

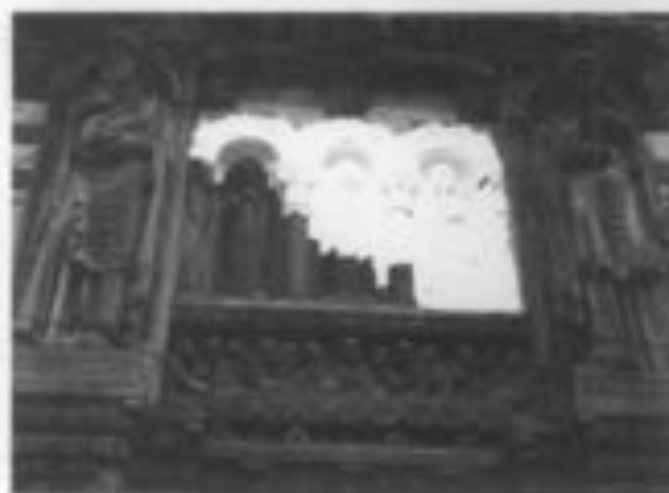
Figure 16. (a) The limestone base was heavily stained by runoff from the bronze statue above. (b) A poultice consisting of copper stain remover and ammonia mixed with fuller's earth was applied to the stone base and covered with plastic sheeting to keep it from drying out too quickly. (c) As the poultice dried, it pulled the stain out of the stone. (d) The poultice residue was removed carefully from the stone surface with wooden scrapers and the stone was rinsed with water. Photos: John Dugger.

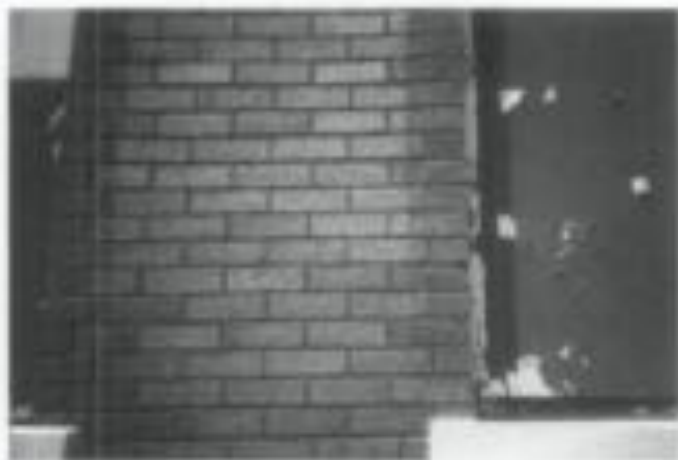
Figure 18. The glazed bricks in the center of the pier were covered by a raphanoid that protected them from being damaged by the sandblasting which removed the glaze from the surrounding bricks.

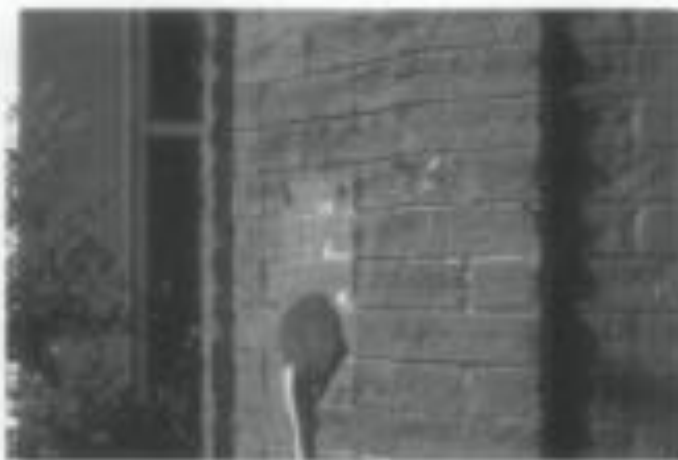
Figure 19. A comparison of undamaged bricks surrounding the electrical conduit with the rest of the brick facade emphasizing the severity of the erosion caused by sandblasting.

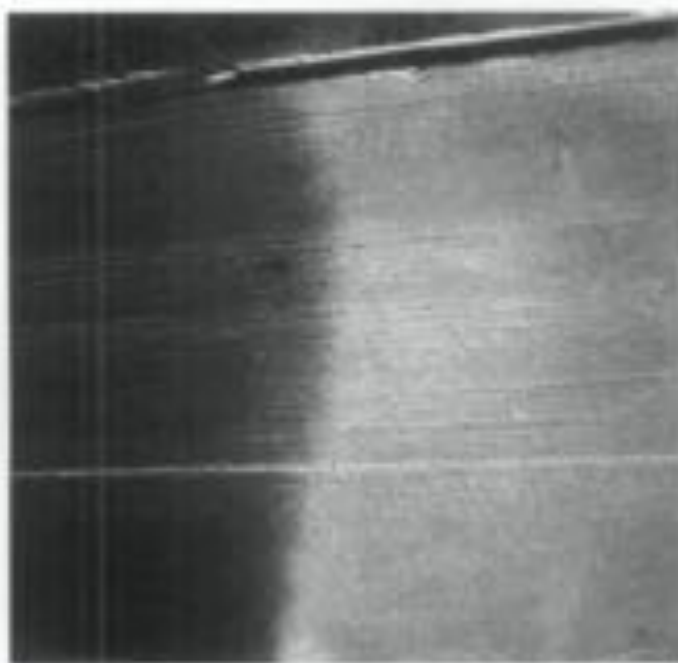
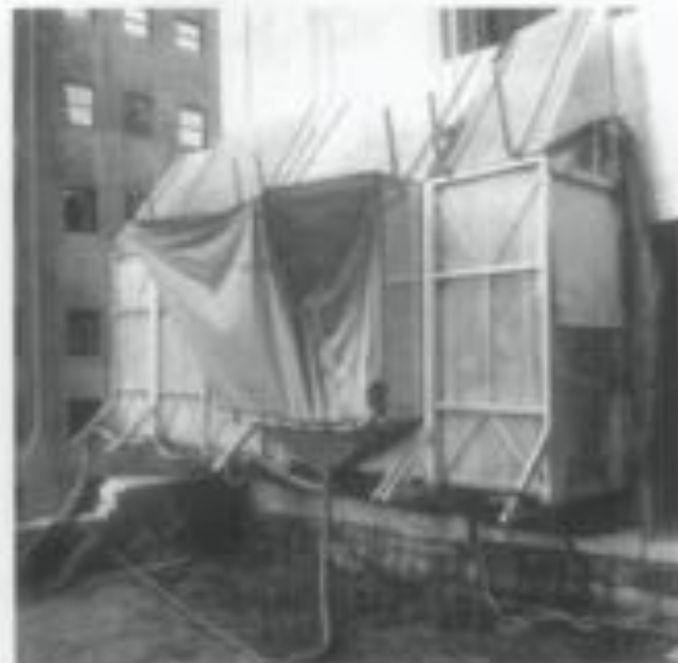
Figure 20. (Left) A comparison of the limestone surface of a 1920s office building before and after “cleaning” with a proprietary abrasive process using fine glass powder clearly shows the effectiveness of this method. But this is an abrasive technique and it has “cleaned” by removing part of the masonry surface with the dirt. Because it is abrasive, it is generally not recommended for large-scale cleaning of historic masonry, although it may be suitable to use in certain, very limited cases under controlled circumstances. (Right) A vacuum chamber where the used glass powder is collected for environmentally safe disposal is a unique feature of this particular process. The specially-trained operators in the chamber wear protective clothing, masks and breathing equipment. Photos: Tom Kishen.

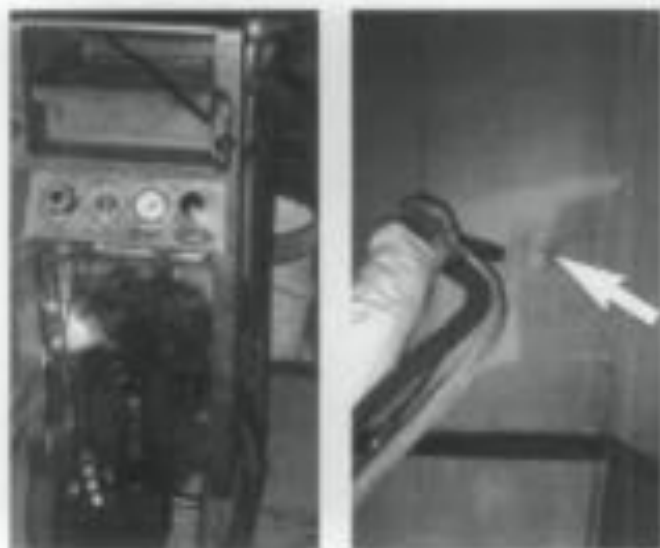
Figure 21. Low-pressure blasting with ice pellets or ice crystals (left) is an abrasive cleaning method that is sometimes recommended for use on interior masonry because it does not involve large amounts of water. However, like other abrasive materials, ice crystals "clean" by removing a portion of the masonry surface with the dirt, and may not remove some stains that have penetrated into the masonry without causing further abrasion (right). Photos: Audrey T. Tipper.

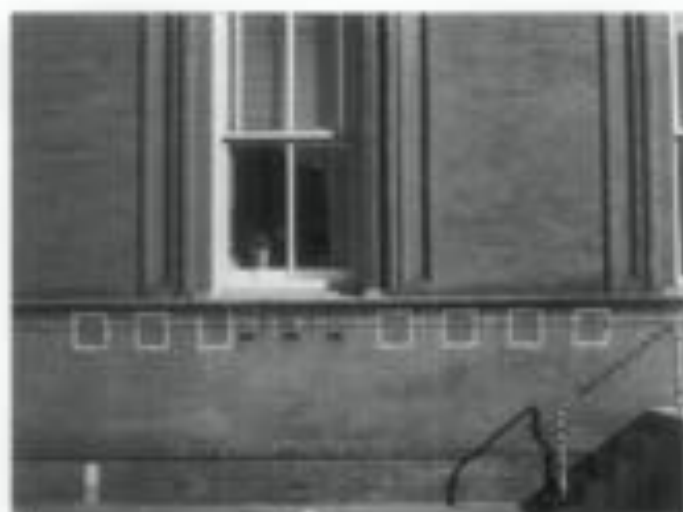
Figure 22. Cleaning test areas may be quite small at first and gradually increase in size as testing determines the "gentlest means possible".
Photo: Frances Gale

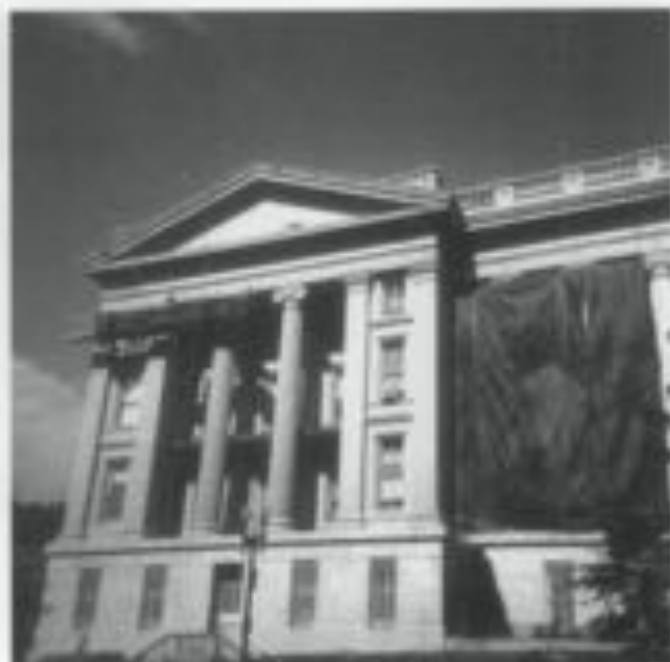
Figure 25. A tarpaulin protects and shields pedestrians from potentially harmful spray while chemical cleaning is underway on the granite exterior of the U.S. Treasury Building, Washington, D.C.

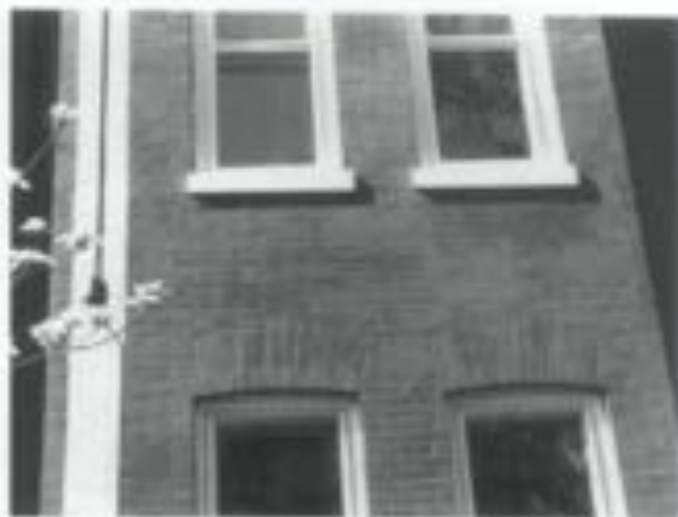
Figure 24. Although the application of a water-repellent coating was probably not needed on either of these buildings, the coating on the brick building (above), is not visible and has not changed the character of the brick. But the coating on the brick columns (below), has a high gloss that is incompatible with the historic character of the masonry.

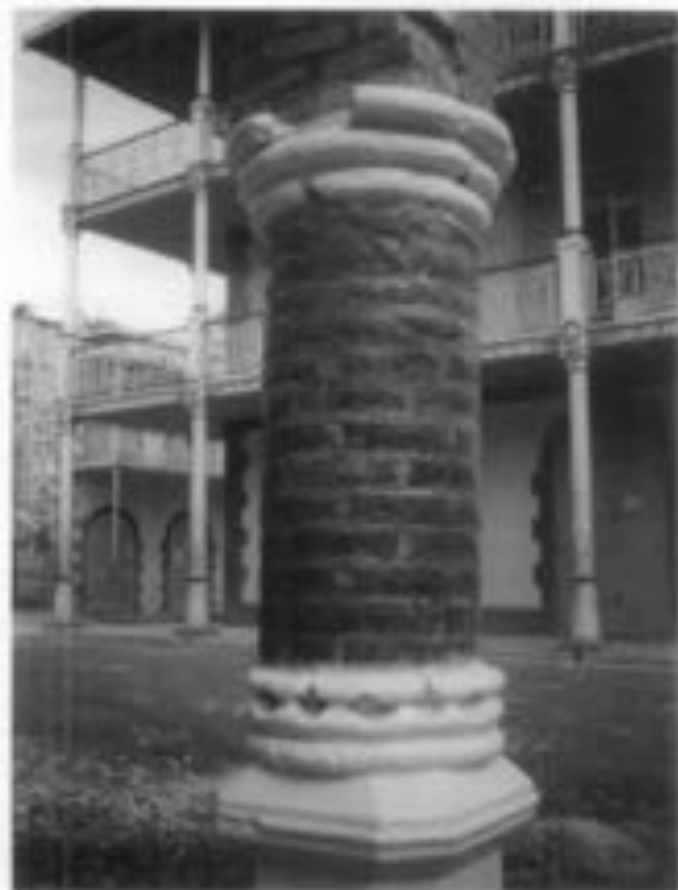
beneath the surface as subflorescence. Subflorescence eventually may cause the surface of the masonry to spall, particularly if a water-repellent coating has been applied which tends to reduce the flow of moisture out from the subsurface of the masonry. Although many of the newer water-repellent products are more breathable than their predecessors, they can be especially damaging if applied to masonry that contains salts, because they limit the flow of moisture through masonry.

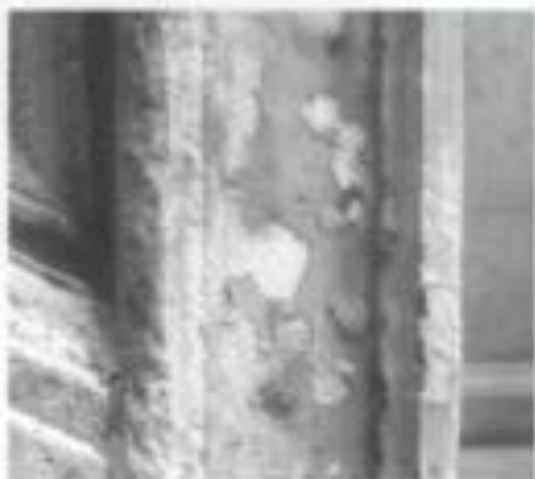
Figure 25. The clear coating applied to this limestone masonry has failed and is taking off some of the stone surface as it peels. Photo: Frances Gale.

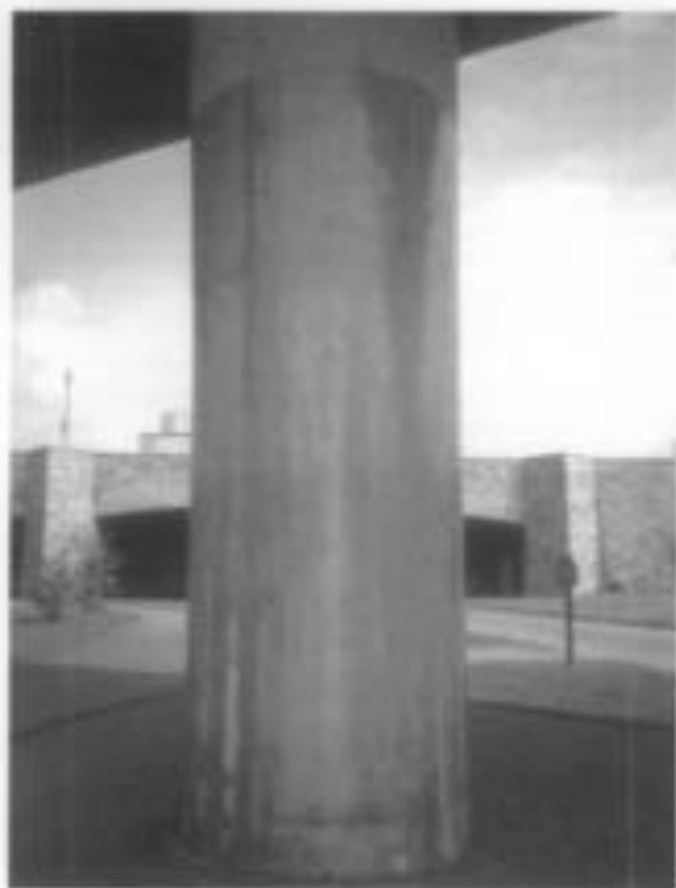
Figure 26. The anti-graffiti or barrier coating on this column is very shiny and would not be appropriate to use on a historic masonry building. The coating has discolored as it has aged and whitish streaks reveal areas of bare concrete where the coating was incompletely applied.

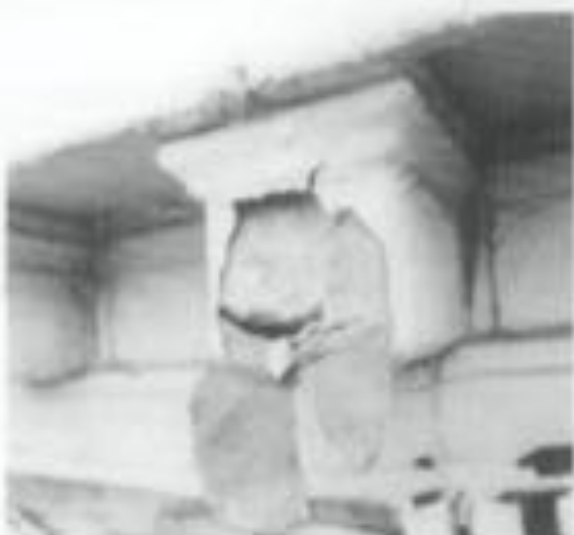
Figure 27. Instead of correcting the roof drainage problems, an elastomeric coating was applied to the already saturated limestone cornice. An elastomeric coating holds moisture in the masonry because it does not "breathe" and does not allow liquid moisture to escape. If the water pressure builds up sufficiently it can cause the coating to break and pop off as shown in this example, often pulling pieces of the masonry with it. Photo: National Park Service Files.

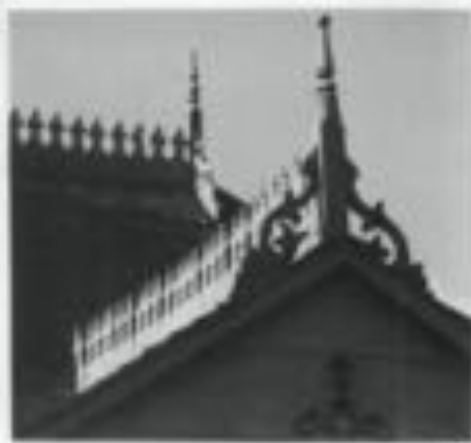
Tiles roofs found in the mid-18th century Moravian settlements in Pennsylvania closely resembled those found in Germany. Typically, the tiles were 14-15" long, 6-7" wide with a curved butt. A lug on the back allowed the tiles to hang on the lathing without nails or pegs. The tile surface was usually scored with finger marks to promote drainage. In the Southwest, the tile roofs of the Spanish missionaries (mission tiles) were first manufactured (ca. 1780) at the Mission San Antonio de Padua in California. These semicircular tiles were

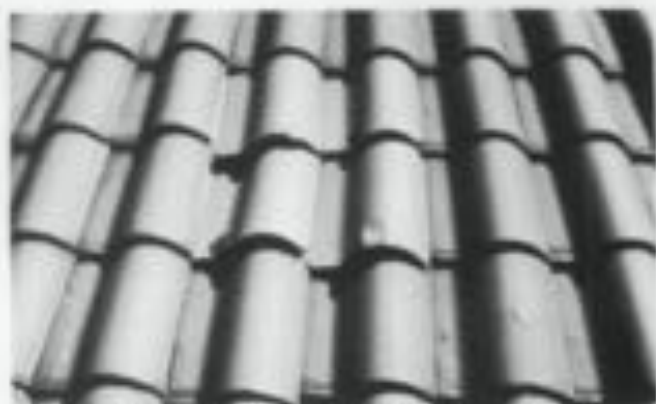
Repairs on this pantile roof were made with new tiles held in place with metal hangers. (Main Building, Ellis Island, New York)

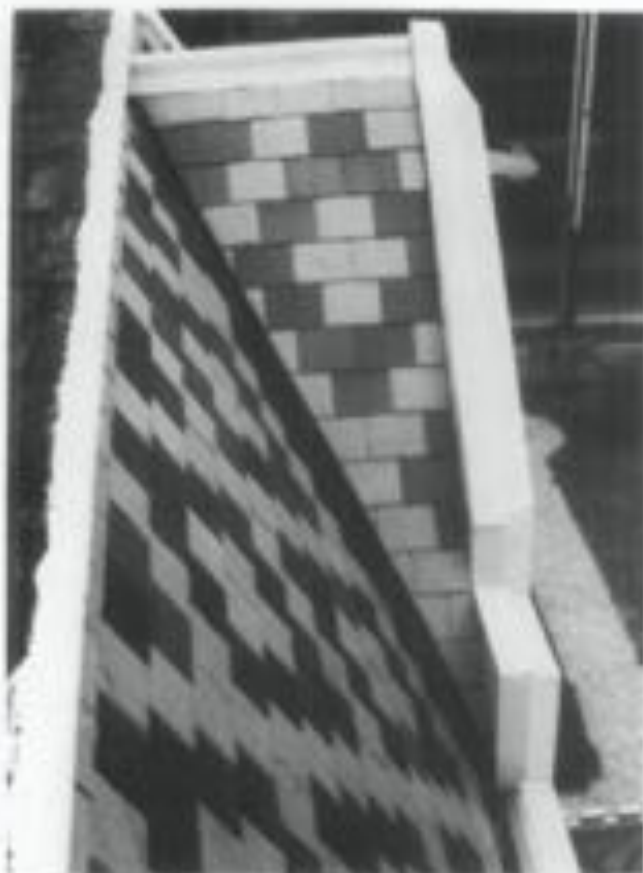
The Victorians loved to use different colored slates to create decorative patterns on their roofs, an effect which cannot be easily duplicated by substitute materials. Before any repair work on a roof such as this, the slate sizes, colors, and position of the patterning should be carefully recorded to assure proper replacement. (Elmwood Maxwell Mansion, Philadelphia, Pennsylvania, photo courtesy of William D. Horsesh)

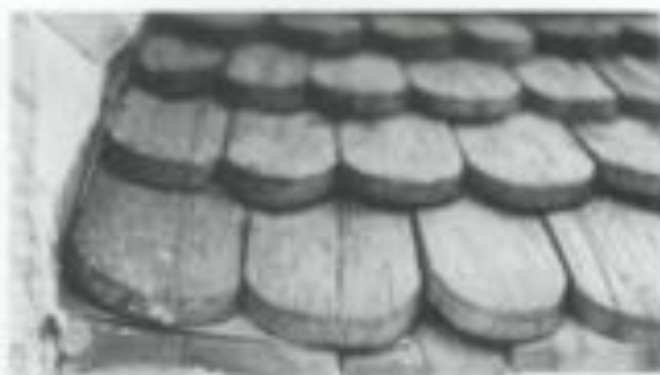
Replacement of particular historic details is important to the individual historic character of a roof, such as the treatment at the eaves of the rounded butt wood shingle roof. Also note that the surface of the roof was carefully sloped to drain water away from the side of the dormer. In the restoration, this function was augmented with the addition of carefully concealed modern metal flashing. (Mount Vernon, Virginia)

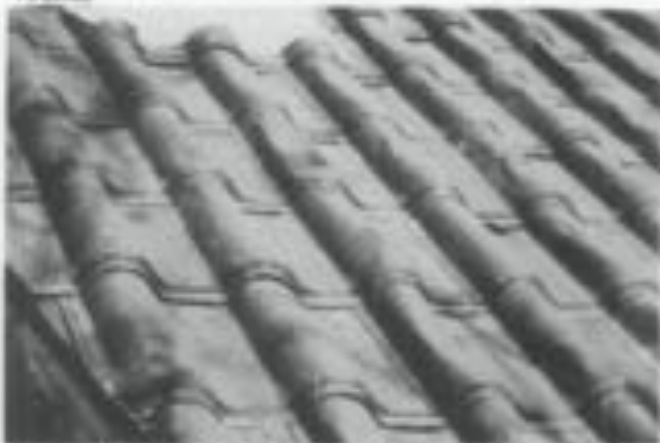
Galvanized sheet metal shingles imitating the appearance of wood shingles remained popular from the second half of the 19th century into the 20th century. (Episcopal Church, now the Jerome Historical Society Building, Jerome, Arizona, 1927)

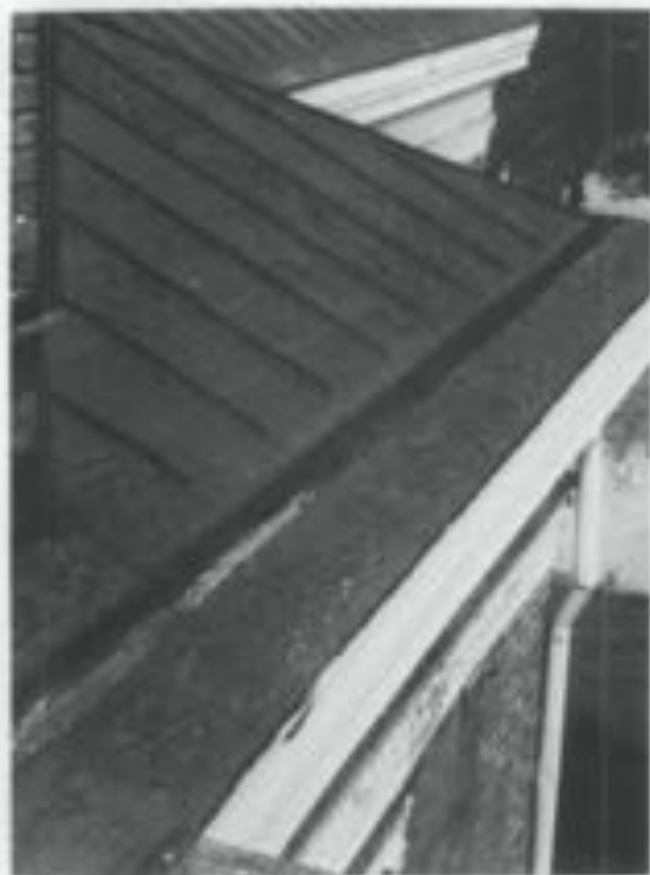
Repeated repair with asphalt, which cracks as it hardens, has created a herringbone surface on this sheet metal roof and built-in gutter, which will retain water. Repairs could be made by carefully heating and scraping the surface clean, repairing the holes in the metal with a flexible mastic compound or a metal patch, and coating the surface with a fiber paint. (Hwane County Courthouse, Kingsport, Tennessee, photo courtesy of Building Conservation Technology, Inc.)

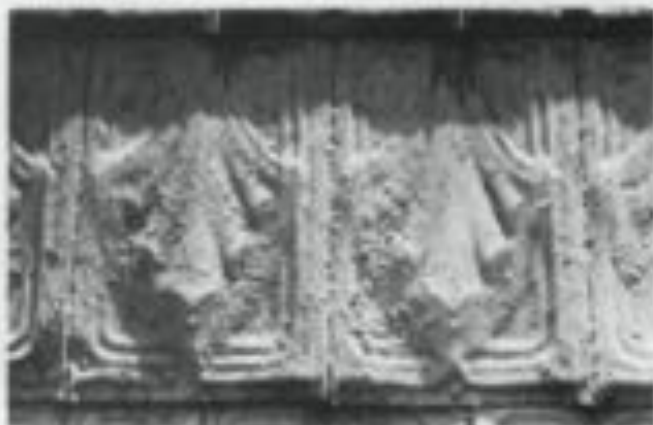
Tin shingles, commonly embossed to imitate wood or tile, or with a decorative design, were popular as an inexpensive, textured roofing material. These shingles 8 1/2 inch by 12 1/2 inch on the exposed surface were designed with interlocking edges, but they have been repaired for surface nailing, which may cause future leakage. (Ballard House, Yorktown, Virginia, photo by Gerald Whittington, National Park Service)

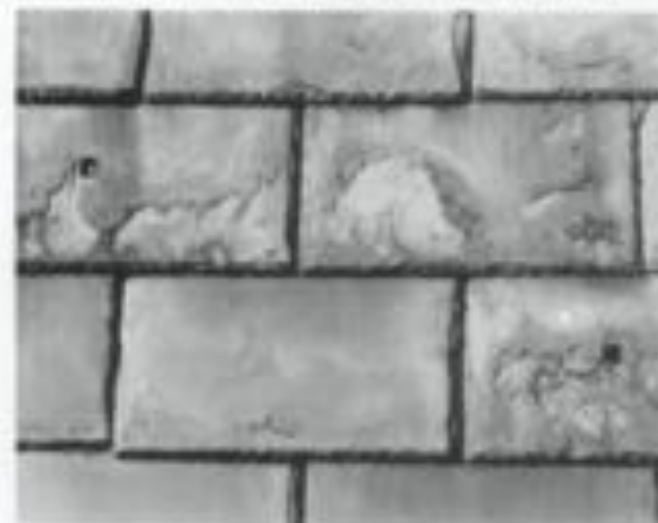
This detail shows slate delamination caused by a combination of weathering and pollution. In addition, the slates have eroded around the repair nails, incorrectly placed in the exposed surface of the slates (Lower Pontalba Building, New Orleans, photo courtesy of Building Conservation Technology, Inc.)

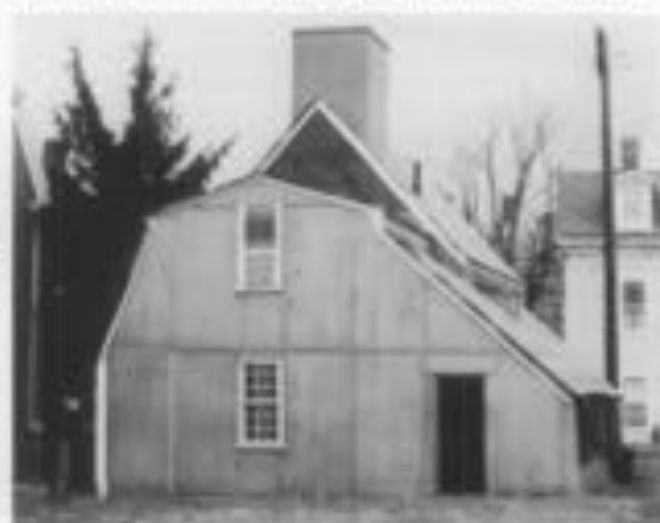
Temporary stabilization or "mushbelling" with materials such as plywood and building paper can protect the roof of a project until it can be properly repaired or replaced. (Narbonne House, Salem, Massachusetts)

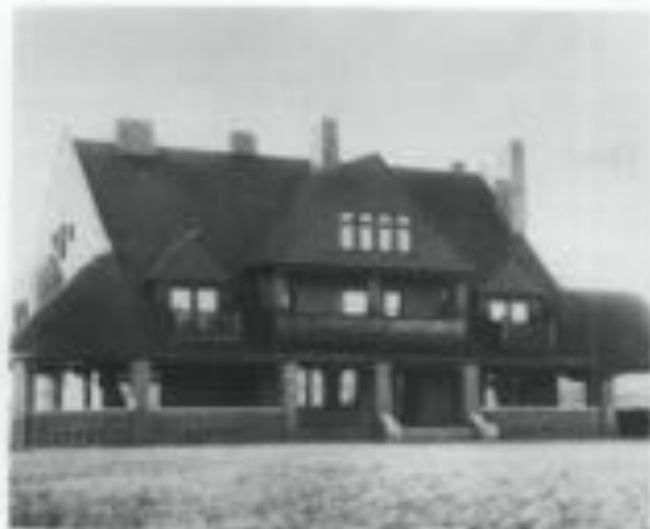
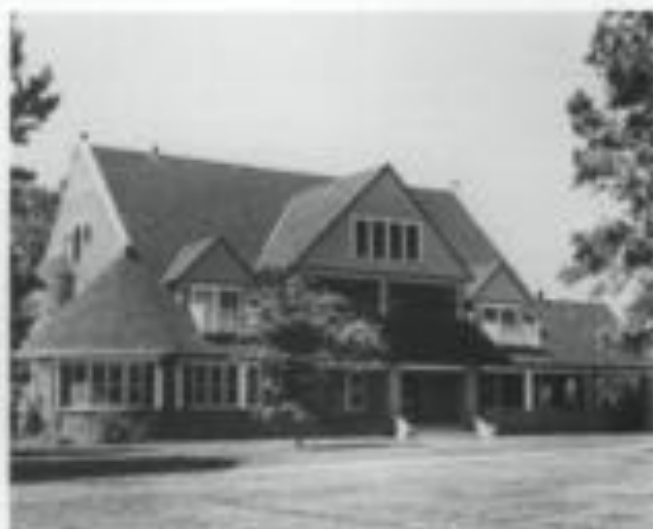
These two views of the same house demonstrate how the use of a substitute material can drastically affect the overall character of a structure. The textural interest of the original tile roof was lost with the use of asphalt shingles. Recent preservation efforts are replacing the tile roof. (Frank House, Kearney, Nebraska, photo courtesy of the Nebraska State Historical Society, Lincoln, Nebraska)

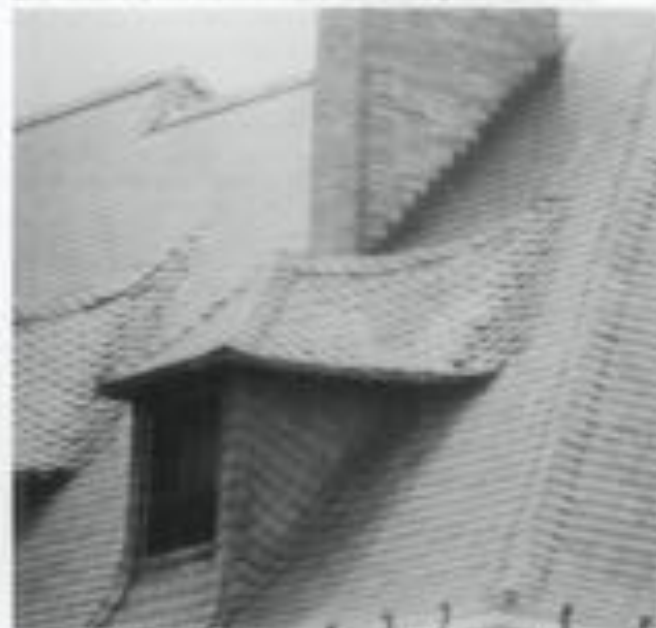
Because of the roof's visibility, the slate detailing around the dormer is important to the character of this structure. Note how the slate swirl from a horizontal pattern on the main roof to a diamond pattern on the dormer roof and side walls. (18th and Que Streets, NW, Washington, D.C.)

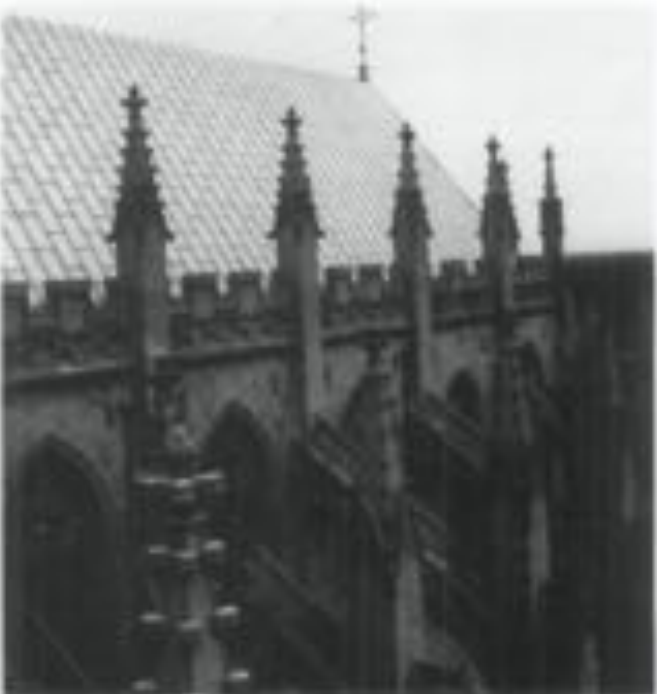
Good design and quality materials for the roof surface, framings, and flashing minimize roofing failures. This is essential on roofs such as on the National Cathedral where a thorough maintenance inspection and minor repairs cannot be done easily without special roof jacking. Moreover, the success of the roof on any structure depends on frequent cleaning and repair of the gutter system. (Washington, D.C., photo courtesy of John Burns, A.I.A.)

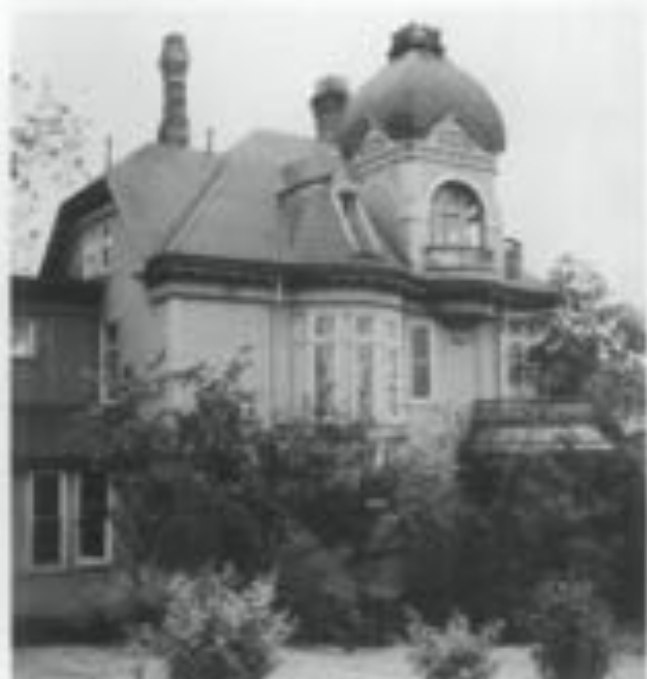
Special problems inherent in the design of an elaborate historic roof can be controlled through the use of good materials and regular maintenance. The shape and detailing are essential elements of the building's historic character, and should not be modified, despite the use of alternative surface materials. (Camwell House, Bellingham, Washington)

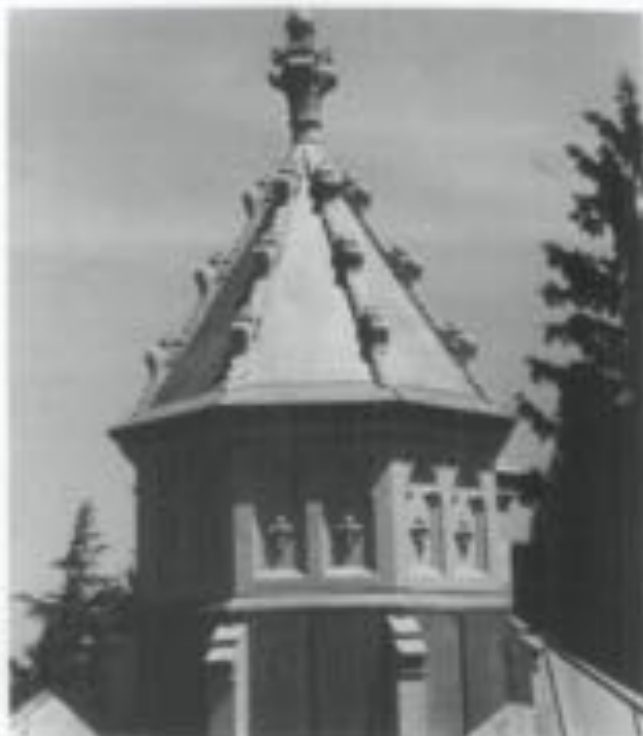
Decorative features such as cupolas require extra maintenance. The flashing is carefully detailed to promote run-off, and the wooden ribbing must be kept well-painted. This roof surface, which was originally tin plate, has been replaced with lead-coated copper for maintenance purposes. (Lyndhurst, Tarrytown, New York, photo courtesy of the National Trust for Historic Preservation)

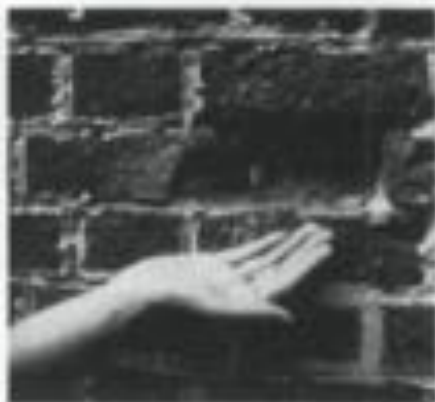
U.S. Department of the Interior
National Park Service
Cultural Resources
Heritage Preservation Services

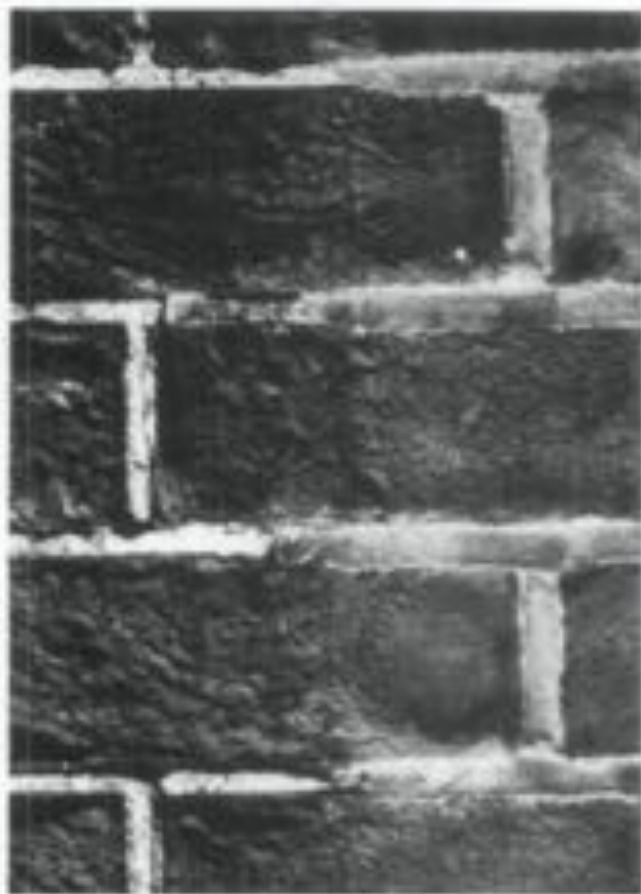
Abrusively Cleaned vs. Untouched Brick. Two brick masonry units with a common facade provide an excellent point of comparison when only one of the bricks has been sandblasted. It is clear that abrasive blasting, by removing the outer surface, has left the brickwork on the left rough and pitted, while that on the right still exhibits an undamaged and relatively smooth surface. Note that the abrasive cleaning has also removed a considerable portion of the mortar from the joints of the brick on the left side, which will require repointing.

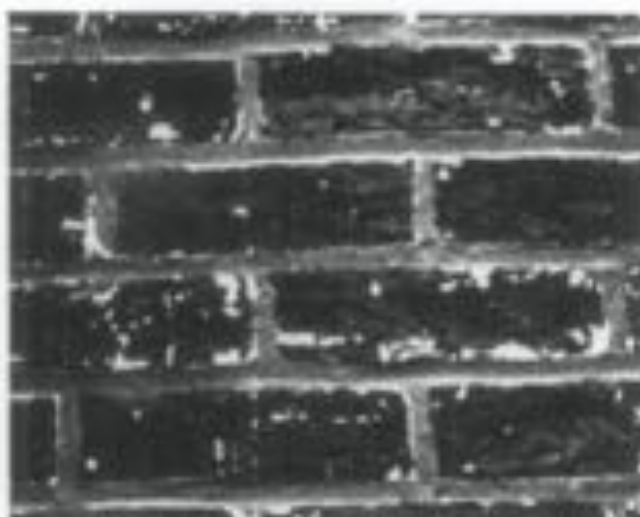
Abrading the Surface without Removing the Paint. Even though the outer outer surface layer of the brick has been sandblasted off, spots of paint still cling to the masonry. Sandblasting or other similarly abrasive methods are not always a successful means of removing paint.

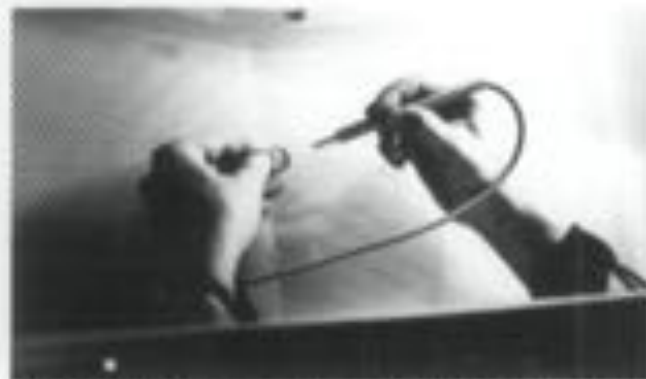
Micro-Abrasive Cleaning. This small, pencil-sized micro-abrasive unit is used by some masonry contractors to clean small objects. This particular micro-abrasive unit is operated within the confines of a box (approximately 2 cubic feet of space), but a similar and slightly larger unit may be used for cleaning larger pieces of sculpture, or areas of architectural detailing on a building. Even a pressure cleaning unit this small is capable of eroding a surface, and must be carefully controlled.

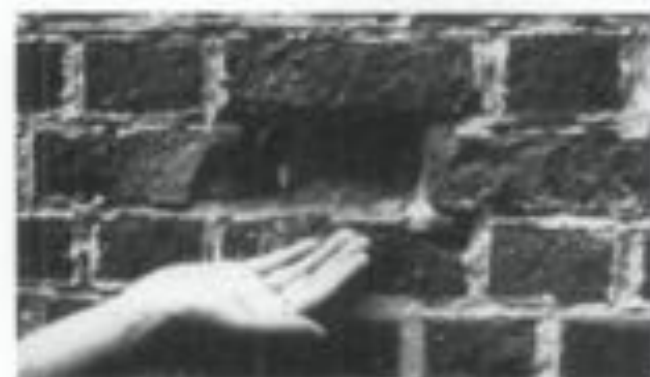
Spalling Brick. This soft, early 19th-century brick was substituted in the 1960s, consequently, severe spalling has resulted. Some bricks have almost totally disintegrated, and will eventually have to be replaced. (Robert E. Campbell)

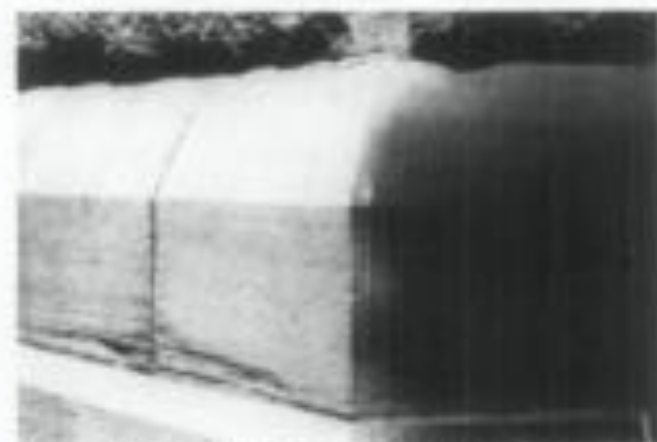
Abrasive Cleaning of Tooled Granite. Even this carefully controlled "wet grit" blasting has caused vertical tooling marks in the cut granite blocks on the left. Not only has the tooling been destroyed, but the damaged stone surface is now more susceptible to accelerated weathering.

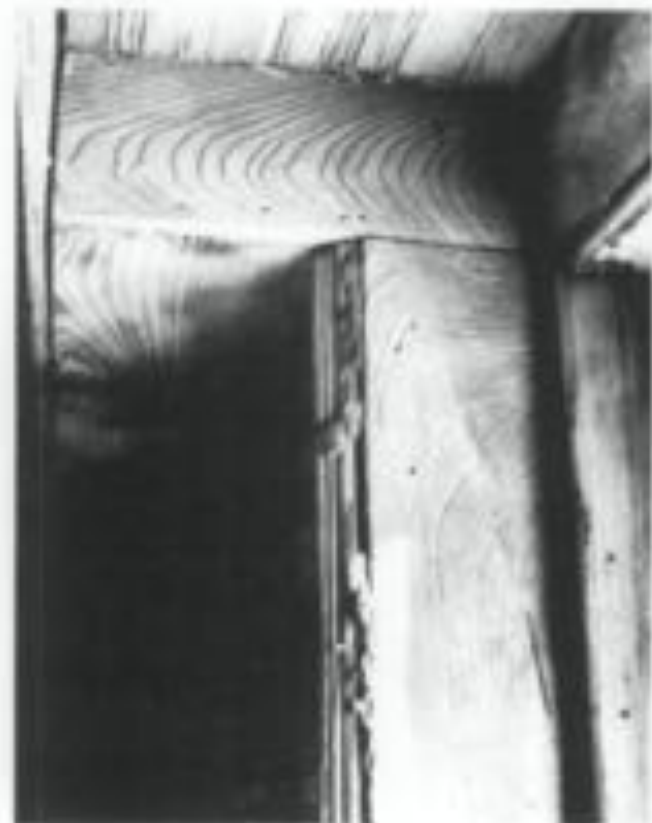
Abrasive Cleaning of Wood. This wooden window sill, molding and paneling have been sandblasted to remove layers of paint in the rehabilitation of this commercial building. Not only is some paint still embedded in cracks and crevices of the woodwork, but more importantly, grit blasting has actually eroded the summer wood, in effect raising the grain, and resulting in a rough surface.

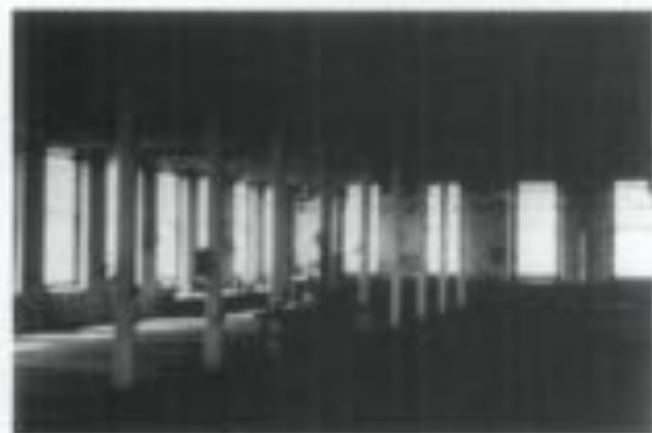
Permissible Abrasive Cleaning. In accordance with the Secretary of the Interior's Guidelines for Rehabilitation Projects, it may be acceptable to use abrasive techniques to clean an industrial interior space such as that illustrated here, because the masonry surfaces do not have significant design, detailing, tooling or finish, and the wooden architectural features are not finished, molded, beaded or worked by hand.

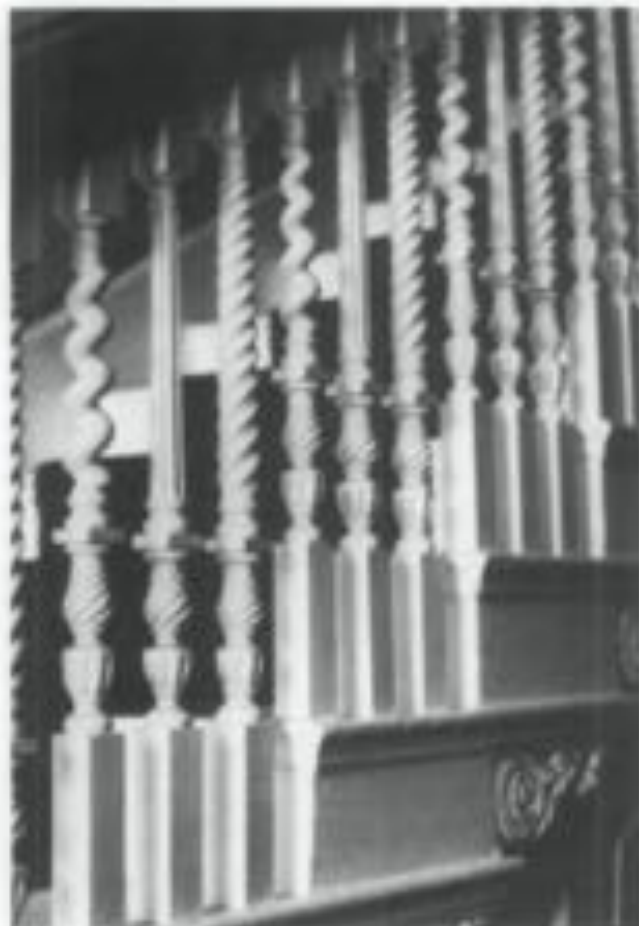
Do not Abrasively Clean these Interiors. Most historic residential and some commercial interior spaces contain finished plaster and wooden elements such as the stair balustrade and paneling which contribute to the historic and architectural character of the structure. Such interiors should not be subjected to abrasive techniques for the purpose of removing paint, dirt, discoloration or plaster.

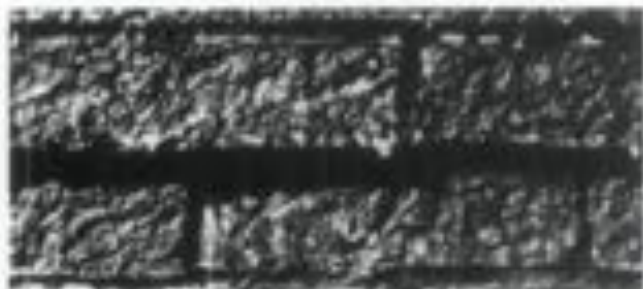
Hazards of Sandblasting and Surface Coating. In order to "protect" this heavily sandblasted brick, a clear surface coating or sealer was applied. Because the air temperature was too cold at the time of application, the sealer failed to dry properly, dripping in places, and giving the brick surface a cloudy appearance.

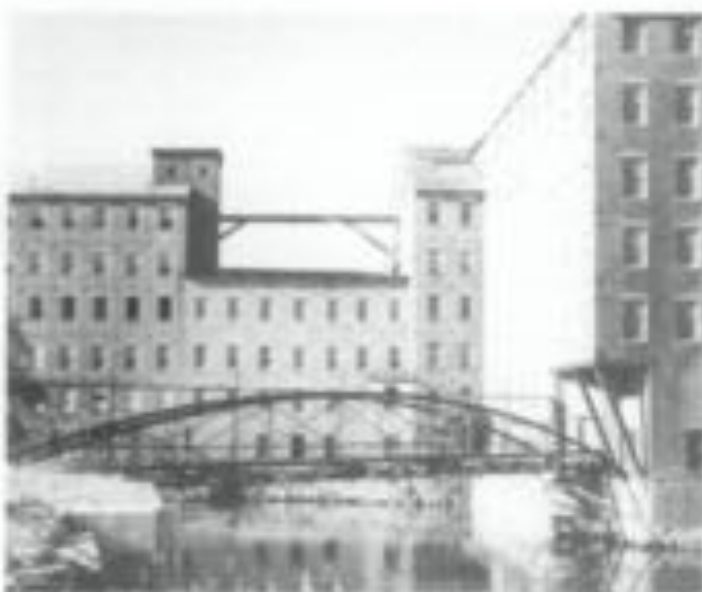
Figure 1. Windows are frequently important visual focal points, especially on simple facades such as this mill building. Replacement of the multi-pane windows here with larger panes could dramatically change the appearance of the building. The areas of missing windows convey the impression of such a change. Photo: John F. Lenz

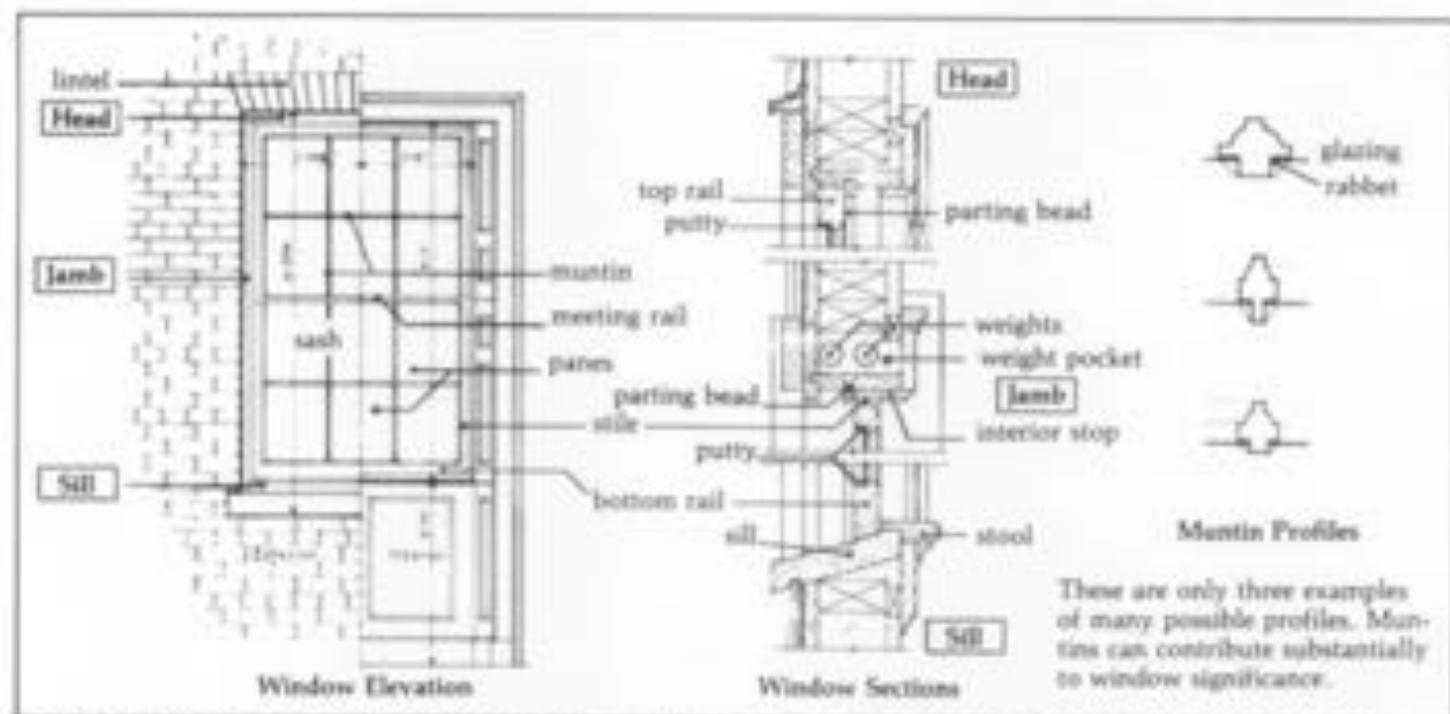
Figure 2. These drawings of window details identify major components, terminology, and installation details for a wooden double-hung window.

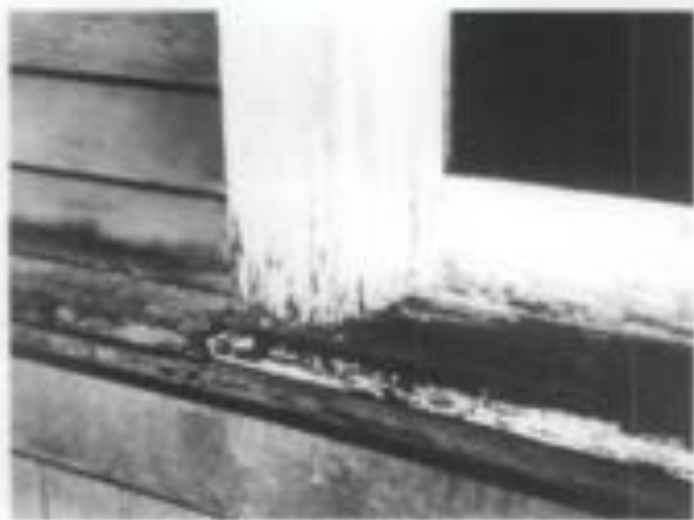
Figure 3. Deterioration of poorly maintained windows usually begins on horizontal surfaces and at joints where water can collect and saturate the wood. The problem areas are clearly indicated by paint failure due to moisture. Photo: Bard M. Smith, AIA

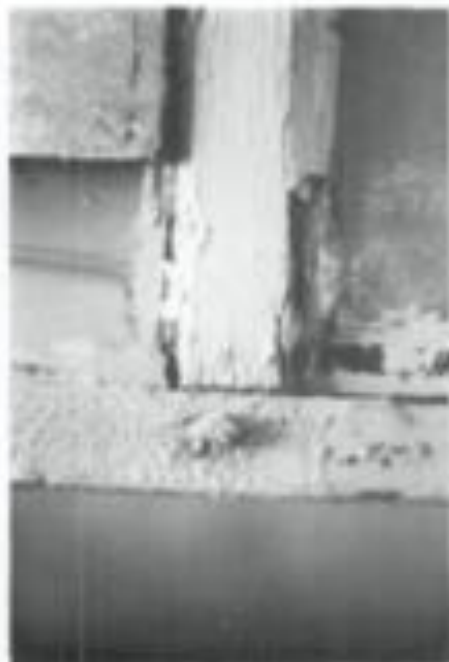
Figure 4a. The following series of photographs of the repair of a historic double-hung window use a sash which is structurally sound but has many layers of paint, some cracked and missing putty, slight separation at the joints, broken sash cords, and one cracked pane. Photo: John H. Myers

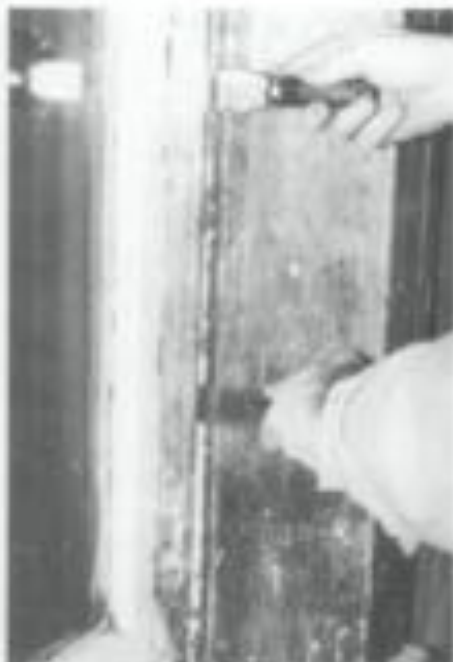
Figure 4b. After removing paint from the sash between the interior stop and the joint, the stop can be grind out and gradually worked loose using a pair of putty knives as shown. To avoid visible scarring of the wood, the sash can be raised and the stop grind loose initially from the outer side. Photo: John H. Myers

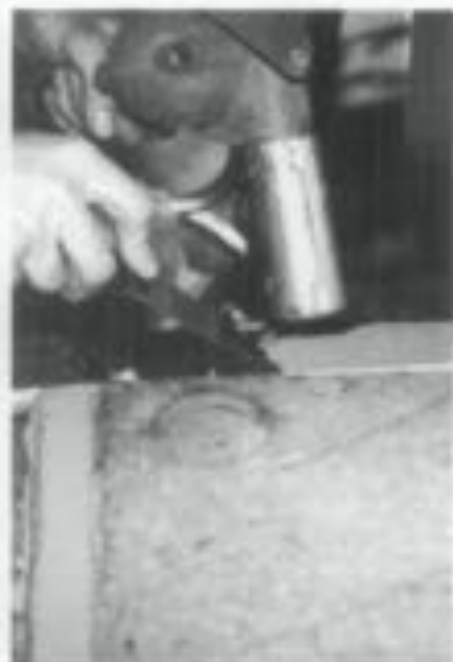
Figure 4c. Sash can be removed and repaired in a convenient work area. Paint is being removed from this sash with a hot air gun while an asbestos sheet protects the glass from sudden temperature change. Photo: John H. Myers

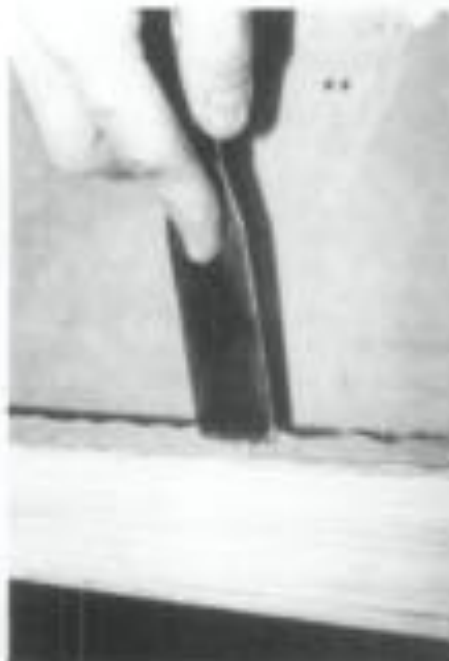
Figure 4d. Replacing or replacement of the putty requires that the existing putty be removed manually, the glazing points be extracted, the glass removed, and the back putty scraped out. To replace, a bed of putty is laid around the perimeter of the rabbet, the pane is pressed into place, glazing points are inserted to hold the pane (shown), and a final coat of putty is beveled around the edge of the glass. Photo: John H. Myers
