GEORGETOWN STEAM PLANT
HISTORIC STRUCTURE & CULTURAL LANDSCAPE REPORT

OCTOBER 9, 2013

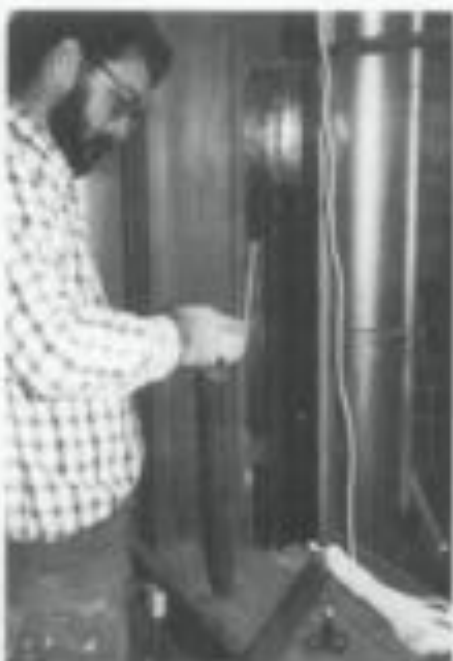
Figure 4e. A common repair is the replacement of broken sash cords with new cords (shown) or with chains. The weight pocket is often accessible through a removable plate in the joint, or by removing the interior trim. Photo: John H. Myers

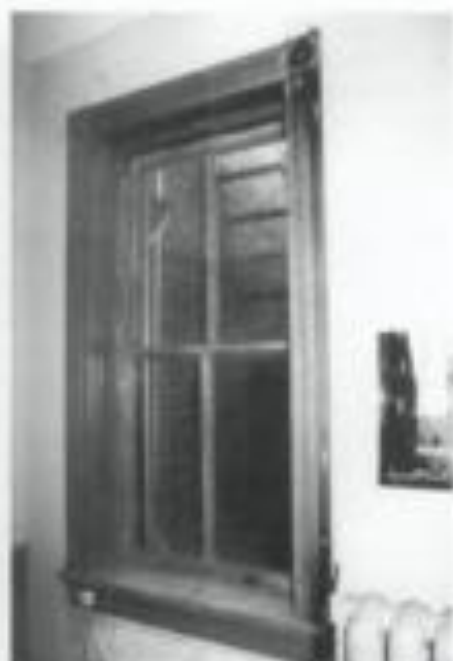
Figure 4f. Following the relatively simple repairs, the window is airtight, like new in appearance, and accessible for many years to come. Both the historic material and the detailing and craftsmanship of this original window have been preserved. Photo: John H. Myers

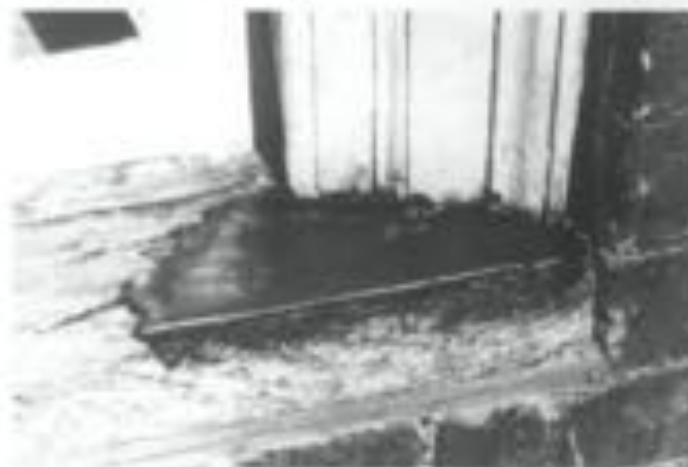
Figure 5. This illustrates a two-part epoxy patching compound used to fill the surface of a weathered sill and rebuild the missing edge. When the epoxy cures, it can be sanded smooth and painted to achieve a durable and waterproof repair. Photo: John H. Myers

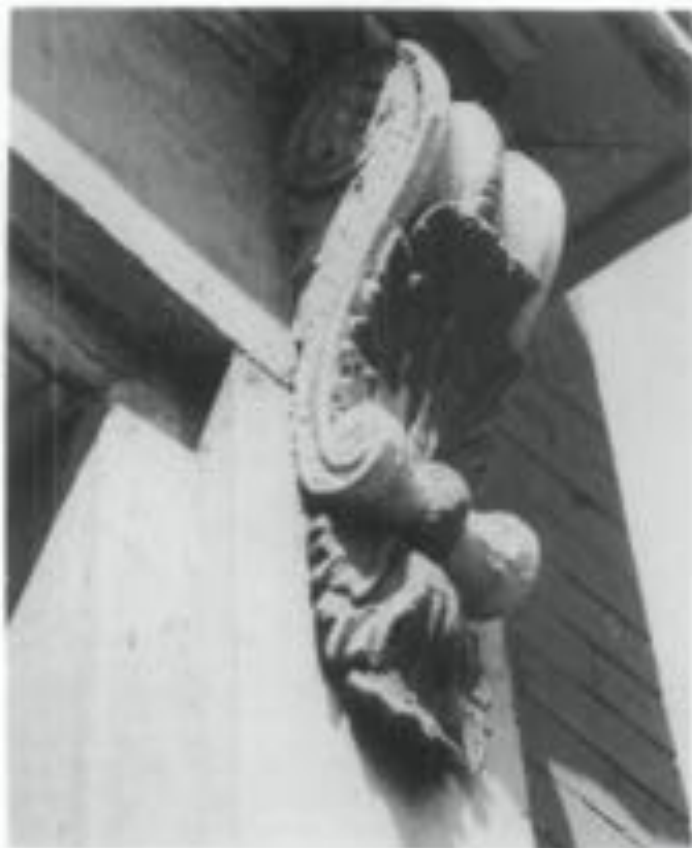
Fig. 1 Excessive paint build-up on architectural details such as this ornamental bracket does not in itself justify total paint removal. If paint is cracked and peeling down to bare wood, however, it should be removed using the gentlest means possible. Photo: David W. Look, AIA.

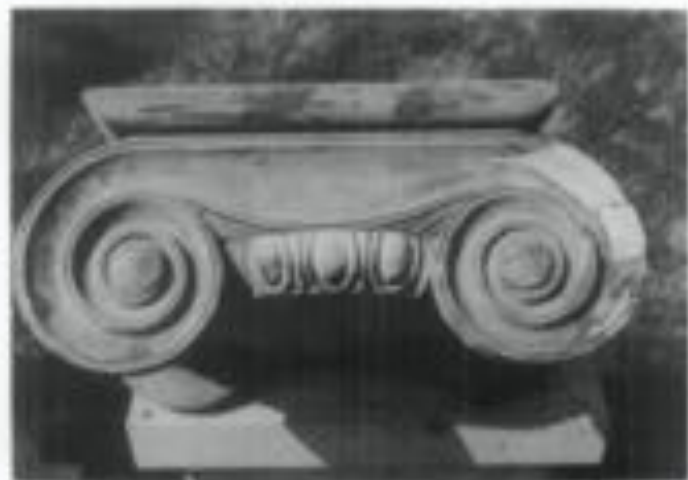
Fig. 3 If damage to parts of a wooden element is severe, new sections of wood will need to be pieced-in. When such piecing-in is required, paint on the adjacent woodwork should be removed so that the old and new woods will make a smooth profile when joined. After repainting, the repair should be virtually impossible to detect. Photo: Morgan W. Phillips.

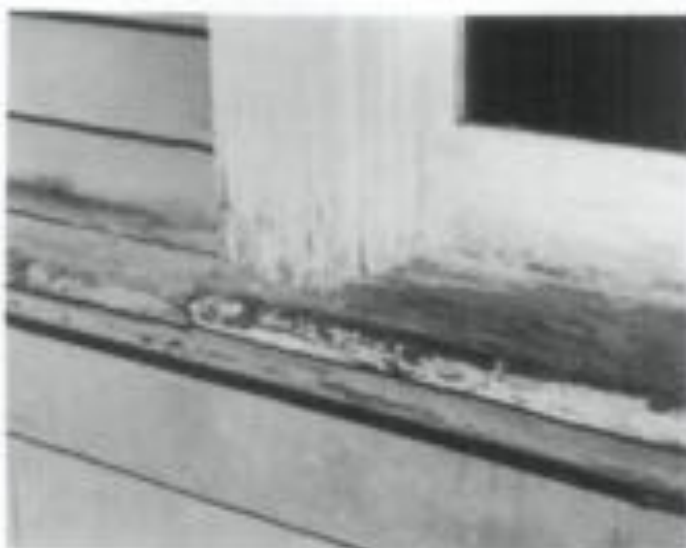
Staining of paint coatings usually results from excess

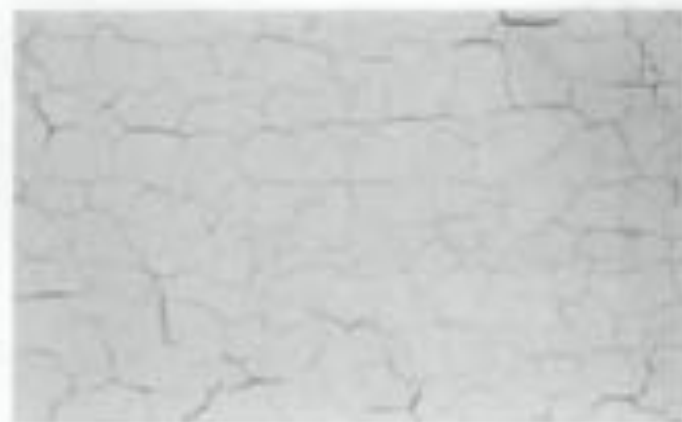
Fig. 5 Cracking—or surface cracking—is an exterior surface condition which can be successfully treated by sanding and painting. Photo: Courtesy, National Decorating Products Association.

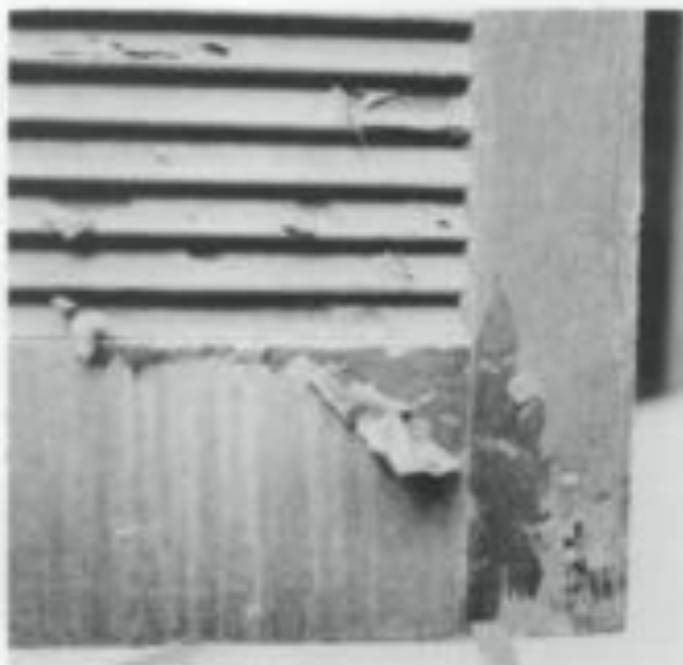
Fig. 6 This is an example of intercoat peeling. A latex top coat was applied directly over old oil paint and, as a result, the latex paint was unable to adhere. If latex is being used over oil, an oil base primer should be applied first. Although much of the peeling latex paint can be scraped off, in this case, the best solution may be to chemically strip the entire shutter to remove all of the paint down to bare wood, rinse thoroughly, then repaint. Photo: Mary L. Dehelen, AIA.

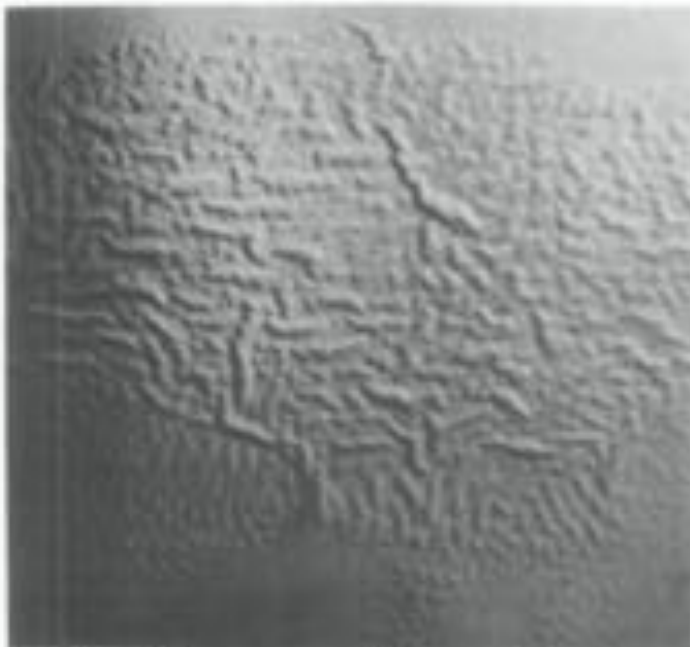
Fig. 7 Wrinkled layers can generally be removed by scraping and sanding as opposed to total paint removal. Following manufacturer's application instructions is the best way to avoid this surface condition. Photo: Courtesy, National Decorating Products Association.

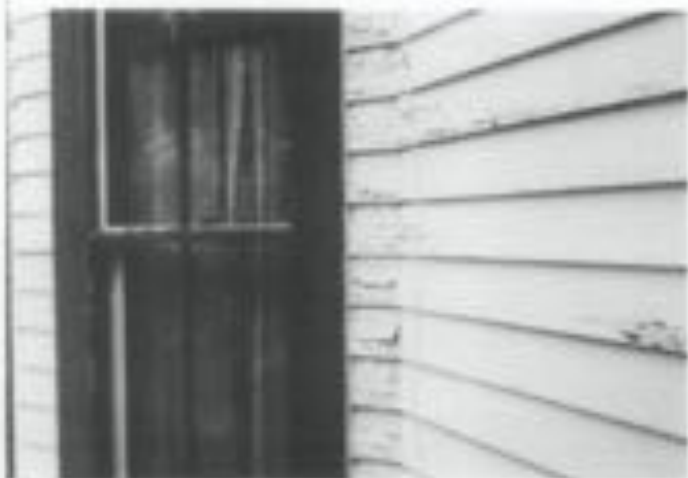
Fig. 8 Peeling to bare wood—one of the most common types of paint failure—is usually caused by an interior or exterior moisture problem. Photo: Anne E. Grimmer

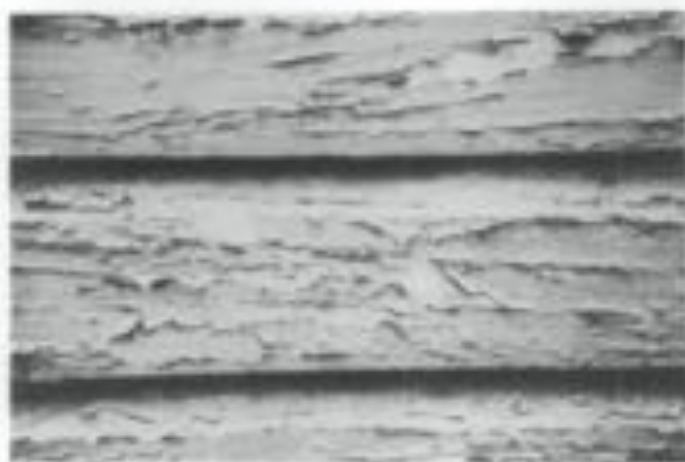
Fig. 9 Cracking, alligatoring, and flaking are evidence of long-term neglect of painted surfaces. The remaining paint on the clipboard shown here can be removed with an electric heat plate and wide-bladed scraper. In addition, unseasoned wood should be replaced and moisture problems corrected before primer and top coats of paint are applied. Photo: David W. Lock, AIA.

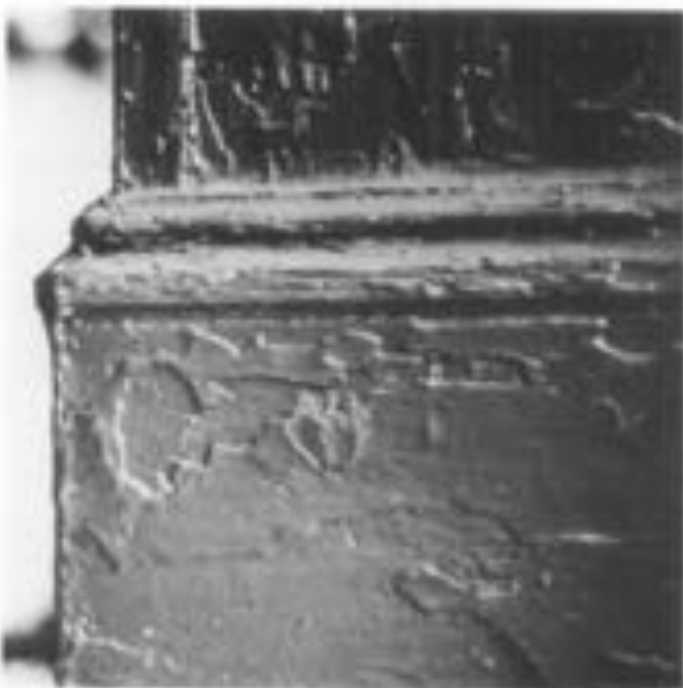
Fig. 10 An excellent example of inadequate scraping before repainting; the problems here are far more than cosmetic. This improperly prepared surface will permit moisture to get behind the paint film which, in turn, will result in chipping and peeling. Photo: Bard M. Smith, AIA.

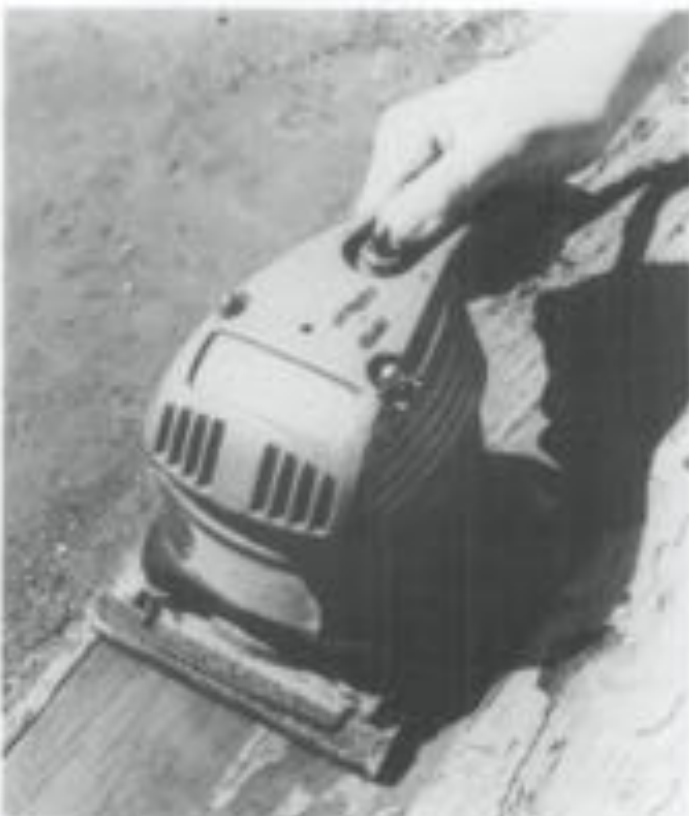
Fig. 11 The orbital sander can be used for limited paint removal, i.e., for smoothing flat surfaces after the majority of deteriorated paint has already been scraped off. Photo: Charles E. Fisher, III.

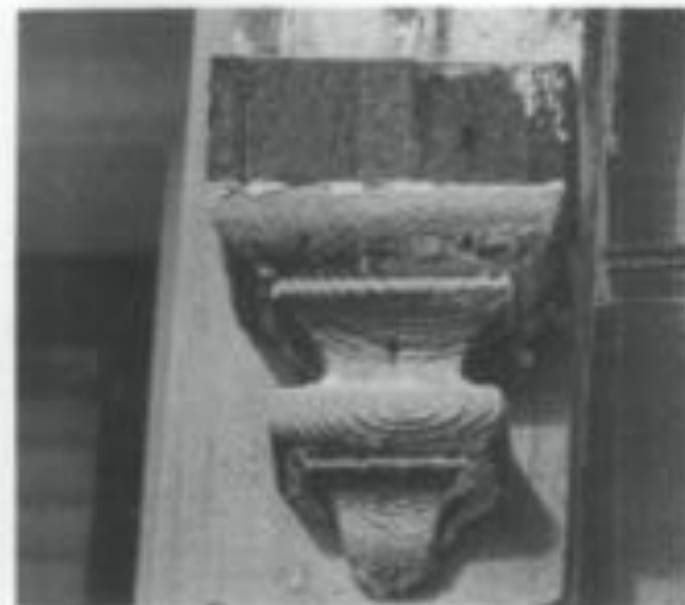
Fig. 12 Sandblasting has permanently damaged this ornamental bracket. Even paint will not be able to hide the deep erosion of the wood. Photo: David W. Look, AIA.

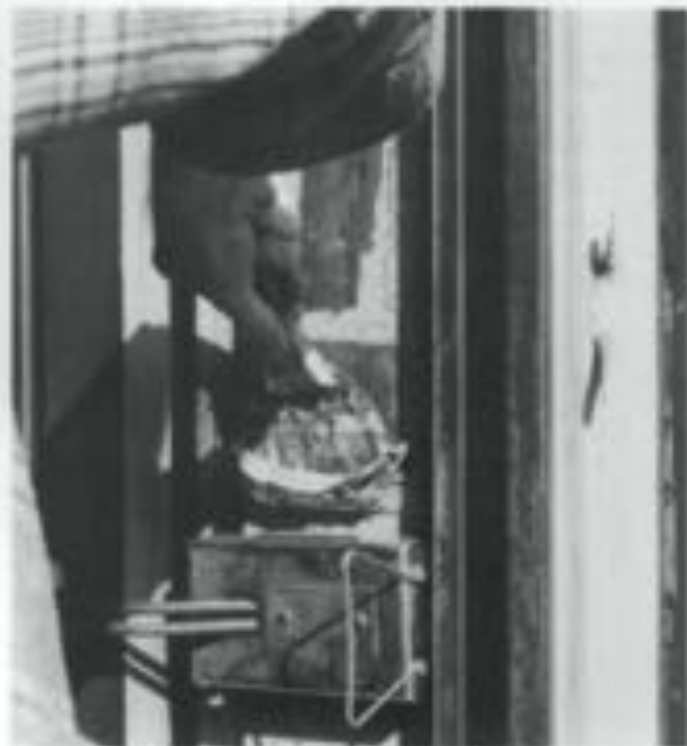
Fig. 13 The electric heat plate (with paint scraper) is particularly useful for removing paint down to bare wood on flat surfaces such as doors, window frames, and siding. After scraping, some light sanding will probably be necessary to smooth the surface prior to application of primer and top coats. Photo: David W. Look, AIA.

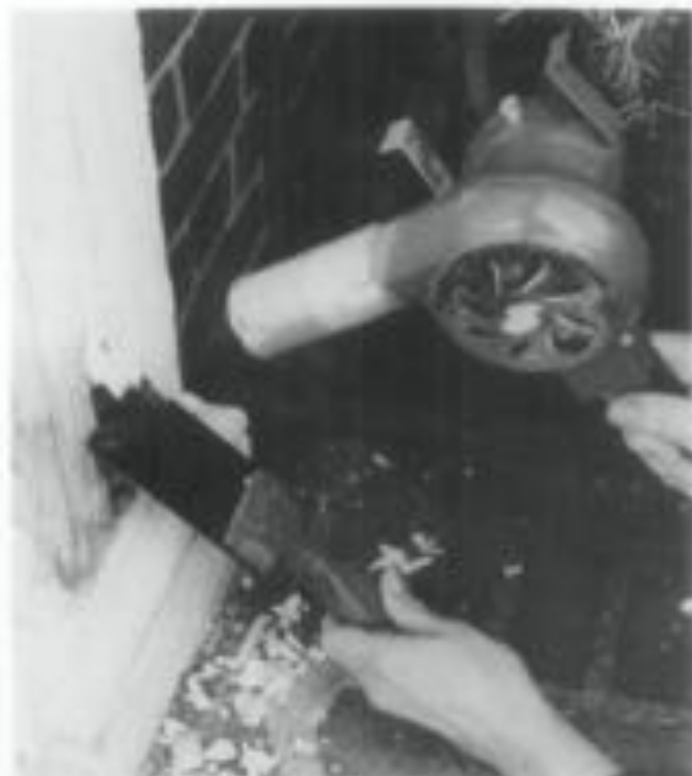
Fig. 24. The nozzle on the electric heat gun permits hot air to be aimed into cavities on solid decorative elements such as this applied column. After the paint has been sufficiently softened, it can be removed with a profiled scraper. Photo: Charles E. Fisher, III.

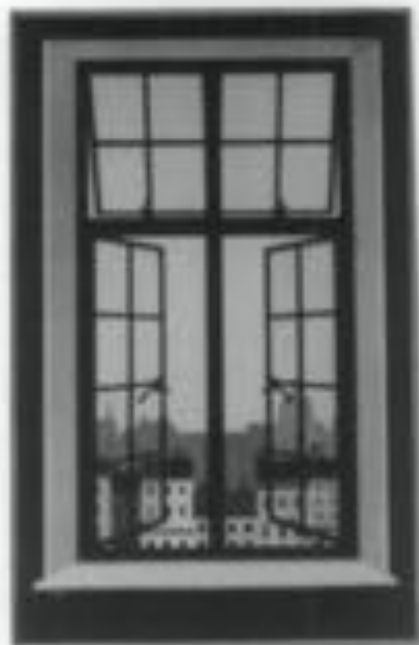
The Secretary of the Interior's "Standards for Rehabilitation" require that where historic windows are individually significant features, or where they contribute to the character of significant facades, their distinguishing visual qualities must not be destroyed. Further, the rehabilitation guidelines recommend against changing the historic appearance of windows through the use of inappropriate designs, materials, finishes, or colors which radically change the sash, depth of reveal, and muntin configuration; the reflectivity and color of the glazing; or the appearance of the frame.

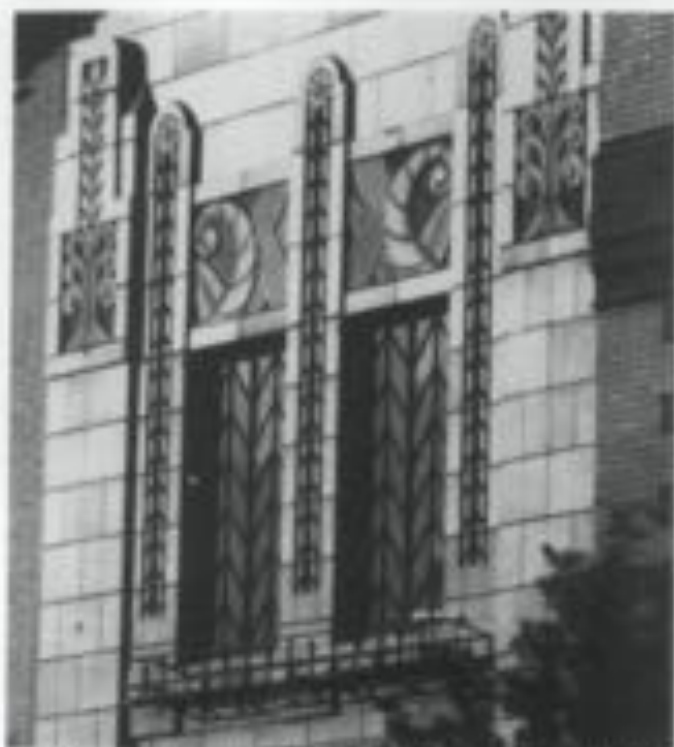
Fig. 1 Often highly distinctive in design and craftsmanship, rolled steel windows play an important role in defining the architectural character of many late nineteenth and early twentieth century buildings. Art Deco, Art Moderne, the International Style, and Post World War II Modernism depended on the slim profiles and streamlined appearance of metal windows for much of their impact. Photo: William G. Johnson.

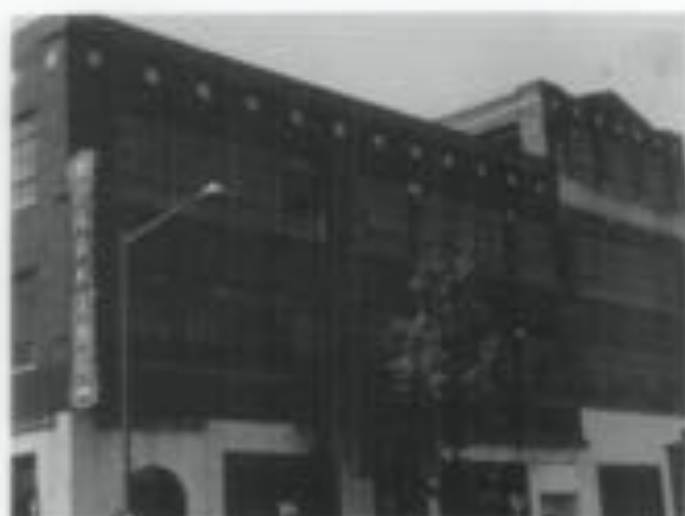
Fig. 5 Windows often provide a strong visual element to relatively simple or unadorned industrial or commercial buildings. This design element should be taken into consideration when evaluating the significance of the windows. Photo: Michael Auer.

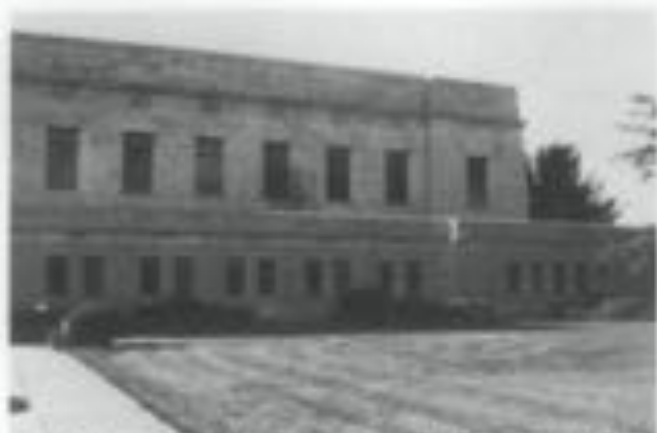
Fig. 6 a. View of the flanking wing of the State Capitol where the rolled steel casement windows are being removed for repair.

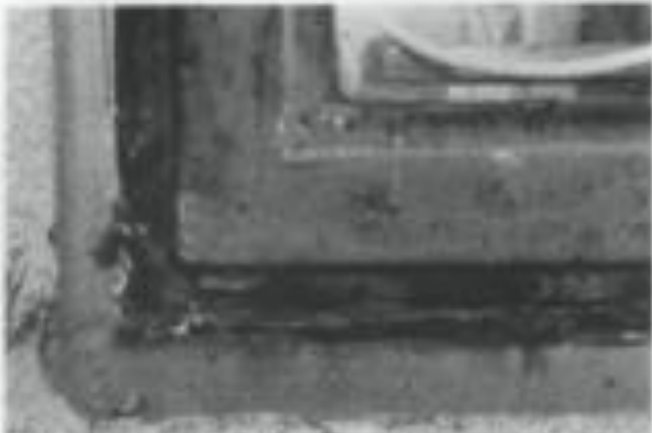
Fig. 6 b. View from the exterior showing the deteriorated condition of the lower corner of a window prior to repair. While the sash was in relatively good condition, the frame behind was rusted to the point of inhibiting operation.

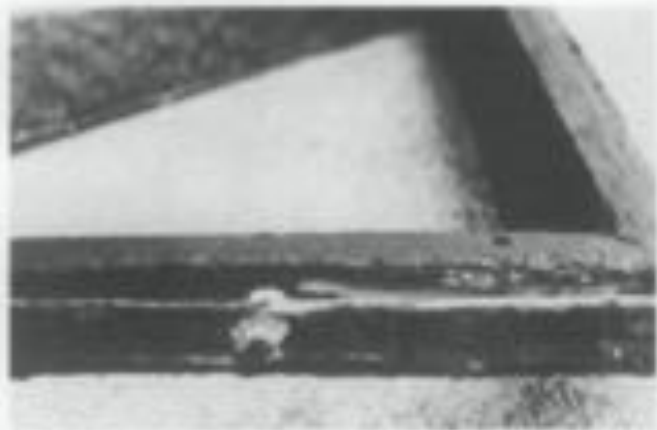
Fig. 6 c. View of the rusted frame which was unscrewed from the subframe and removed from the window opening and taken to a workshop for sandblasting. In some cases, severely deteriorated sections of the frame were replaced with new sections of milled bar steel.

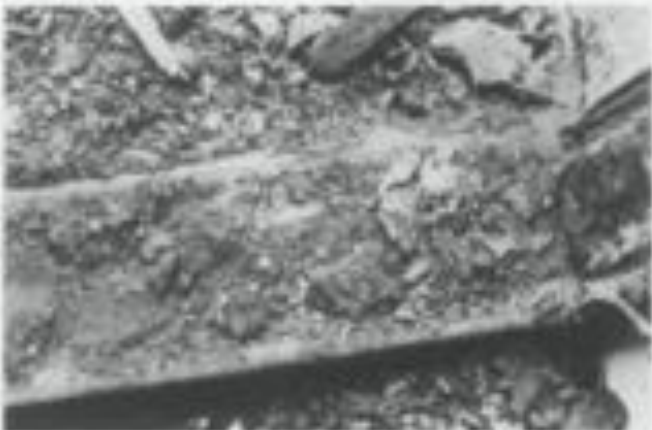
Fig. 6 d. View looking down towards the sill. The subframes appeared very rusted, but were in good condition once debris was vacuumed and surface rust was removed, in place, with chemical compounds. Where necessary, epoxy and steel filler was used to patch depressions in order to make the subframe serviceable again.

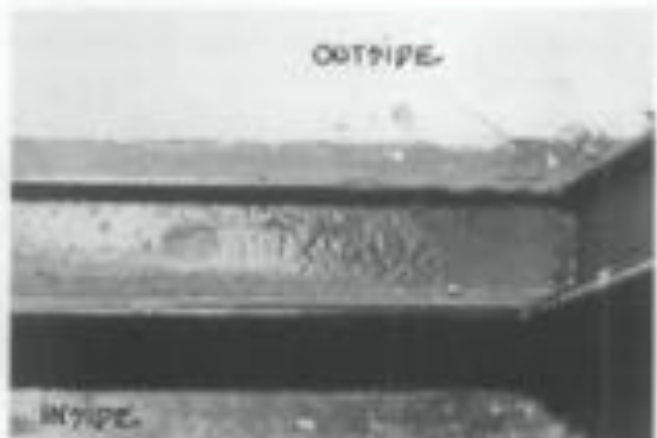
Fig. 6 e. View looking down towards the sill. The cleaned frame was reset in the window opening. The frame was screwed to the refurbished subframe at the jamb and the head only. The screw holes at the sill, which had been the cause of much of the earlier rusting, were infilled. Vinyl weatherstripping was added to the frame.

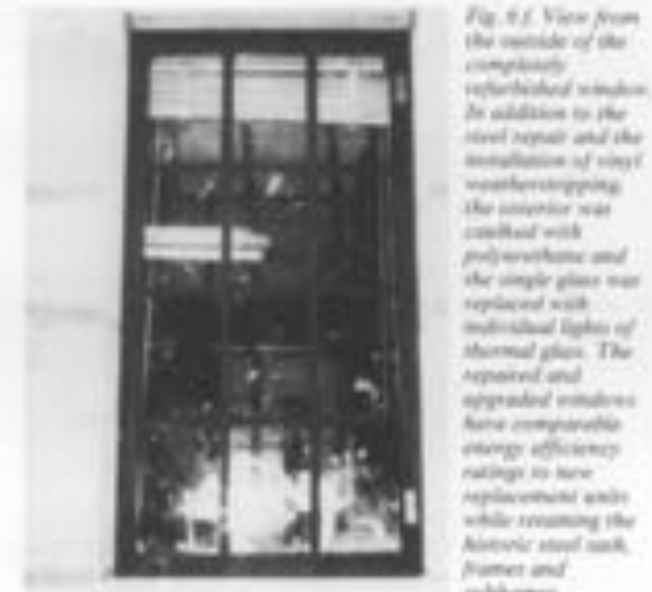
Fig. 6 f. View from the outside of the completely refurbished window. In addition to the steel repair and the installation of vinyl weatherstripping, the interior was caulked with polyurethane and the single glass was replaced with individual lights of thermal glass. The repaired and upgraded windows have comparable energy efficiency ratings to new replacement units while retaining the historic steel sash, frames and subframes.

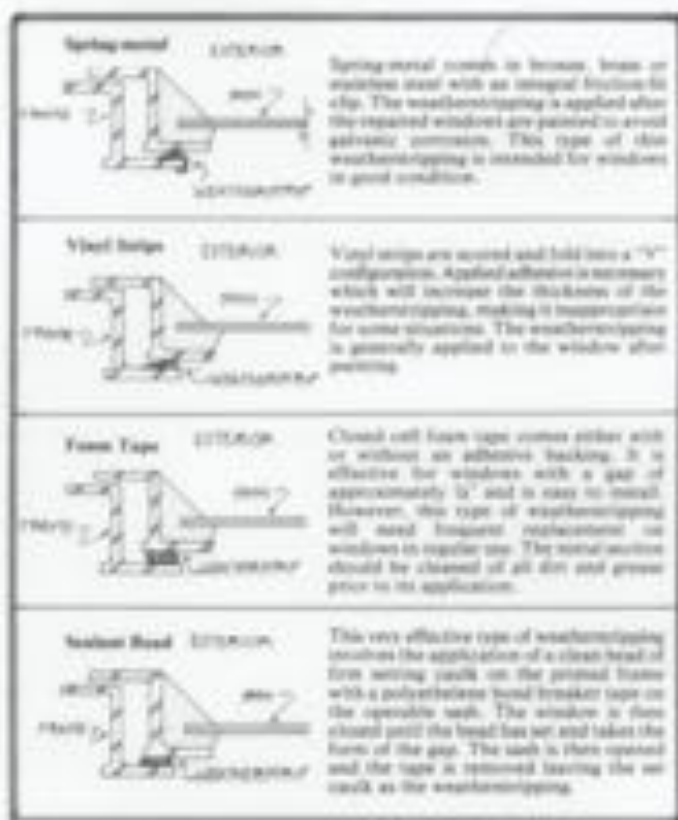
Fig. 8 APPROPRIATE TYPES OF WEATHERSTRIPPING FOR METAL WINDOWS. Weatherstripping is an important part of upgrading the thermal efficiency of historic steel windows. The chart above shows the jamb section of the window with the weatherstripping in place. Drawings: Sharon C. Park, AIA.

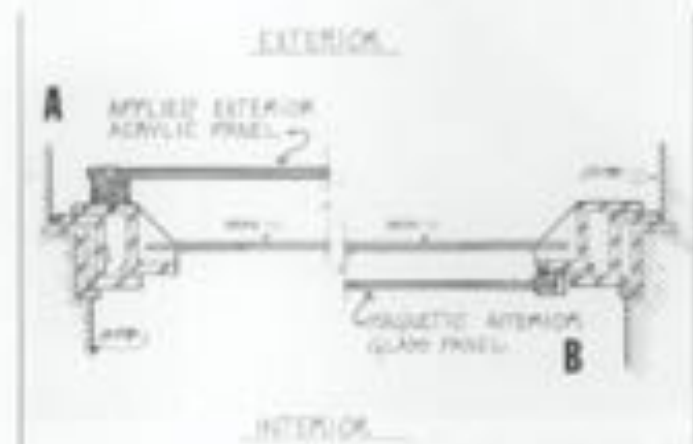
Fig. 9 Two examples of adding a second layer of glazing in order to improve the thermal performance of historic steel windows. Scheme A showing jamb details is of a 1/4" acrylic panel with a closed cell foam gasket attached with self-tapping stainless steel screws directly to the exterior of the outwardly opening sash. Scheme B showing jamb details is of a glass panel in a magnetized frame affixed directly to the interior of the historic steel sash. The choice of using glass or acrylic mounted on the inside or outside will depend on the ability of the window to tolerate additional weight, the location and size of the window, the cost, and the long-term maintenance outlook. Drawing: Sharon C. Park, AIA.

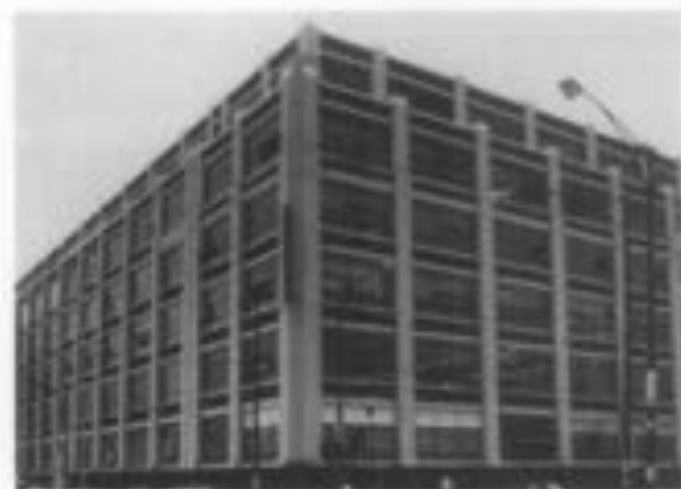
Fig. 10 a. A six-story concrete manufacturing building prior to the replacement of the steel pivot windows. Photo: Charles Parratt.

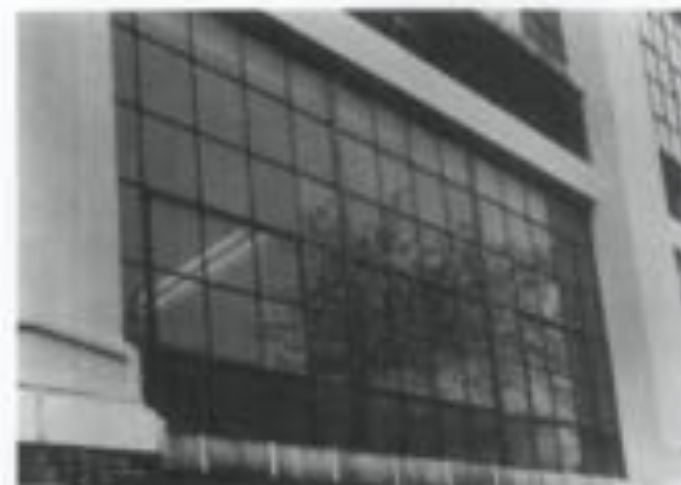
Fig. 10 b. Close-up view of the new replacement steel window which matched the multi-lighted originals exactly. Photo: Charles Parratt.

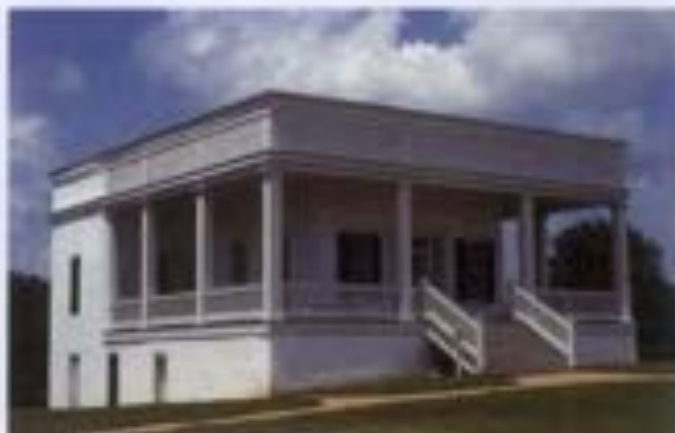
Figure 1. The Schuette House in Seguin, Texas, is an 1856 Greek Revival-style house constructed of lime concrete. Lime concrete or "limcrete" was a popular construction material, as it could be made inexpensively from local materials. By 1900, the town had approximately ninety limcrete structures, twenty of which remain. Photo: Texas Parks and Wildlife Department.

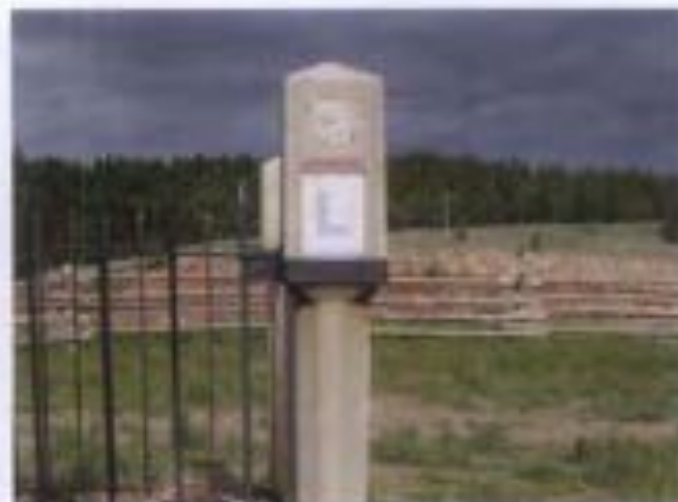
Figure 3. The Lincoln Highway Association promoted construction of a high quality continuous hard surface roadway across the country. The Boy Scouts of America installed concrete road markers along the Lincoln Highway in 1928.

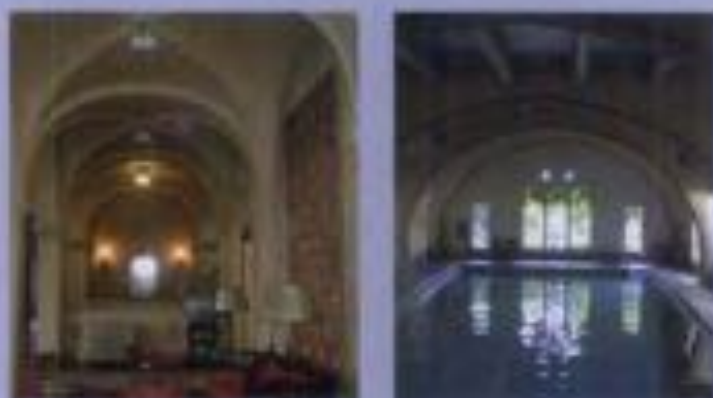
Figure 10. The Berkeley City Club has significant interior spaces and features of concrete construction, including the lobby and pool. Photos: Lisa Gilman (left) and Brian Kohse (right). Min. Source: Elmer Associates, Inc.

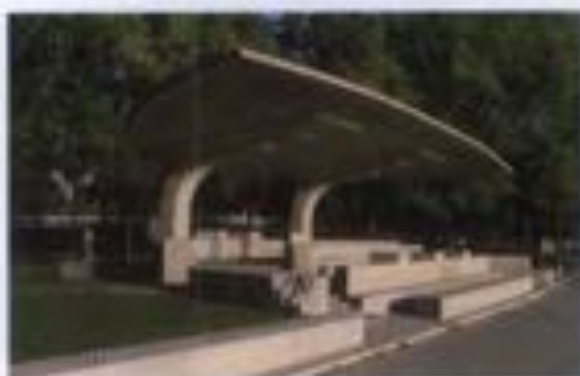
Figure 8. The Chess Pavilion in Chicago's Lincoln Park was designed by architect Morris Weisler and constructed in 1956. The pavilion is a distinctive landscape feature, with its reinforced concrete cantilevered slab that provides cover for chess players.

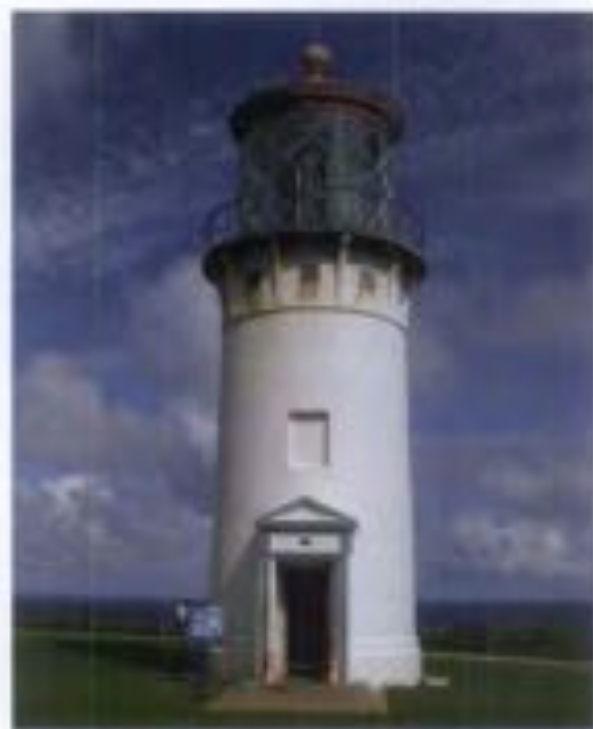
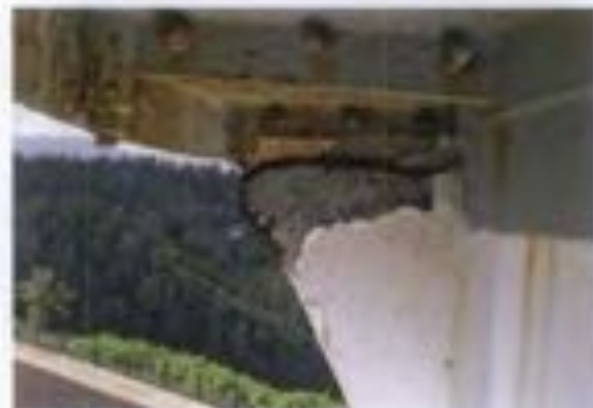
Figure 12. The concrete lighthouse at the Kilian Point Light Station, Kilian, Kauai, Hawaii, was constructed circa 1915. The concrete, which was a good quality, high strength mix for its day, is in good condition after almost one hundred years in service. Deterioration in the form of spalling related to corrosion of embedded reinforcing steel has occurred primarily in areas of higher ornamentation such as projecting bands and brackets (see close-up photo).

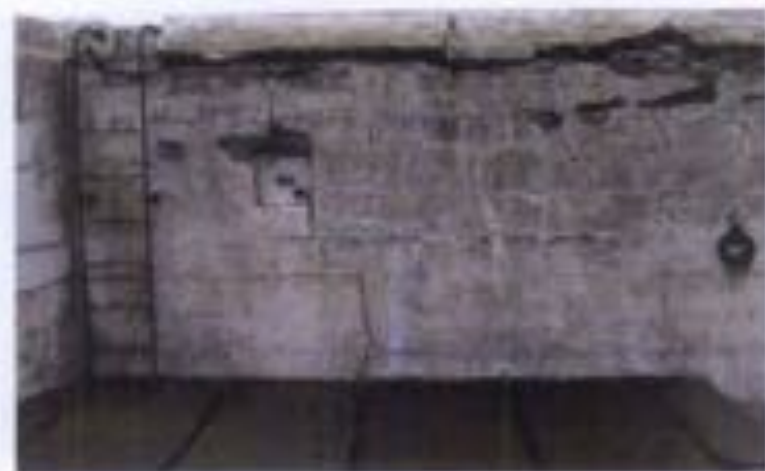
Figure 13. Fort Casey on Admiralty Head, Fort Casey, Washington, was constructed in 1888. The lift lines from placement of concrete are clearly visible on the exterior walls and characterize the finished appearance.

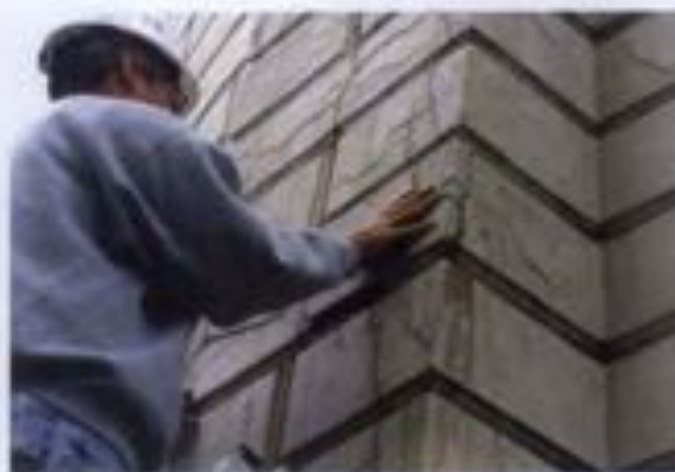
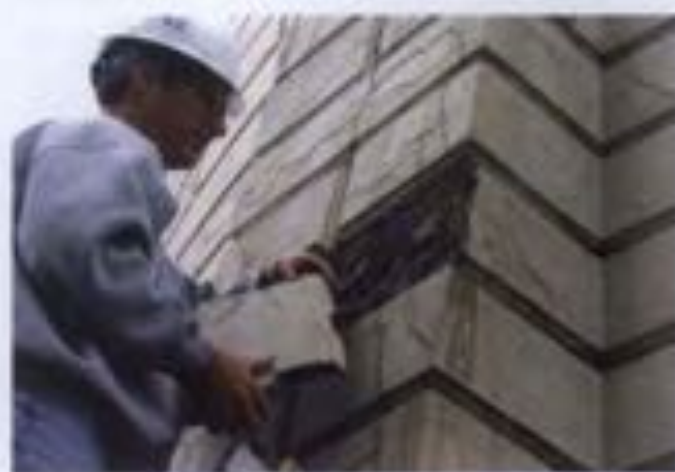
Figure 14. Layers of architectural concrete that have debonded (spalled) from the surface were removed from a historic water tank during the investigation performed to assess existing conditions. Photos: Anita Washko, WSP, January, EITner Associates, Inc.

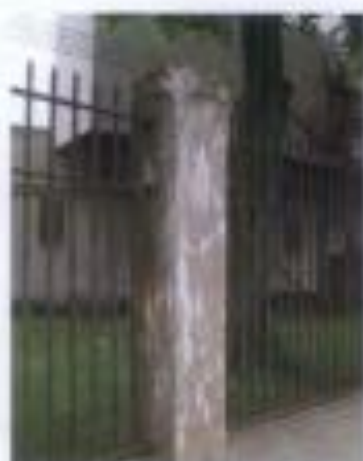
Figure 15. Evidence of moisture movement through concrete is apparent in the form of mineral deposits on the concrete surface. Cyclic freezing and thawing of entrapped moisture, and corrosion of embedded reinforcement, have also contributed to deterioration of the concrete columns on this fence at Crocker Field in Fitchburg, Massachusetts, designed by the Olmsted Brothers.

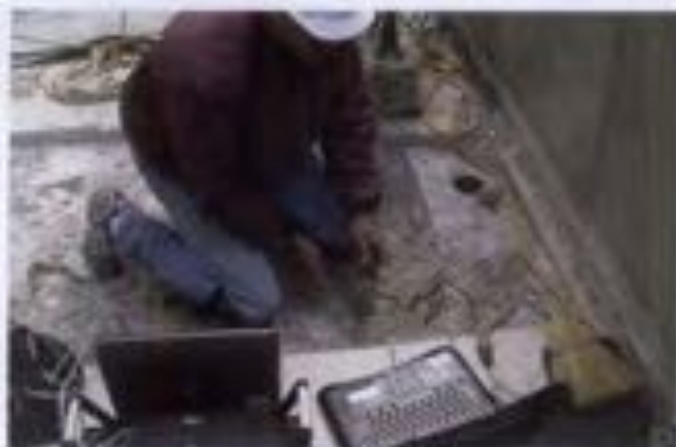
Figure 16. Impact echo testing is performed on a concrete structural slab to help determine depth of deterioration. In this method, a short pulse of energy is introduced into the structure and a transducer mounted on the impacted surface of the structure receives the reflected input waves or echoes. These waves are analyzed to help identify flaws and deterioration within the concrete.

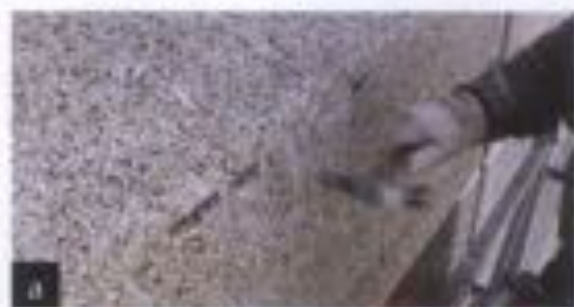
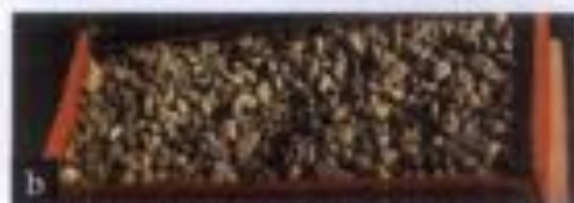
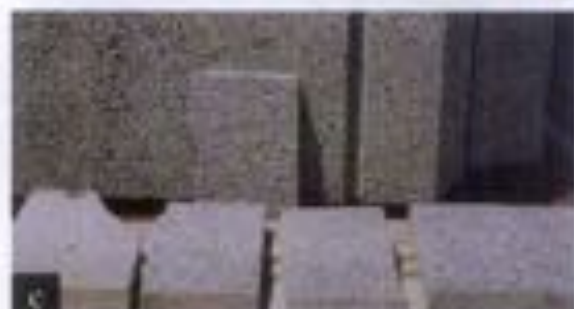
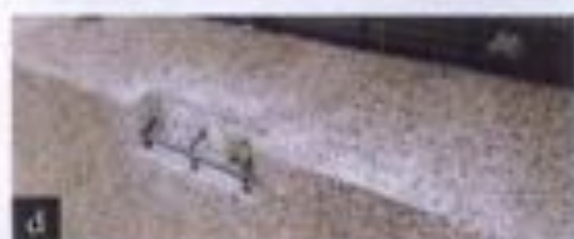
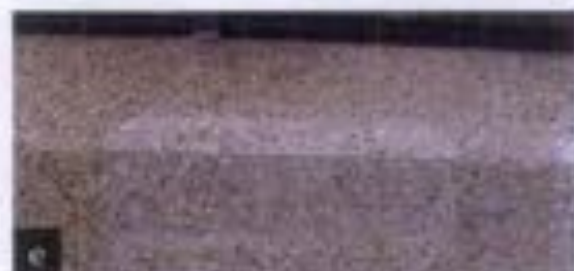
The concrete's durability, or resistance to deterioration, and the materials and methods selected for repair depend on its composition, design, and quality of workmanship. In most cases, a mix design for durable replacement concrete should use materials similar to those of the original concrete mix. Prepackaged materials are often not appropriate for repair of historic concrete. The concrete patching material can be air entrained or polymer-modified if subject to exterior exposure, and should incorporate an appropriate selection of aggregate and cement type, and proper water content and water

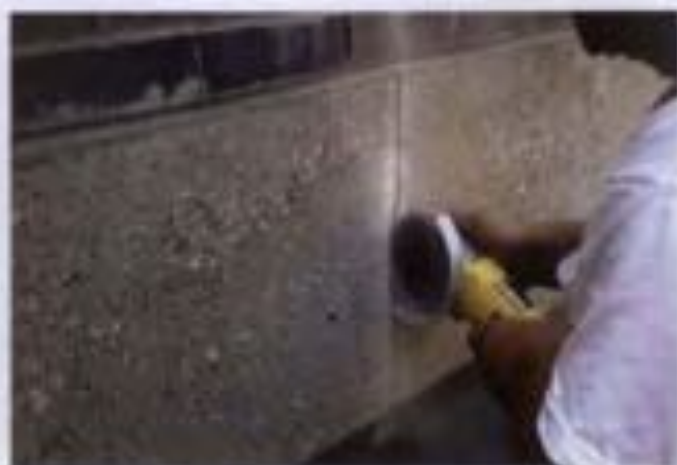
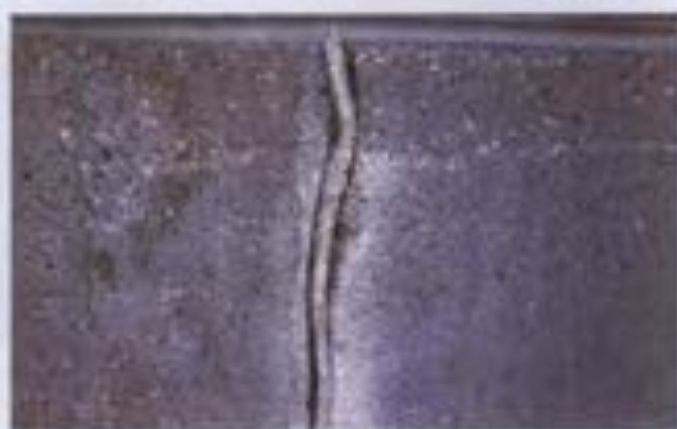
Figure 19. A high-speed grinder is used to widen a crack in preparation for installation of a sealant. This process is called "routing." After the crack is prepared, the sealant is installed to prevent moisture infiltration through the crack. Although sealant repairs can provide a durable, watertight repair for moving cracks, they tend to be very visible.

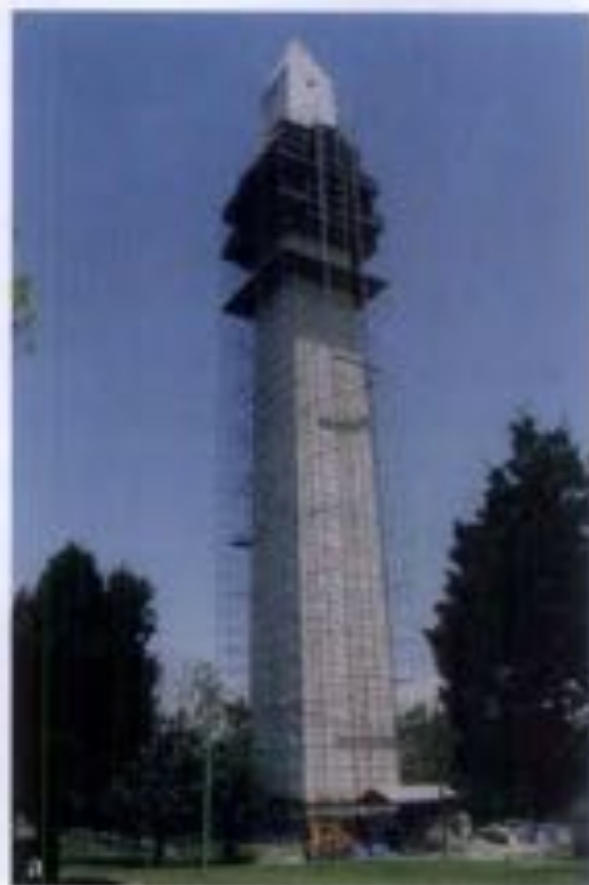
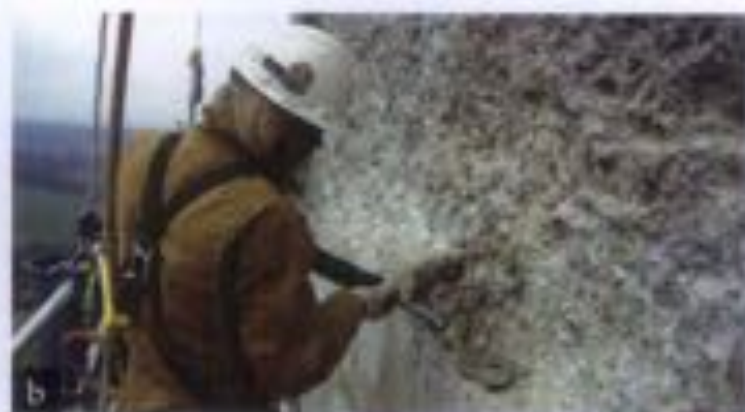
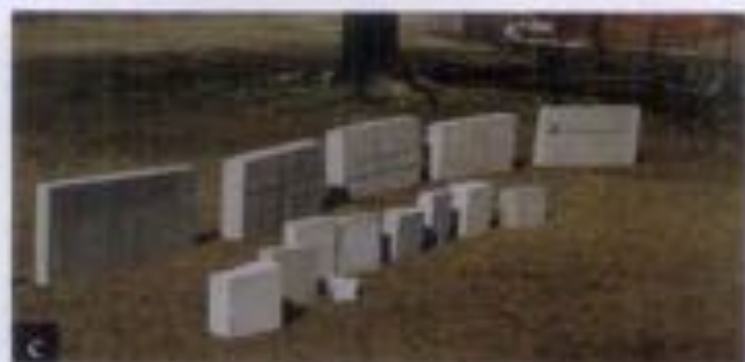
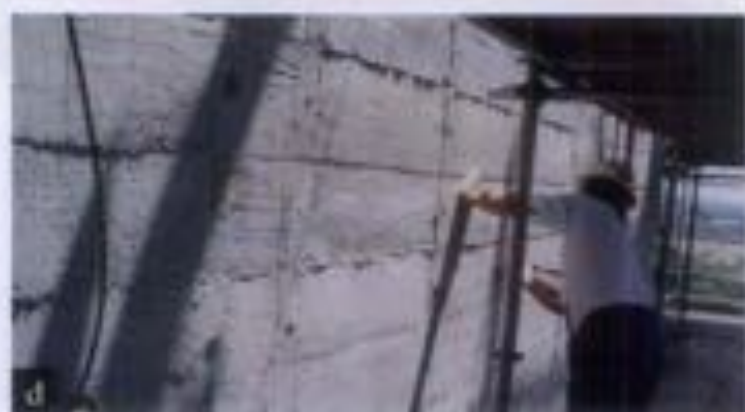
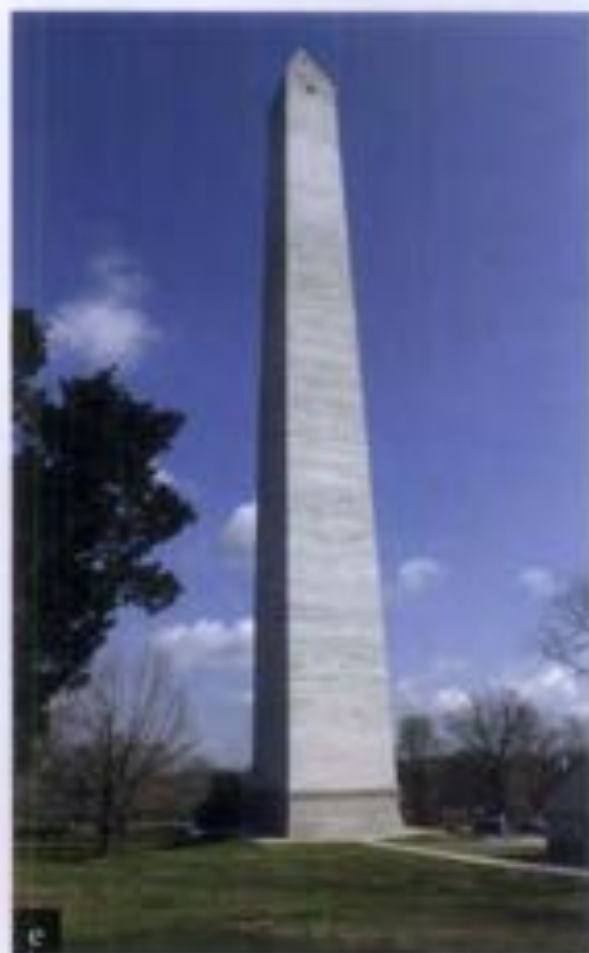
Coatings and Penetrating Sealers. Protection systems such as a penetrating sealers or film forming coating are often used with non-historic structures to protect the concrete and increase the length of the service life of concrete repairs. However, film-forming coatings are often inappropriate for use on a historic structure, unless the structure was coated historically. Film-forming coatings will often change the color and appearance of a surface, and higher build coatings can also mask architectural finishes and ornamental details. For example, the application of a coating on concrete having a formboard finish may hide the wood texture of the surface. Pigmented film-forming coatings are also typically not appropriate for use over exposed aggregate concrete, where the uncoated exposed surface contributes significantly to the historic character of

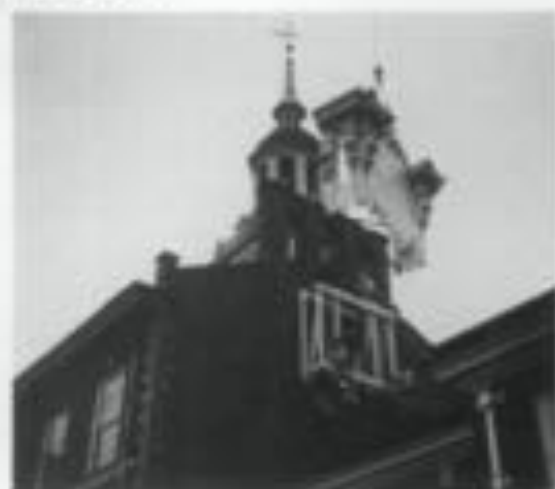
The Secretary of the Interior's Standards for Rehabilitation require that "deteriorated architectural features be repaired rather than replaced, wherever possible. In the event that replacement is necessary, the new material should match the material being replaced in composition, design, color, texture, and other visual properties." Substitute materials should be used only on a limited basis and only when they will match the appearance and general properties of the historic material and will not damage the historic resource.

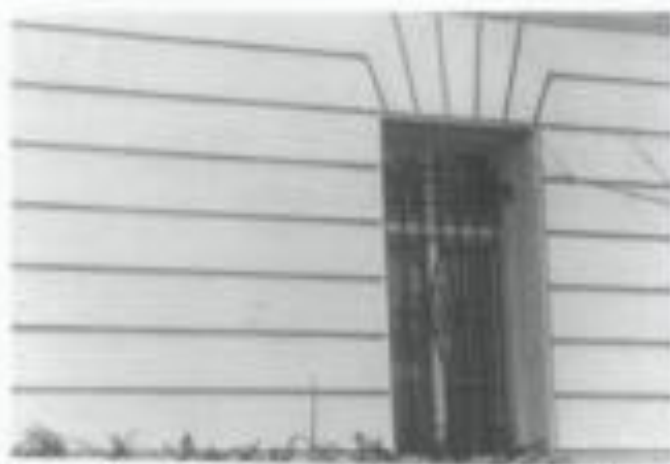
Illus. 2. Stucco has for many centuries represented a number of building materials. Seen here is the ground floor of a Beaux Arts mansion, circa 1900, which represents a finely laid stone foundation wall executed in wood stucco. Photo: Sharon C. Park, AIA.

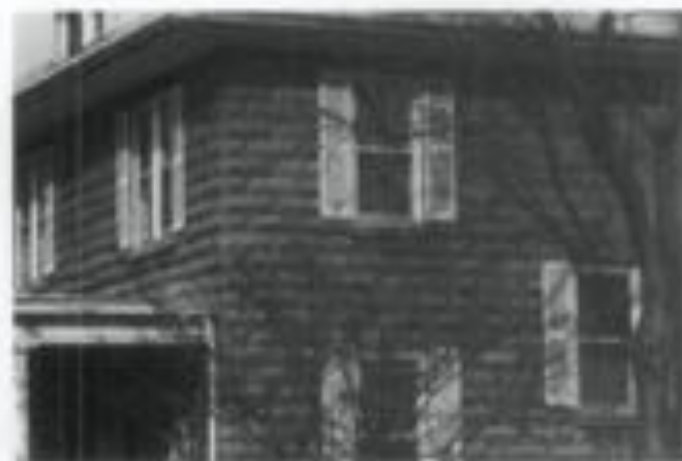
Illus. 3. Casting concrete to represent quarried stone was a popular late 19th-century technique seen in this circa 1910 multi-story house. While most components were delivered by rail, the foundations and exterior masonry were completed by local craftsmen. Photo: Sharon C. Park, AIA.

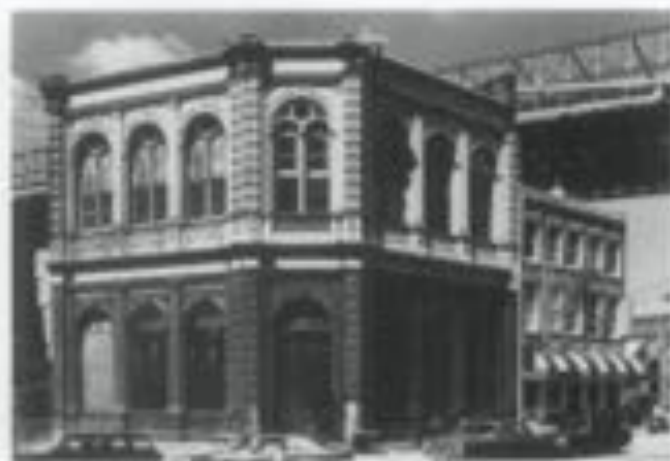
Illus. 4. The 19th-century also produced a variety of metal products used in imitation of other materials. In this case, the entire exterior of the Long Island Safety Deposit Company is cast-iron representing stone. Photo: Bucket Logan, Friends of Cast Iron Architecture.
