GEORGETOWN STEAM PLANT
HISTORIC STRUCTURE & CULTURAL LANDSCAPE REPORT

OCTOBER 9, 2013

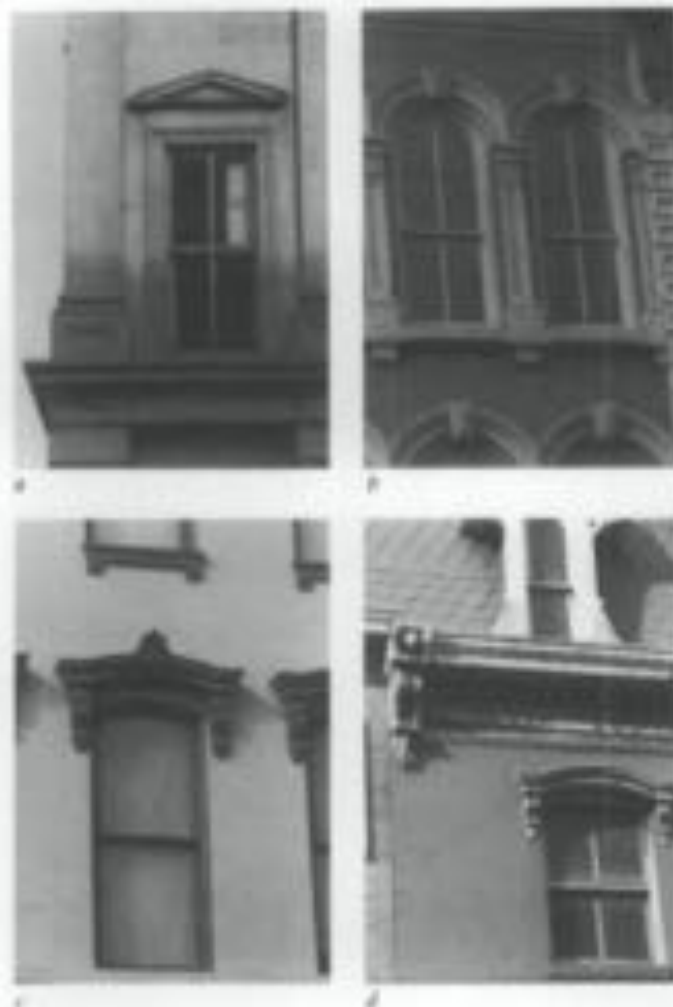
Illus. 5. The four historic examples of various window heads shown are: (a) stone; (b) cast stone; (c) cast-iron; and (d) sheet metal. The criteria for selecting substitute materials today (availability, quality, delivery dates, cost) are not much different from the past. Photo: Sharon C. Park, AIA.

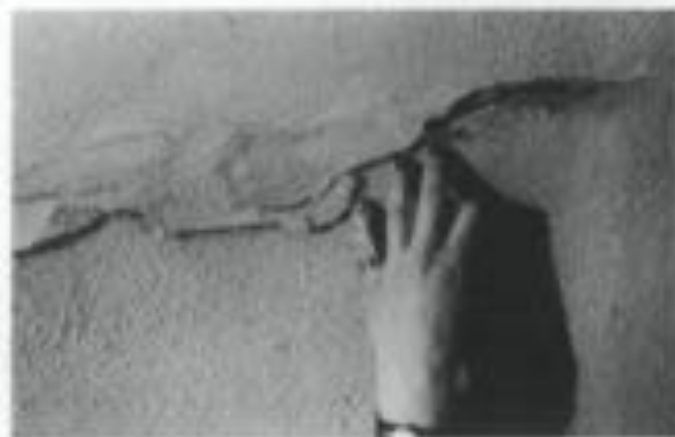
Illus. 6. Substitute materials should never be considered as a cosmetic cover-up for they can cause great physical damage and can alter the appearance of historic buildings. For example, a fiberglass coating was used at Rancho de Taos, NM, in place of the historic adobe coating which had deteriorated. The waterproof coating sealed moisture in the walls and caused the spalling shown. It was subsequently removed and the walls were properly repaired with adobe. Photo: Lee H. Nelson, FALA.

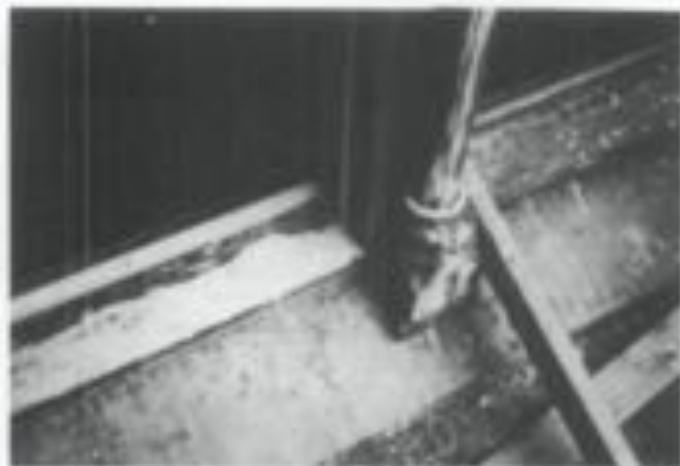
Illus. 7. Whenever possible, historic materials should be repaired rather than replaced. Epoxy, a synthetic resin, has been used to repair the wood window frame and sill at the Auditors Building (1878) Washington, DC. The cured resin is white in this photo and will be ground and painted. Photo: Lee H. Nelson, FAIA.

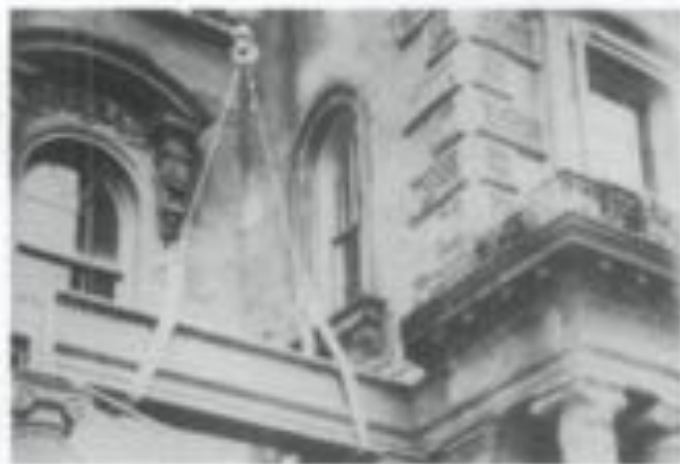
Illus. 8. Simple solutions should not be overlooked when materials are no longer available. In the case of the Morse-Libby Mansion (1838), Portland, ME, the deteriorated ironstone porch beam was replaced with a carved wooden beam painted with sand impregnated paint. Photo: Stephen Sewall.

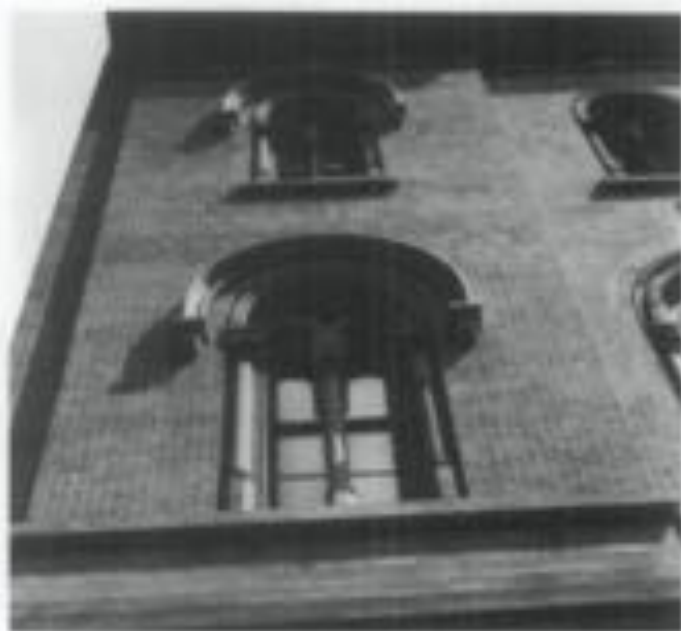
Illus. 8. Even when materials are not locally available, it may be possible and cost effective to find sources elsewhere. For example, the local sandstone was no longer available for the restoration of the New York Shakespeare Festival Public Theater. The deteriorated sandstone window heads were replaced with stone from Germany that closely matched the color and texture of the historic sandstone. Photo: John G. Waite.

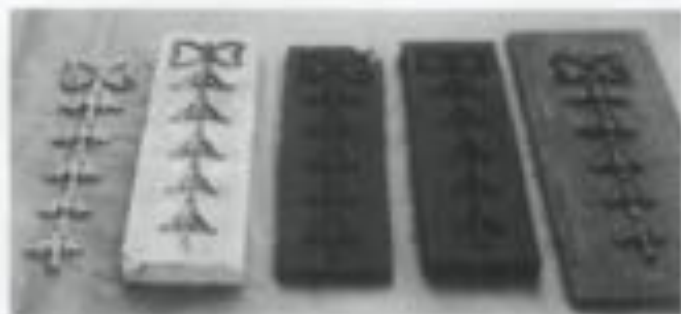
Illus. 10. The use of substitute materials is not necessarily cheaper or easier than using the original materials. The complex process of fabricating the polyester bronze reproduction pieces of the gilded wood molding for the clockcase at Independence Hall required talented artisans and substantial mold-making time. From left to right is the final milled polyester bronze detail; the plaster casting mold; the positive and negative interim negative rubber molds; and the expertly carved wooden master. Photo: Courtesy of Independence National Historical Park.

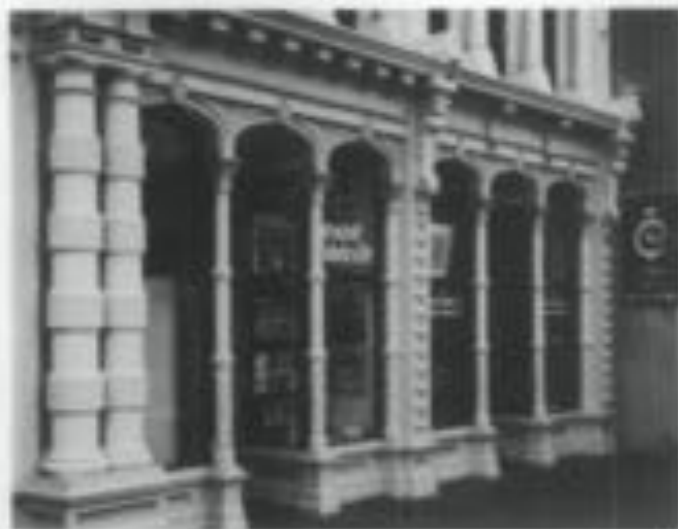
Illus. 11. The unavailability of historic craft techniques is another reason to consider substitute materials. The original first floor cast iron front of the Grand Opera House, Wilmington, DE, was missing; the expeditious reproduction in cast aluminum was possible because artisans working in this medium were available. Photo: John G. Wertz.

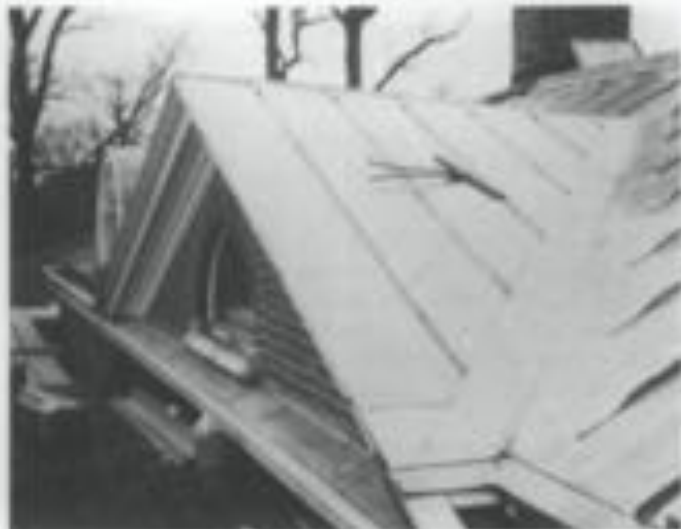
Illus. 12. Substitute materials may be considered when the original materials have not performed well. For example, early sheet metals used for roofing, such as tinplate, were reasonably durable, but the modern equivalent, terne-coated steel, is subject to corrosion once the thin tin plating is damaged. Terne-coated stainless steel or lead-coated copper (shown here) are now used as substitutes. Photo: John G. Wertz.

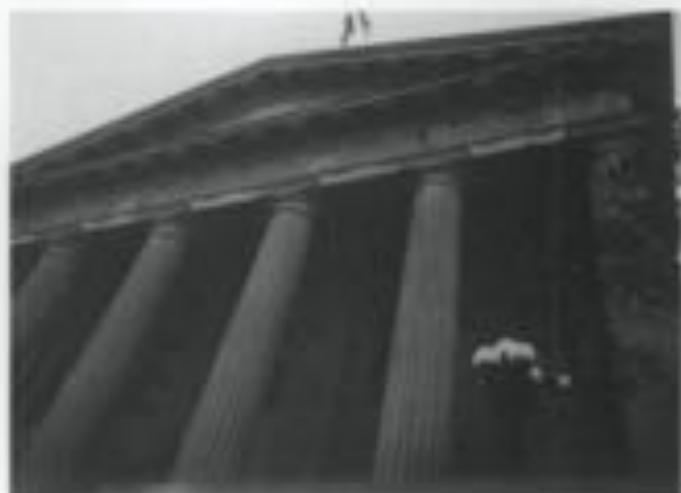
Illus. 13. Code-related changes are of concern in historic preservation projects because the integrity of the historic resource may be irretrievably affected. In the case of the Old San Francisco Mint, the fiberglass cornice was used to bring the building into seismic conformance. The original cornice was deteriorated, and the replacement (1982) was limited to the projecting pediment. The historic stone fascia was retained as were the stone columns. The limited replacement of deteriorated material did not jeopardize the integrity of the building. Photo: Walter M. Southamer.

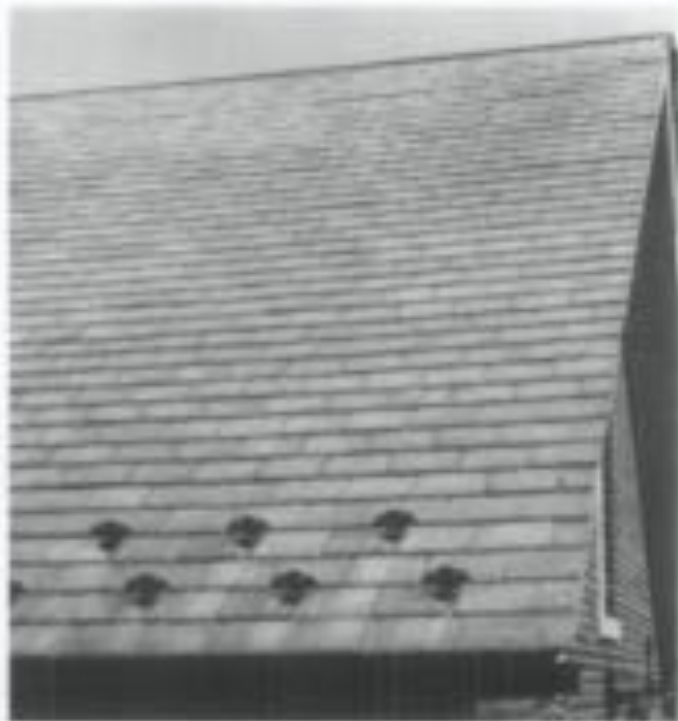
illus. 14. The visual qualities of the historic feature must be matched when using substitute materials. In this illustration, the lighter weight mineral fiber cement shingles used to replace the deteriorated historic slate roof were detailed to match the color, size, shape and pattern of the original roofing and the historic stone birds were reattached. Photo: Sharon C. Park, AIA.

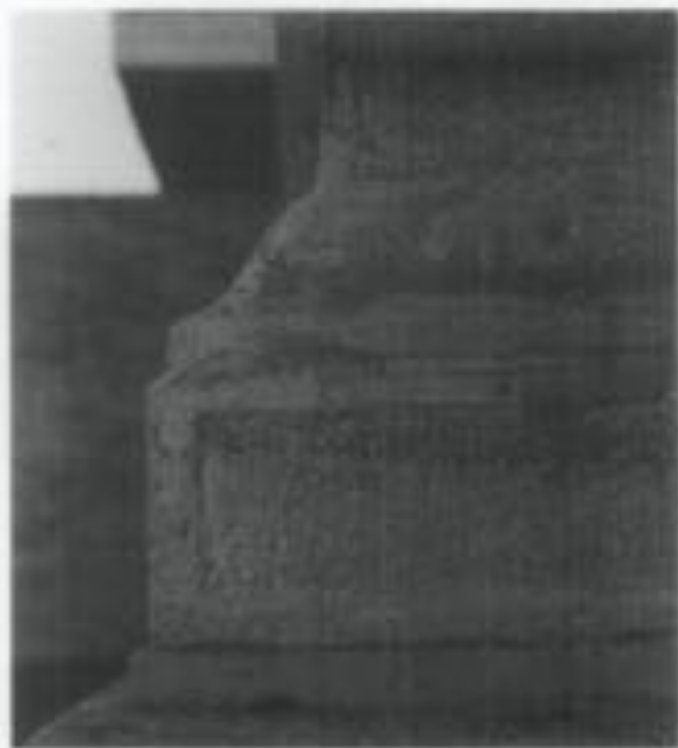
illus. 15. Poor quality workmanship can be avoided. In this example, the crudely cast concrete entrance pier (shown) did not match the visual qualities of the remaining historic masonry (not shown). The aggregate is too large and exposed; the casting is not crisp; the beveled leading edges are not articulated; and the color is too pale. Photo: Sharon C. Park, AIA.

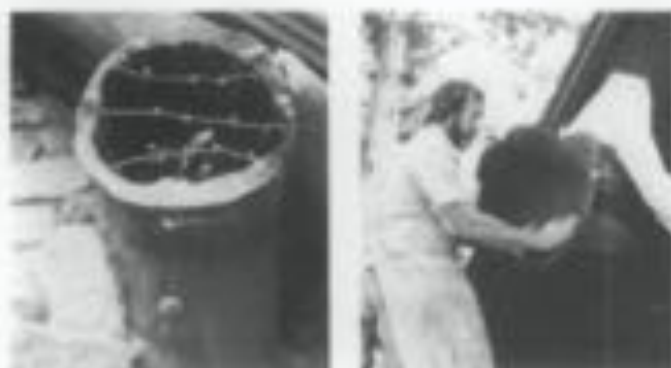
Illus. 17. Care must be taken to ensure that the replacement materials will work within a pre-designed system. At the Norris Museum, Yellowstone National Park, the 12-inch diameter log refers, part of an intricate truss system, had rotted at the inner core from the exposed ends back to a depth of 48 inches. The exterior wooden shells remained intact. Fiberglass rolag (left photo) and specially formulated structural epoxy were used to fill the cleaned out cores and a cast epoxy cap was used with all the detail of the original wood graining was laminated onto the log end (right photo). This treatment preserved the original feature with a combination of repair and replacement using substitute materials as part of a well thought out system. Photo: Courtesy of Harrison Goodall.

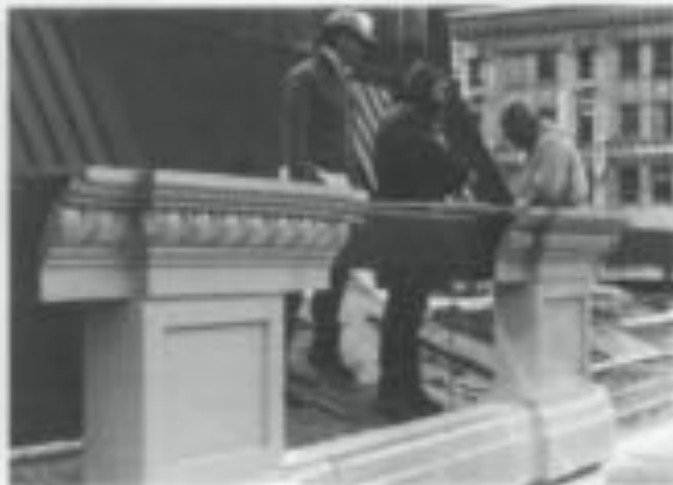
Illus. 18. Substitute materials must be properly installed to allow for expansion, contraction, and structural security. The new balustrade (a polymer concrete modified with glass fibers) at Carnegie Hall, New York City, was installed with steel structural supports to allow window-washing equipment to be suspended securely. In addition, the formulation of this predominantly epoxy material allowed for the natural expansion and contraction within the pre-designed joints. Photo: Courtesy of MIM Studios.

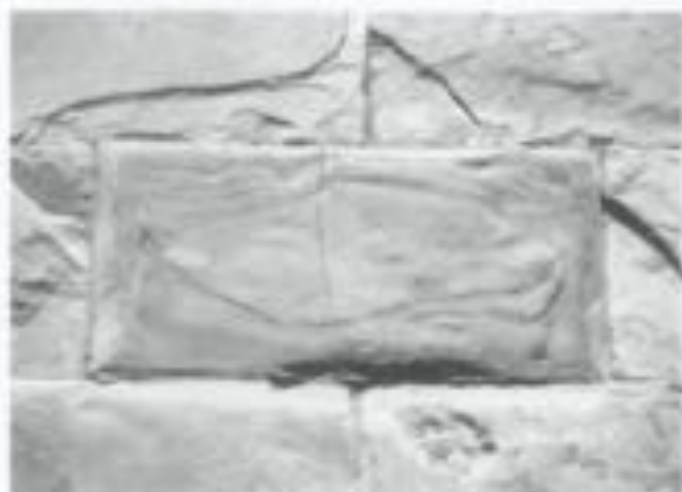
Illus. 19. When the physical properties are not matched, particularly thermal expansion and contraction properties, great damage can occur. In this case, an extremely rigid epoxy replacement unit was installed in a historic masonry wall. Because the epoxy was not modified with fillers, it did not expand or contract systematically with the natural stones in the wall surrounding it. Pressure built up resulting in a vertical crack at the center of the unit, and spalled edges to every historic stone that was adjacent to the rigid unit. Photo: Walter M. Sorethamer.

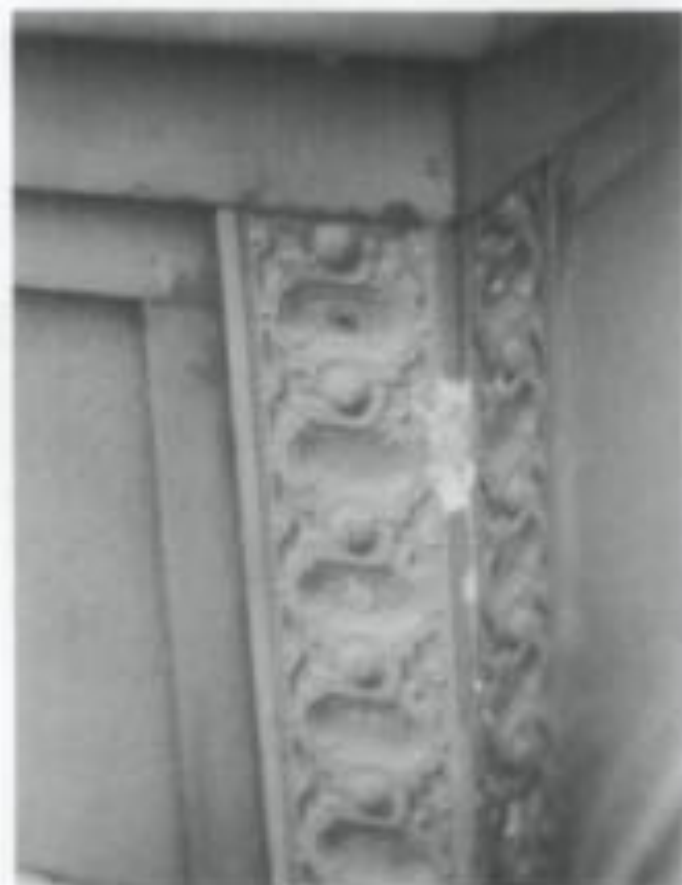
Illus. 20. Long-term performance can be affected by where the substitute material is located. In this case, fiberglass was used as part of a storefront at street level. Due to the brittle nature of the material and the frequency of impact likely to occur at this location, an unsightly chip has resulted. Photo: Sharon C. Park, AIA.

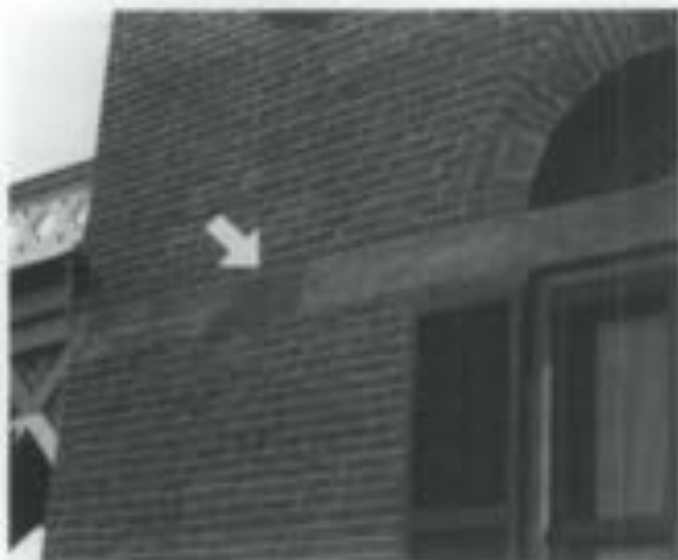
illus. 21. Change of color over time is one of the greatest problems of synthetic substitute materials used outdoors. Ultra-violet light can cause materials to change color over time; some will lighten and others will darken. In this photograph, the synthetic patching material to the sandstone bonding to the left of the window has aged to a darker color. Photo: Sharon C. Park, AIA.

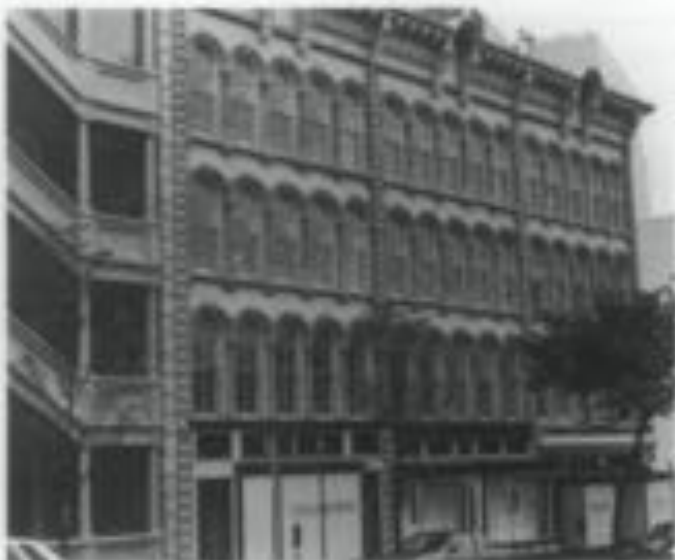
illus. 22. A fiber reinforced polymer (fiberglass) cornice and precast concrete elements replaced deteriorated features on the 19th-century exterior. Photo: Sharon C. Park, AIA.

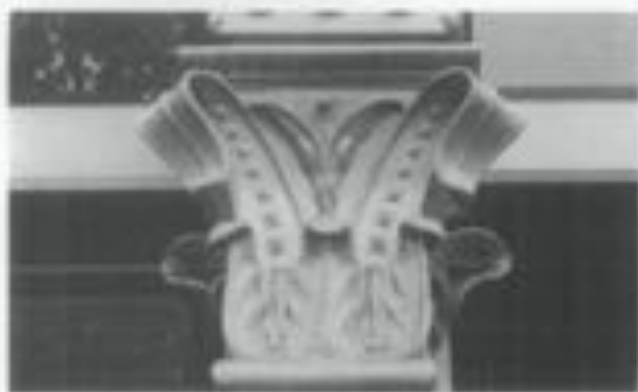
Close-up detail showing the crisp casting in aluminum of this 19th-century replica column and capital for a storefront. Photo: Sharon C. Park, AIA.

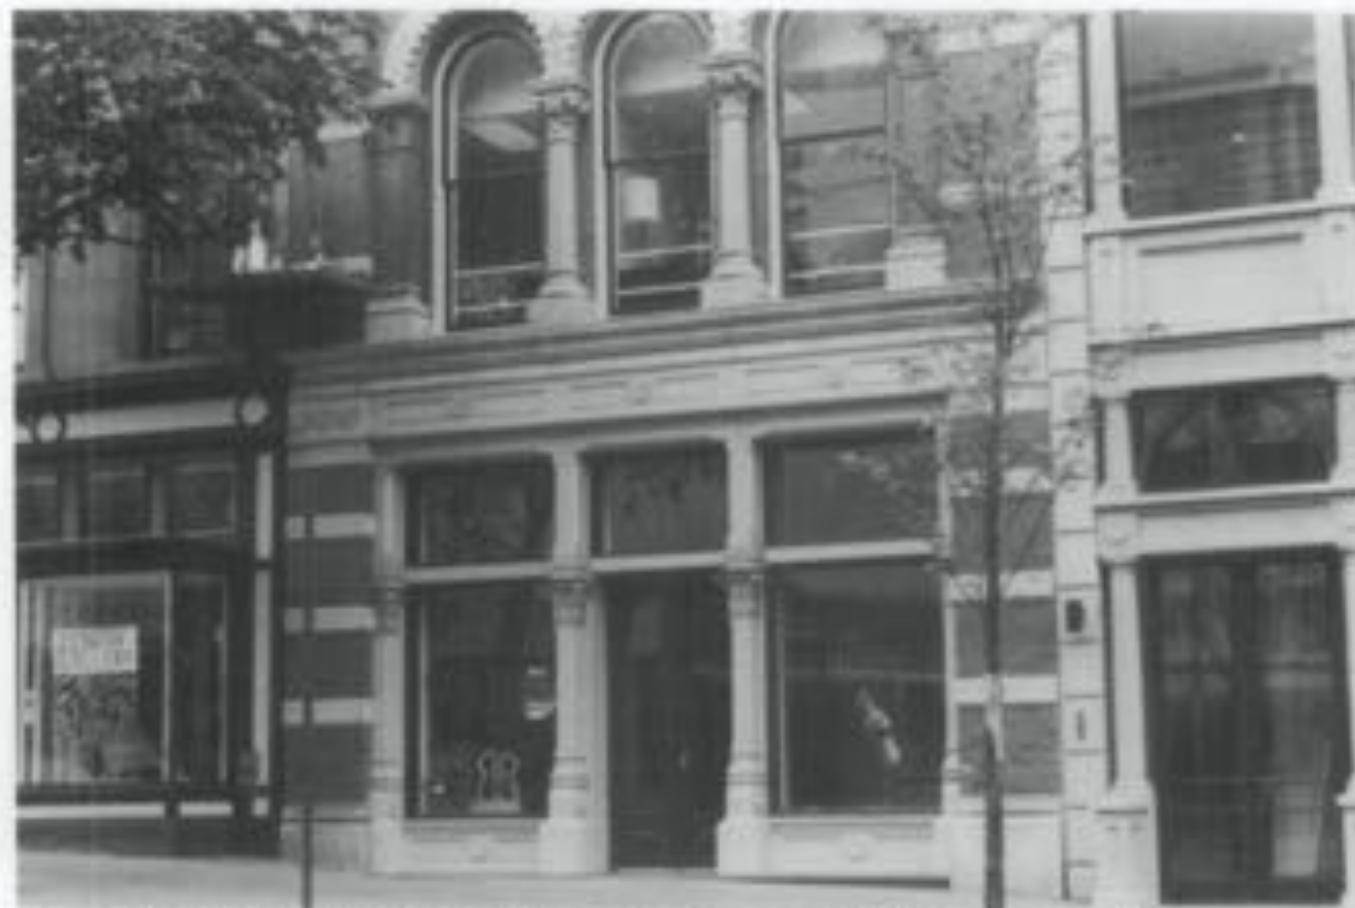
The new cast aluminum storefront replaced the last 19th-century cast-iron original. Photo: Sharon C. Park, AIA.

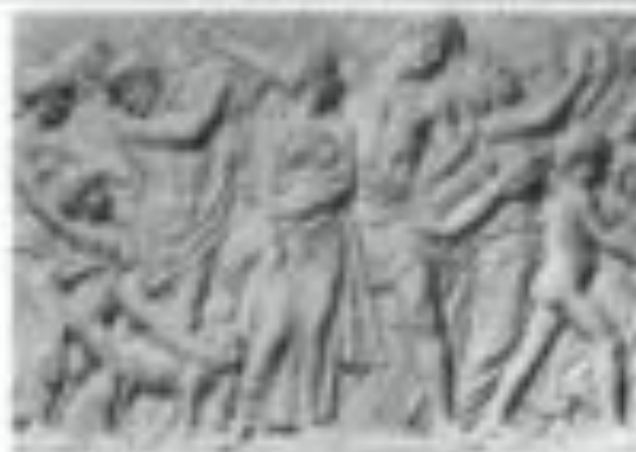
The glass fiber reinforced concrete painted wall panel will replace the artwork damaged rock and plaster original. A fully finished window was achieved by spraying the GFRC over the mold that was created from the historic panel and integrated back in historic photographs. Photo: Courtesy of S&B Studio.

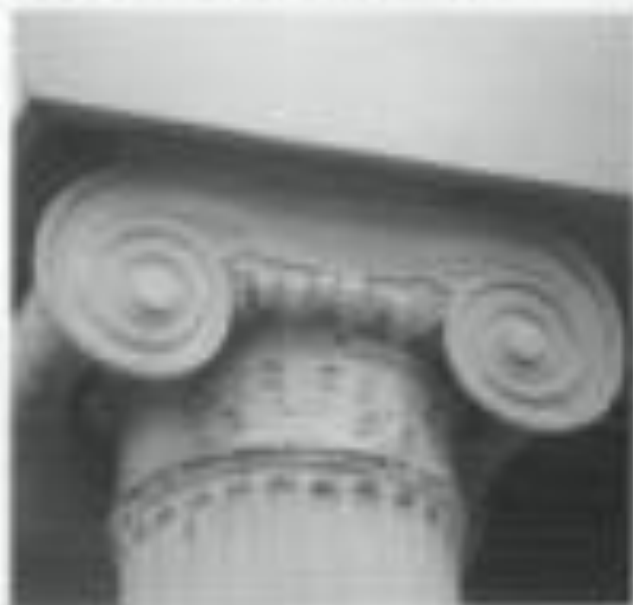
The capital column capital was made using epoxy resin poured into a mold taken from the building. The historic window sashes still are original during the restoration. Photo: George Del Cosentino

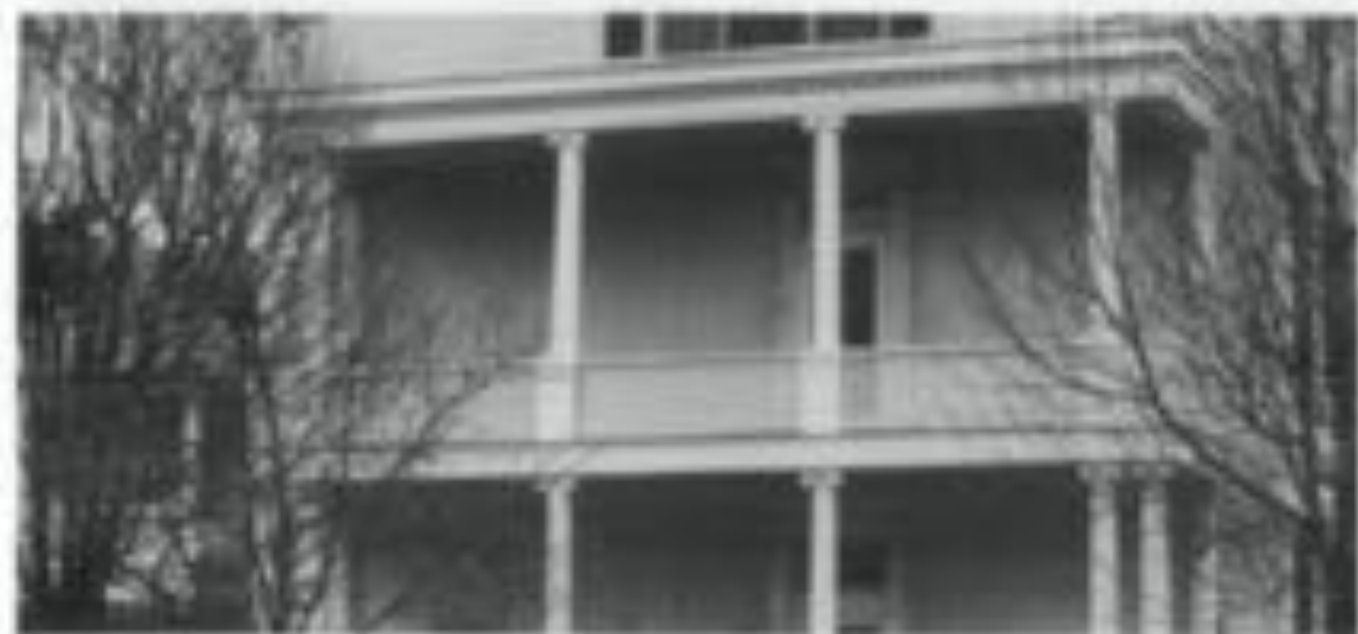
Columns were repaired and a capital was replaced in epoxy on the 19th century 3 story porch. Photo: Del Cosentino

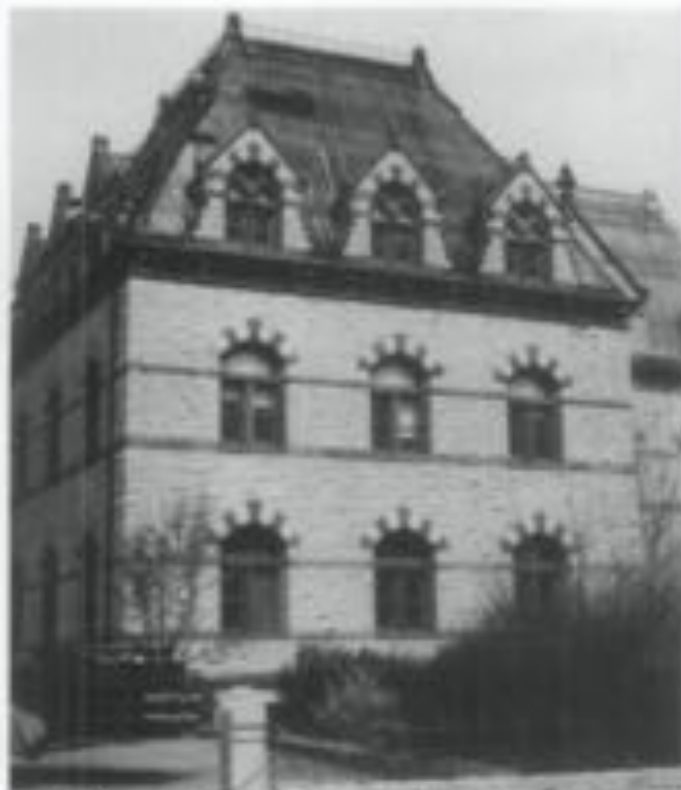
Overall Visual Character: Roof and Related Features

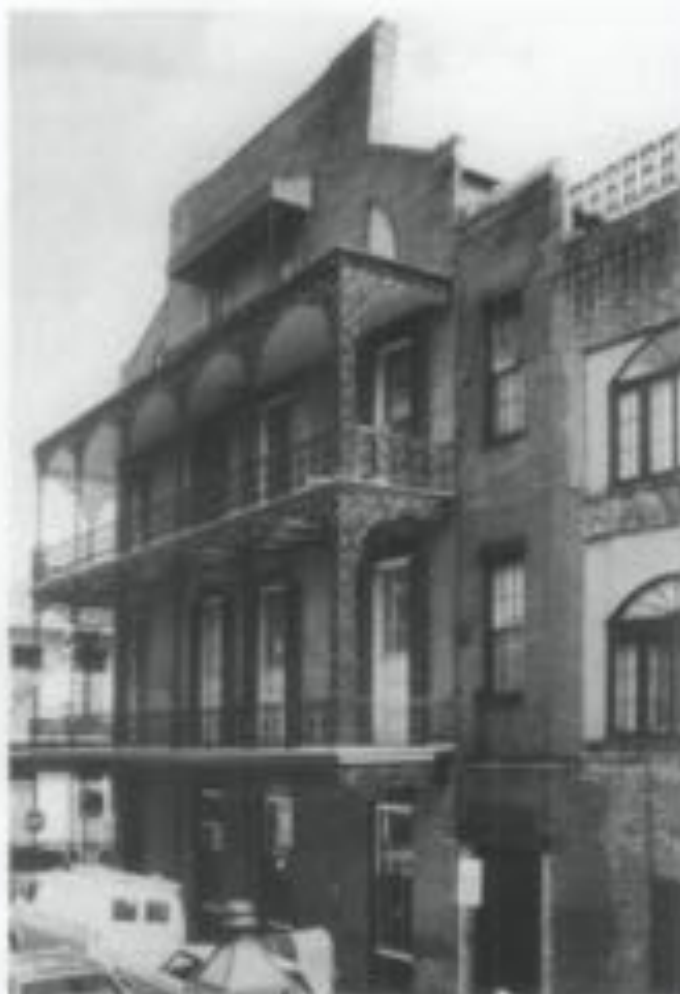
Overall Visual Character: Projections

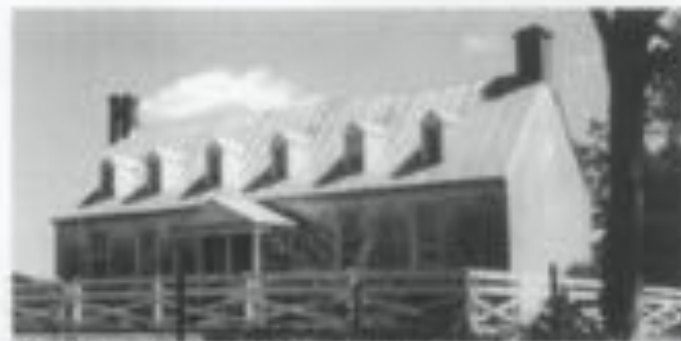
Overall Visual Character: Roof and Related Features

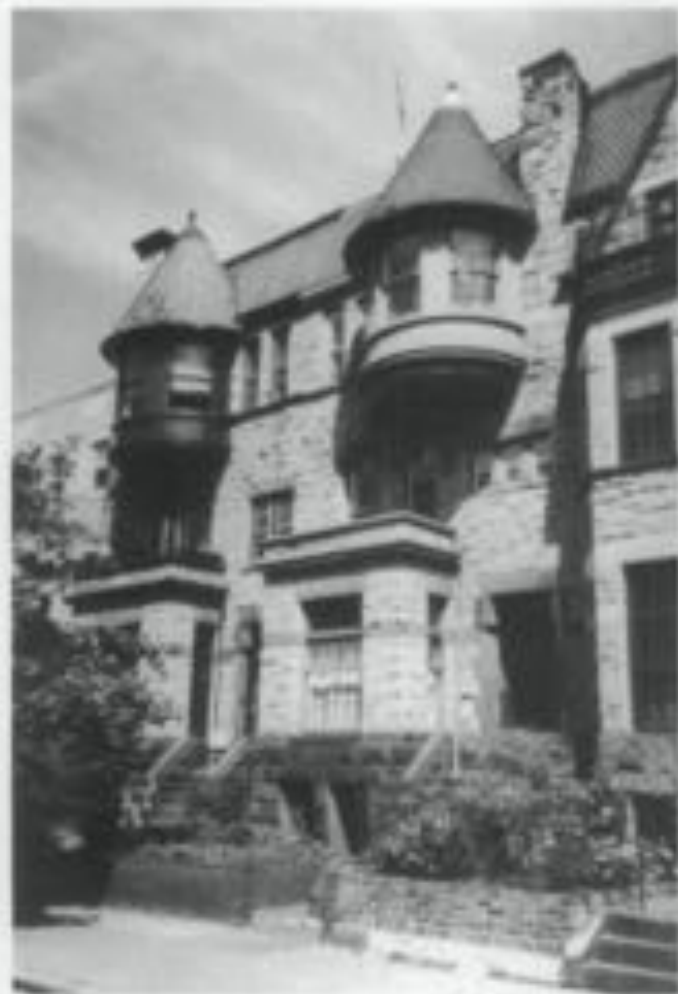
Overall Visual Character: Projections

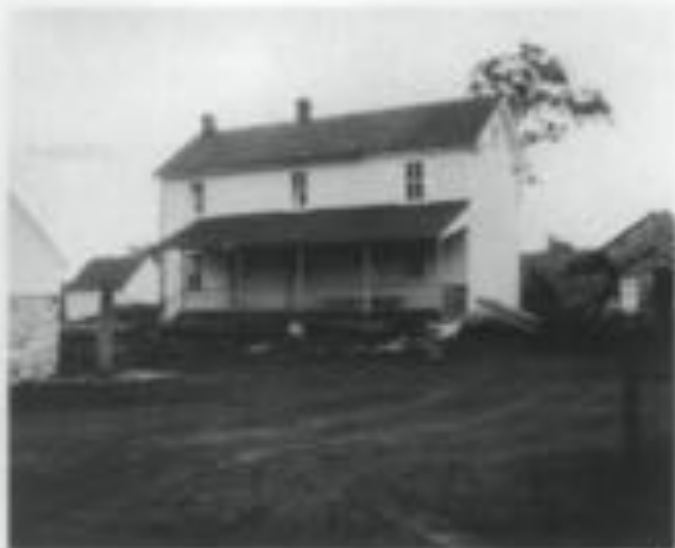
Overall Visual Character: Projections

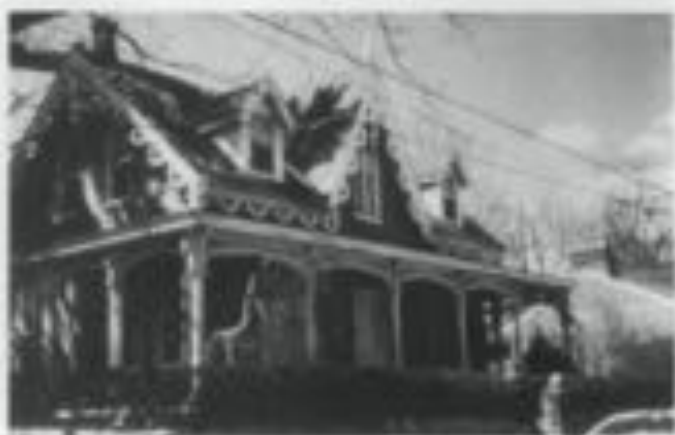
Overall Visual Character: Trim

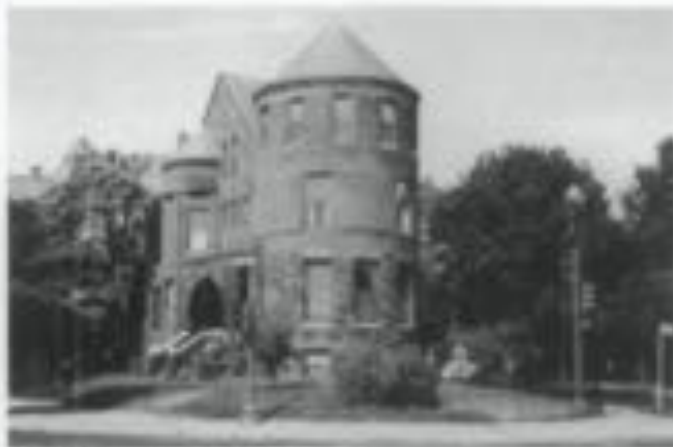
Overall Visual Character: Setting

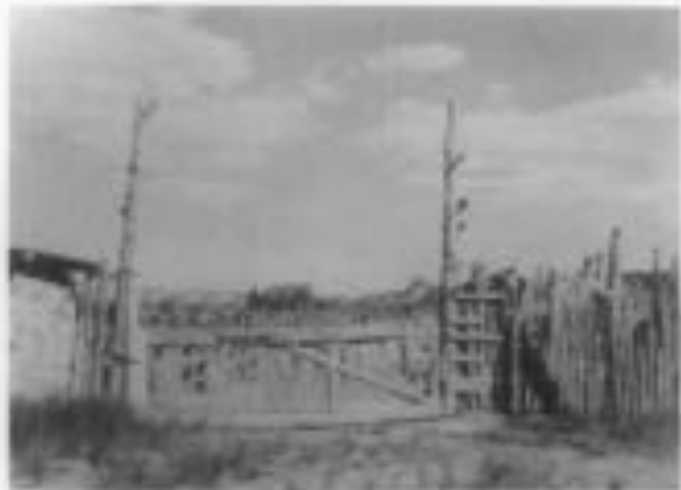
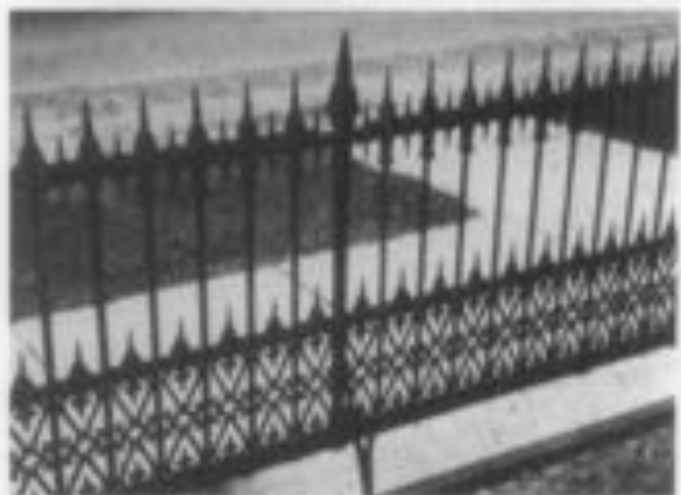
Overall Visual Character: Setting

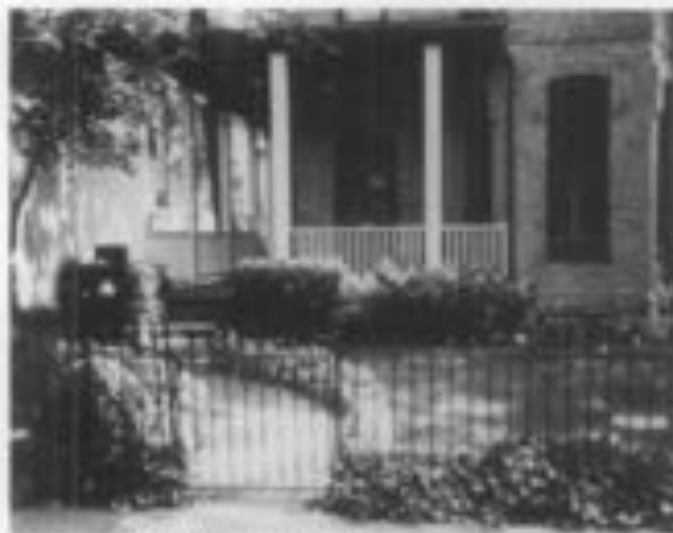
Overall Visual Character: Setting

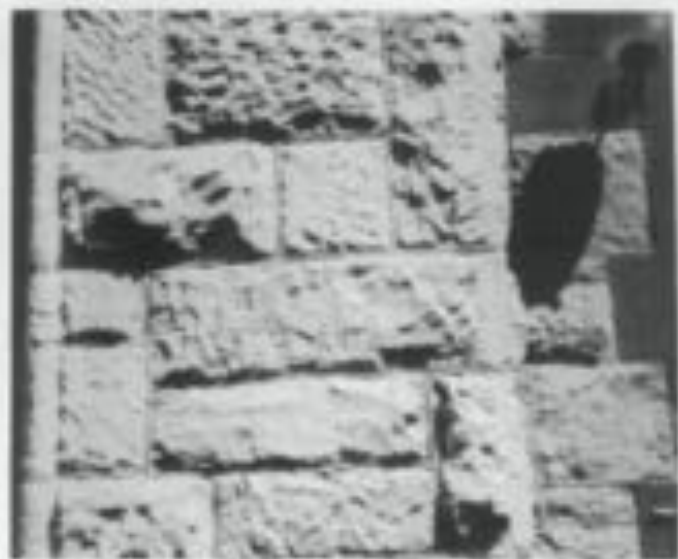
Arm's Length Visual Character: Craft Details

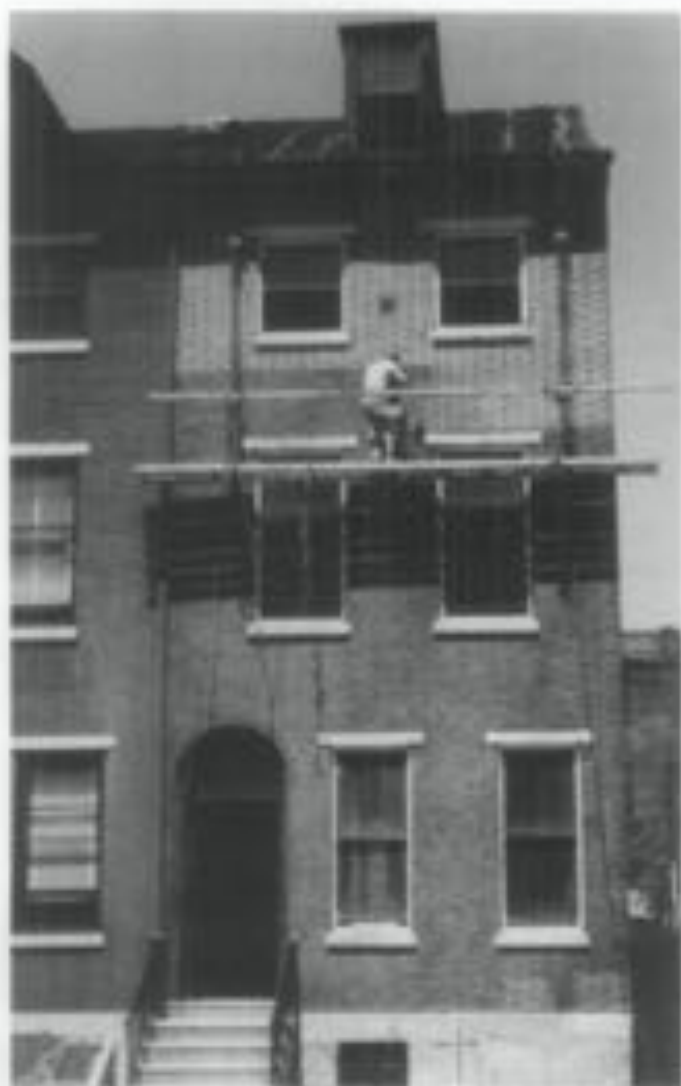
Fragility of A Building's Visual Character

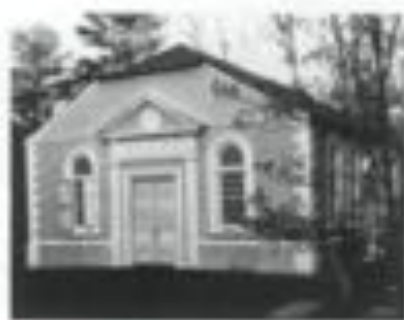
The Preservation and Repair of Historic Stucco

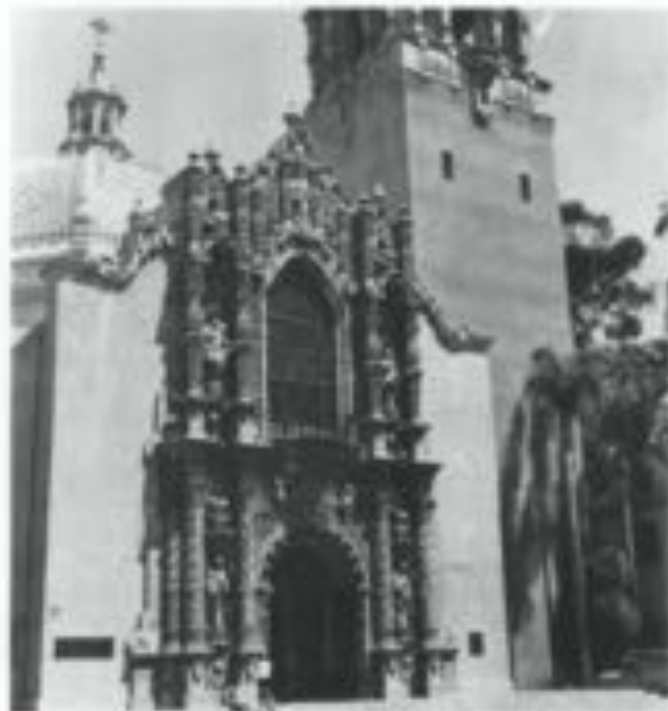
Fig. 4. The elaborate Spanish Colonial Revival style of this building designed by Bertram Goodhue for the 1915 Panama California Exposition held in San Diego's Balboa Park emphasizes the sculptural possibilities of stucco. Photo: C.W. Snell, National Historic Landmark Files.

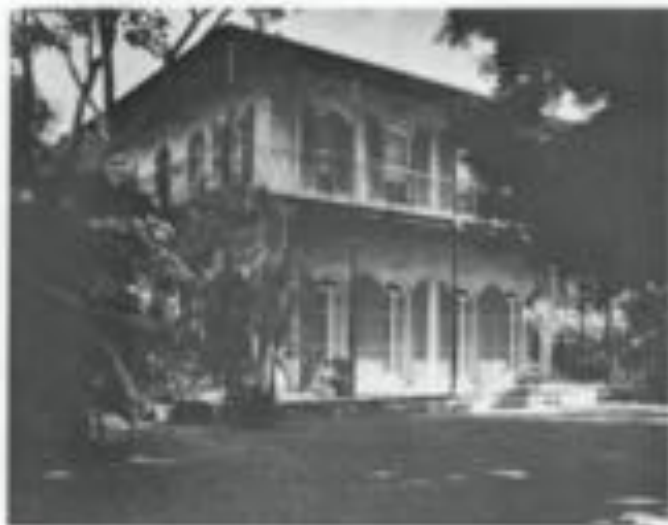
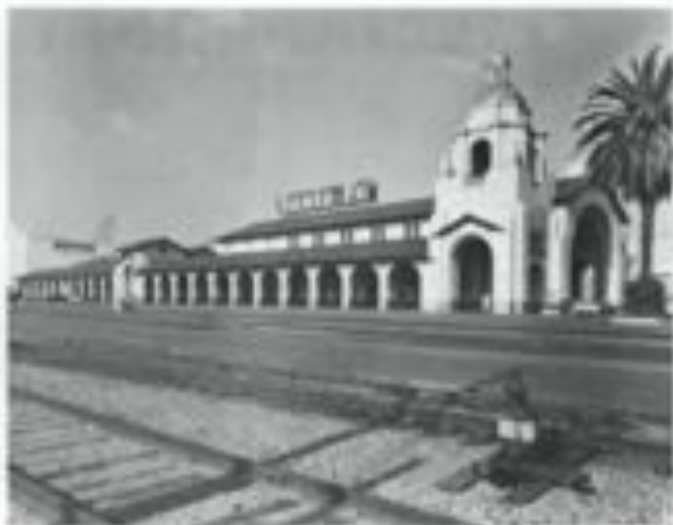
Fig. 5. During the 19th and 20th centuries stucco has been a popular material not only for residential, but also for commercial buildings in the Spanish style. Two such examples are (a) the 1851 Ernest Hemingway House, Key West, Florida, built of stuccoed limestone in a Spanish Caribbean style; and (b) the Santa Fe Depot (Union Station), San Diego, California, designed by the architects Bakewell and Bryson in 1914 in a Spanish Colonial Revival style, and constructed of stucco over brick and hollow tile. Photos: (a) J.E. Brooks, HABS Collection, (b) Marvin Rand, HABS Collection.

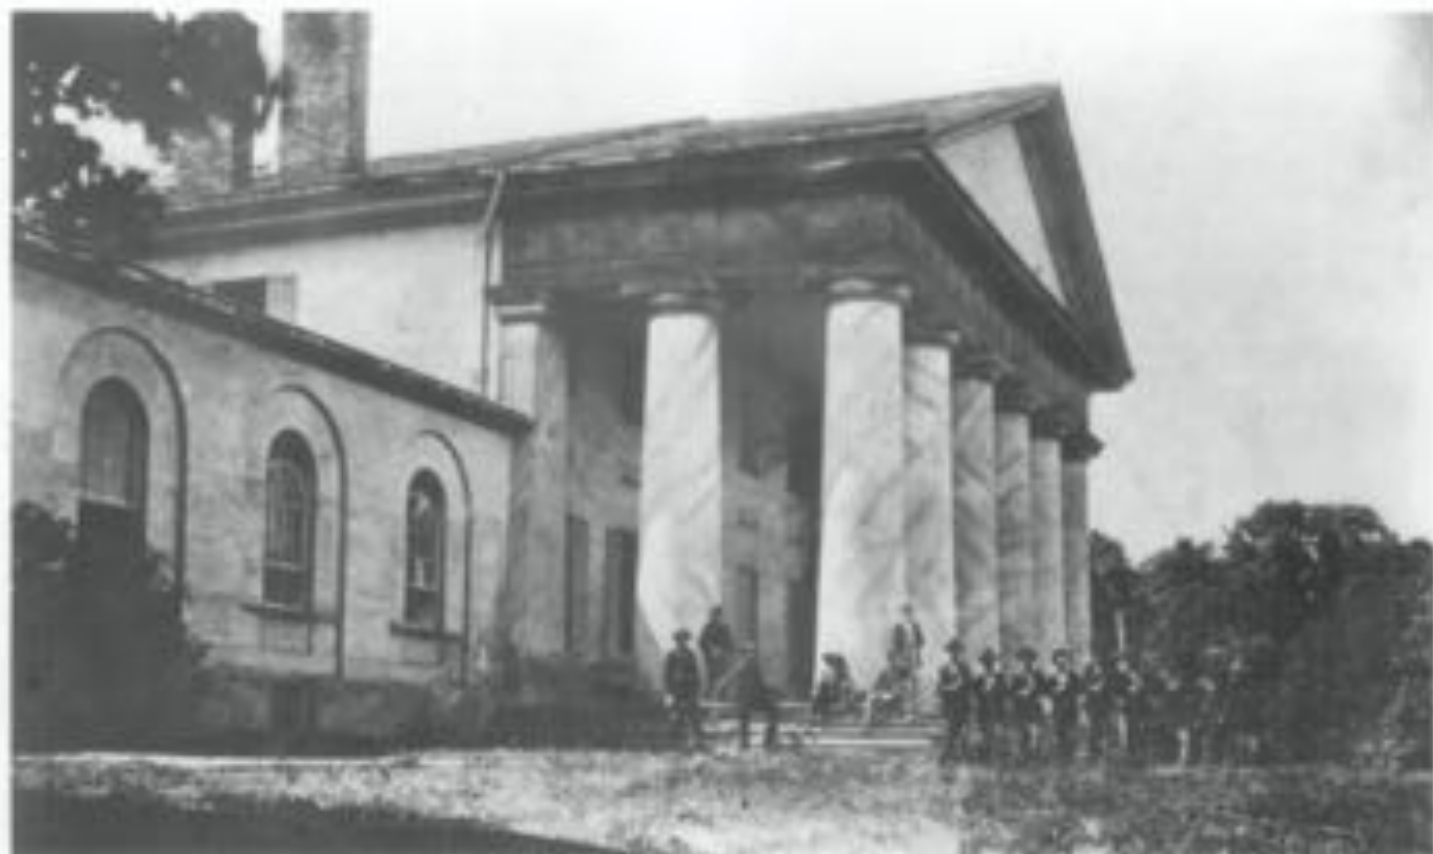
Fig. 6. Arlington House, Arlington, Virginia, was built between 1802-1818 of brick covered with stucco. It was designed by George Hatfield for George Washington Parke Custis, grandson of Martha Washington, and was later the home of Robert E. Lee. This photograph taken on June 28, 1864, by Captain Andrew J. Russell, a U.S. Signal Corps photographer, shows the stucco after it had been marbledized during the 1850's. Yellow ochre and burnt umber pigments were combined to imitate Siena marble, and the stucco, with the exception of the roughcast foundation, was scored to heighten the illusion of stone. Photo: National Archives, Arlington House Collection, National Park Service.

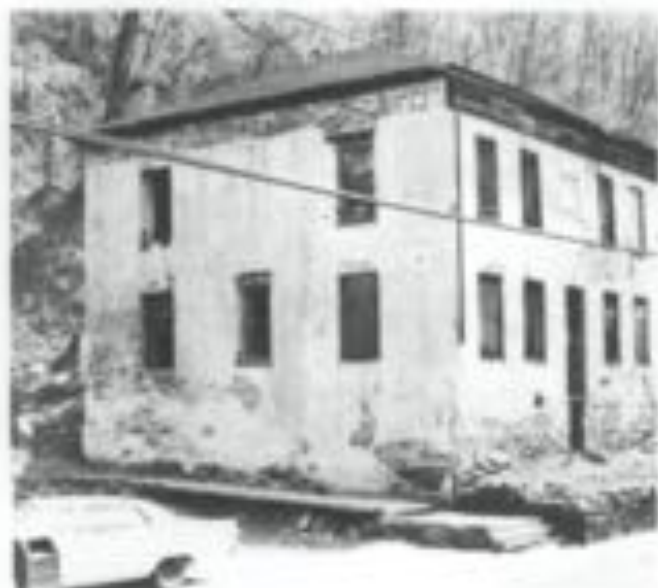
Fig. 7. Patches of stucco have fallen off this derelict 19th century structure exposing the rough-cut local stone substrate. The missing wood entablature on the side and the rough wood lintel now exposed above a second-floor window offer clues that the building was stuccoed originally. Photo: National Park Service Files.

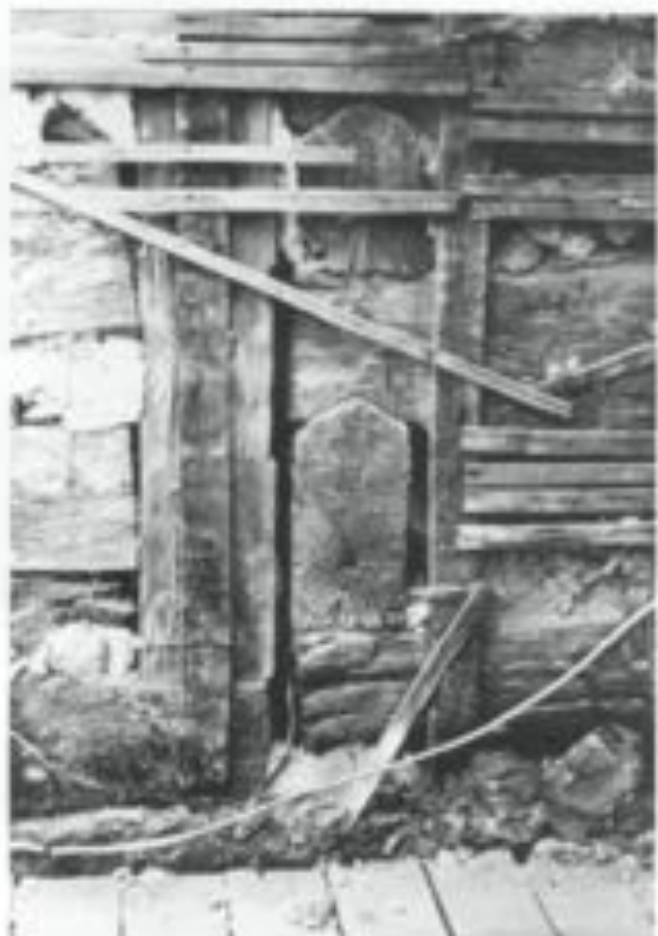
Fig. 8. Removal of deteriorated stucco in preparation for stucco repair on this late-19th century log house in Middleway, West Virginia, reveals that the stucco was applied to hand-riven wood lath nailed over vertical wood strips attached to the logs. Photo: Anne Grimmer.

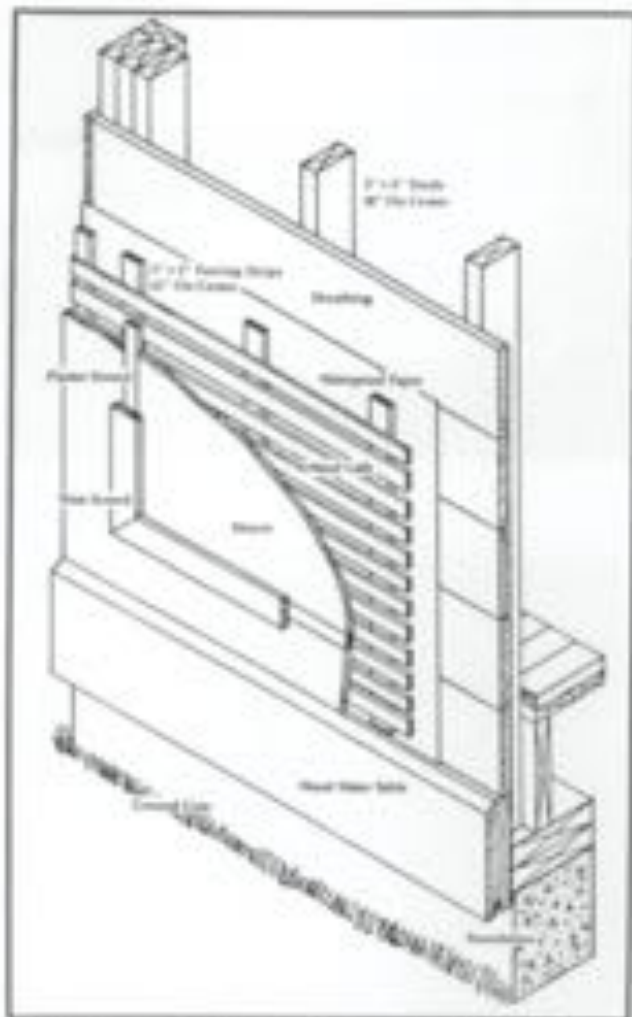
Fig. 9. This cutaway drawing shows the method of attachment for stucco commonly used on wood frame or balloon frame structures from the late-19th to the 20th century. Drawing: Brian Conway. "Illinois Preservation Series Number 2: Stucco."

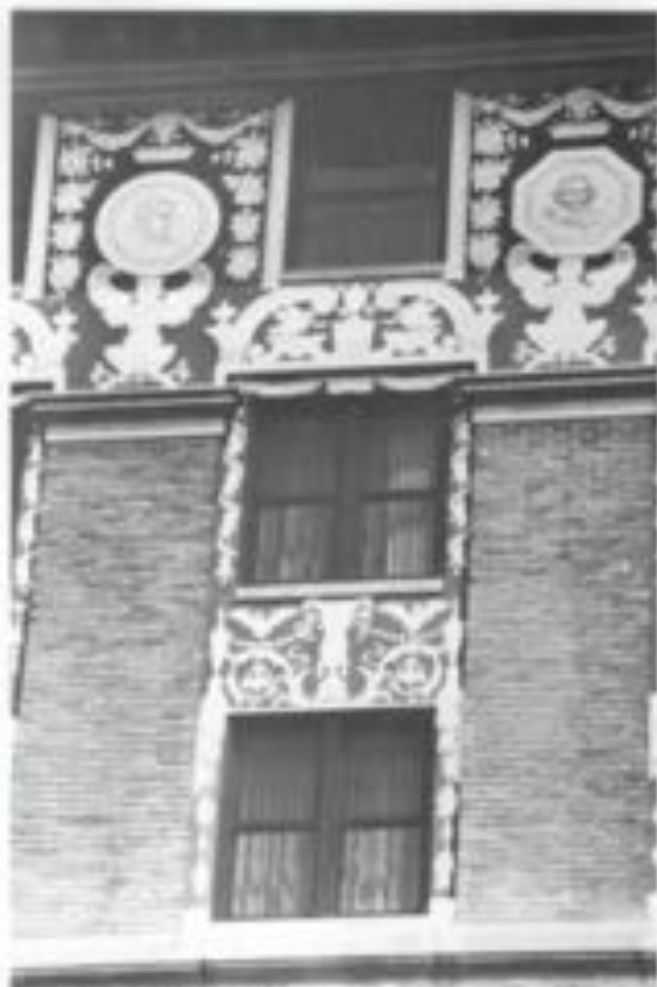
Fig. 11. The Hotel Washington, Washington, D.C. (1916-1917), is notable for its decorative sgraffito surfaces. Stucco panels under the cornice and around the windows feature classical designs created by artists who incised the patterns in the outer layer of red-colored stucco while still soft, thereby exposing a stucco underneath of a contrasting color. Photo: Kaye Ellen Stoussman.
