GEORGETOWN STEAM PLANT
HISTORIC STRUCTURE & CULTURAL LANDSCAPE REPORT

OCTOBER 9, 2013

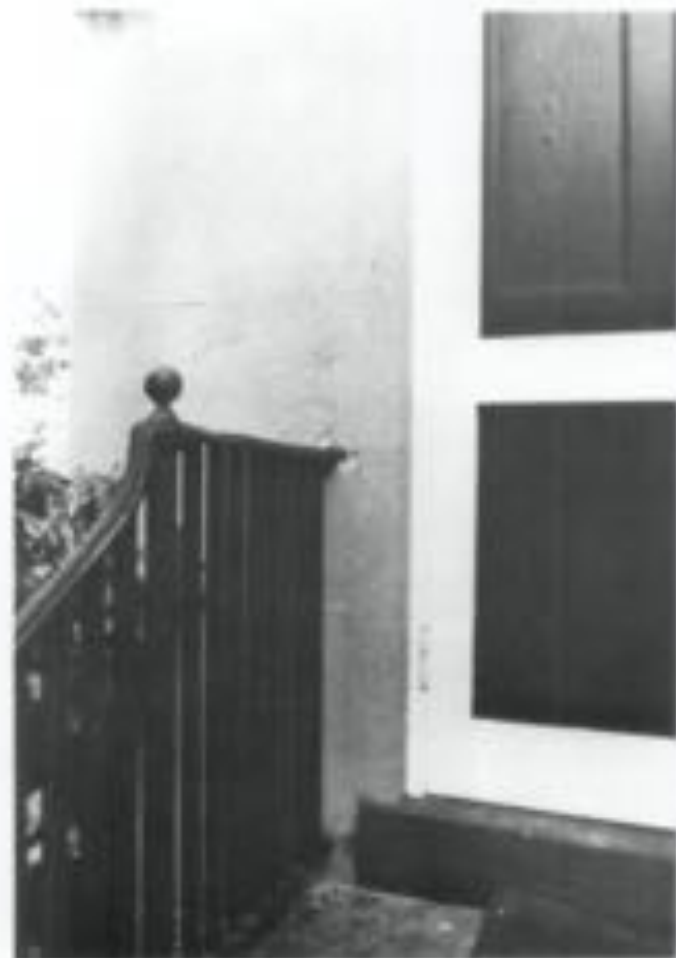
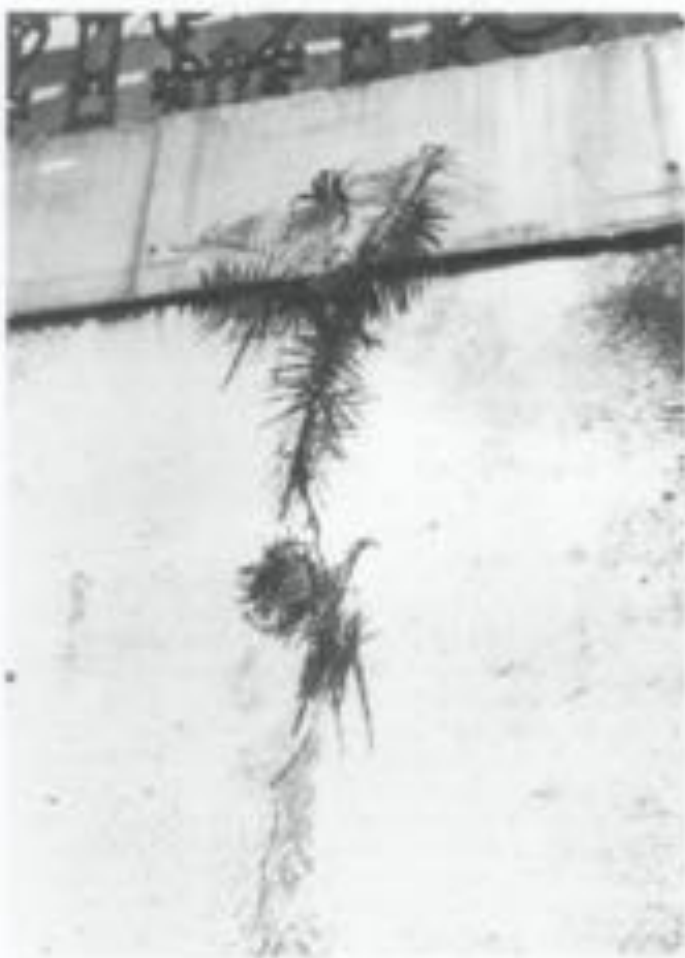
Fig. 12. (a) Water intrusion caused by rusting metal, or the plant growth left unattended will gradually enlarge these cracks, resulting in spalling, and eventually requiring extensive repair of the stucco. Photos: National Park Service Files.

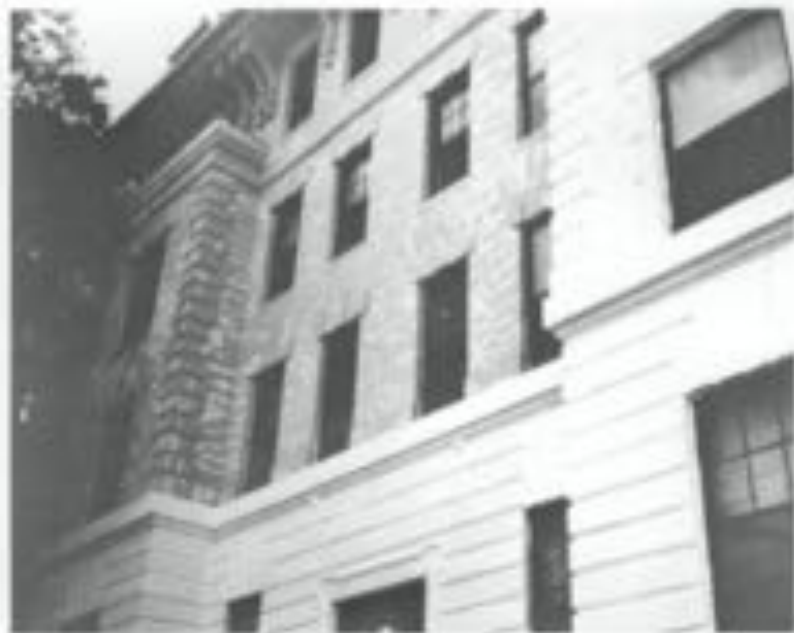
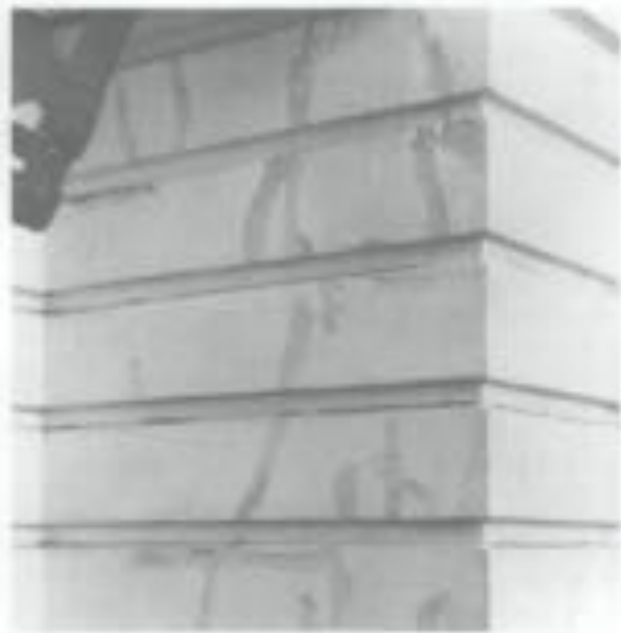
Fig. 13. (a) In preparation for repainting, hairline cracks on this Mediterranean style stucco apartment building were filled with a commercial caulking compound; (b) dirt is attracted and adheres to the texture of the caulked areas, and a year after painting, these inappropriate repairs are highly obvious. Photos: Anne Grimm.

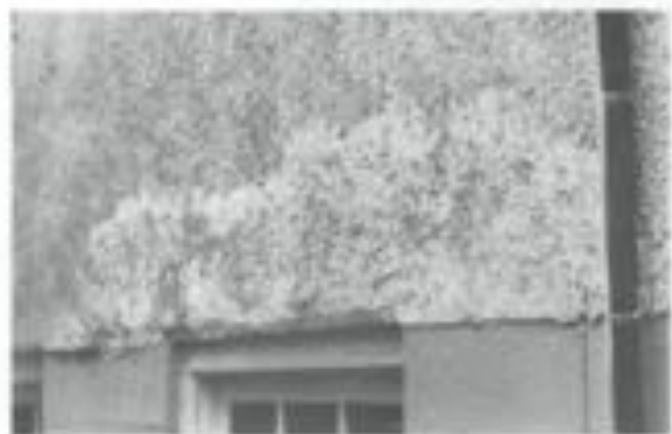
Fig. 14. This poorly executed patch is not the work of a professional plasterer. While it may serve to keep out water, it does not match the original surface, and is not an appropriate repair for historic stucco. Photo: Bethy Christensen.

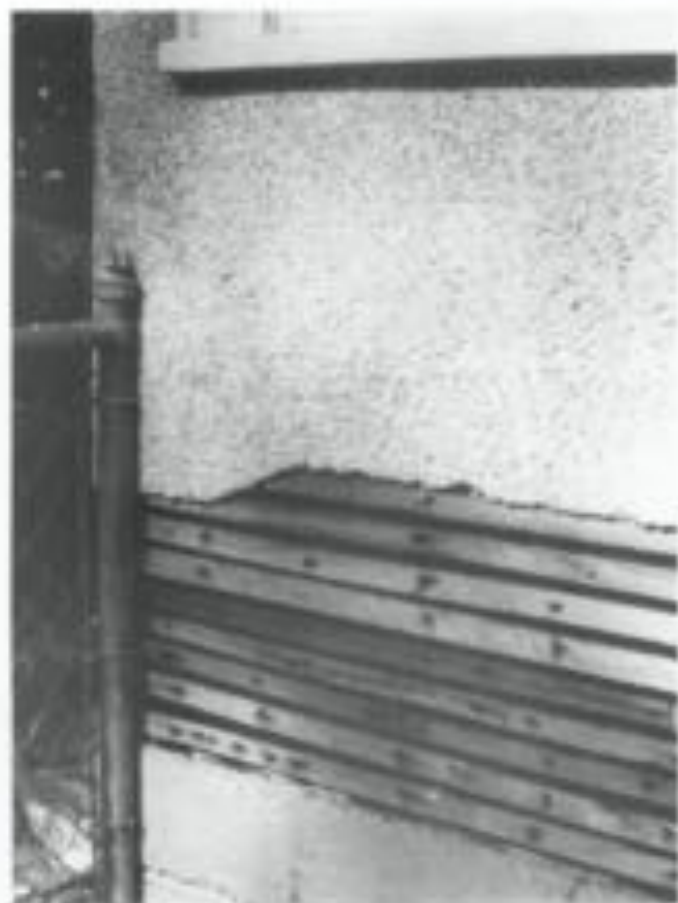
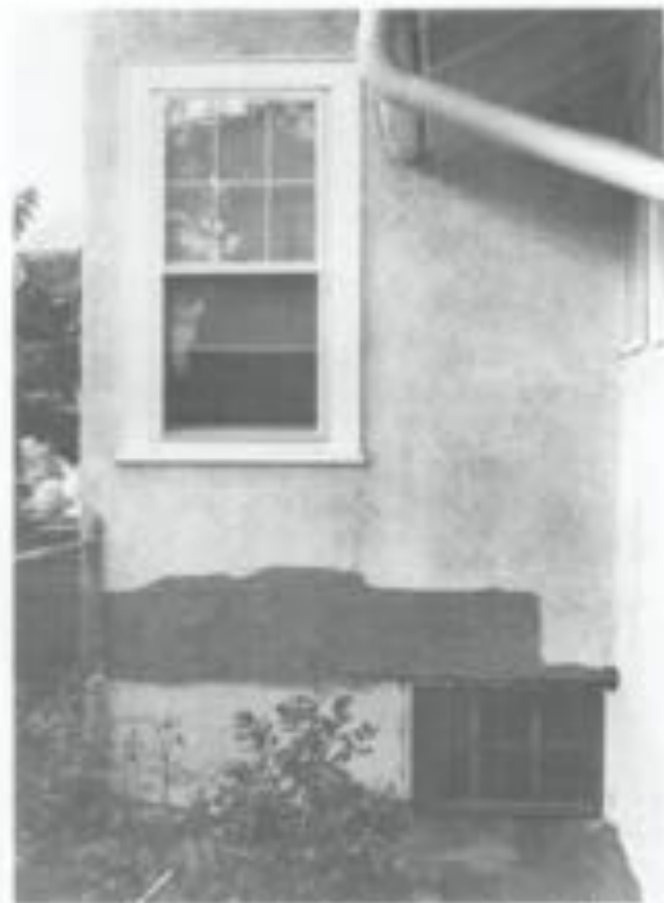
Fig. 15. (a) After ratcheting any loose wood lath to the furring strip underneath, the area to be patched has been cleaned, the lath thoroughly wetted, and (b) the first coat of stucco has been applied and scratched to provide a key to hold the second layer of stucco. Photos: Betty Chittenden.

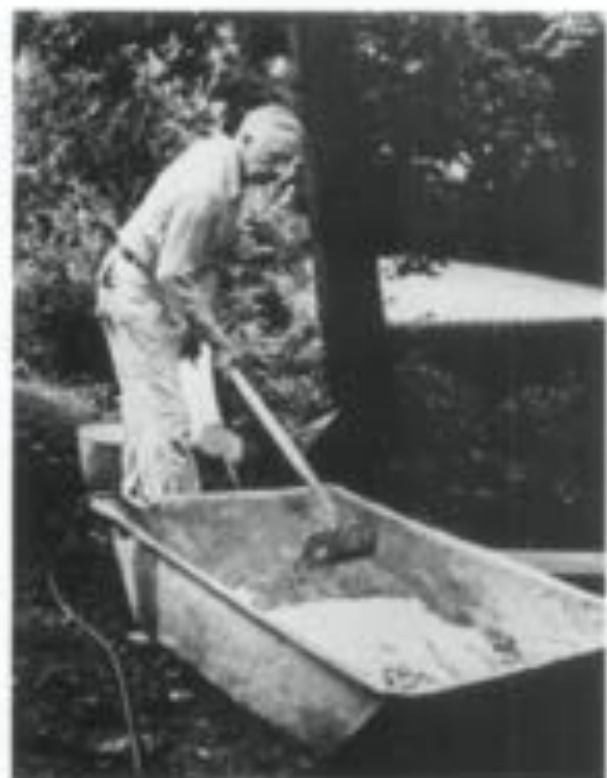
Cement-based paints, most of which today contain some portland cement and are really a type of limewash, have traditionally been used on stucco buildings. The ingredients were easily obtainable. Furthermore, the lime in such paints actually bonded or joined with the stucco and provided a very durable coating. In many regions, whitewash was applied annually during spring cleaning. Modern, commercially available pre-mixed masonry and mineral-based paints may also be used on historic stucco buildings.

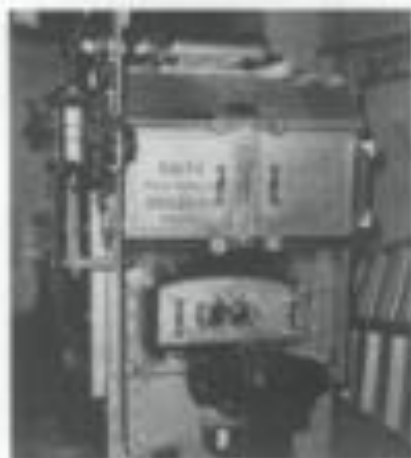
U.S. Department of the Interior
National Park Service
Cultural Resources
Heritage Preservation Services

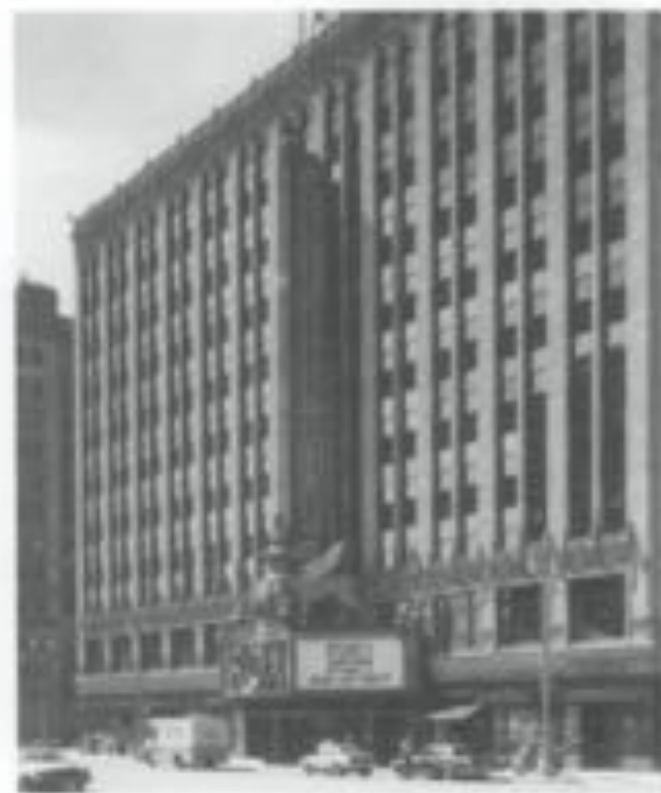
3. The circa 1918 Fox Theater in Detroit, designed by C. Howard Crane, was one of the earliest twentieth century buildings to provide air conditioning to its patrons. The early water-cooled system was recently restored. Commercial and highrise buildings of the twentieth century were able, mostly through electrical power, to provide sophisticated systems that integrated many building services. Photo: William Kessler and Associates, Architects.

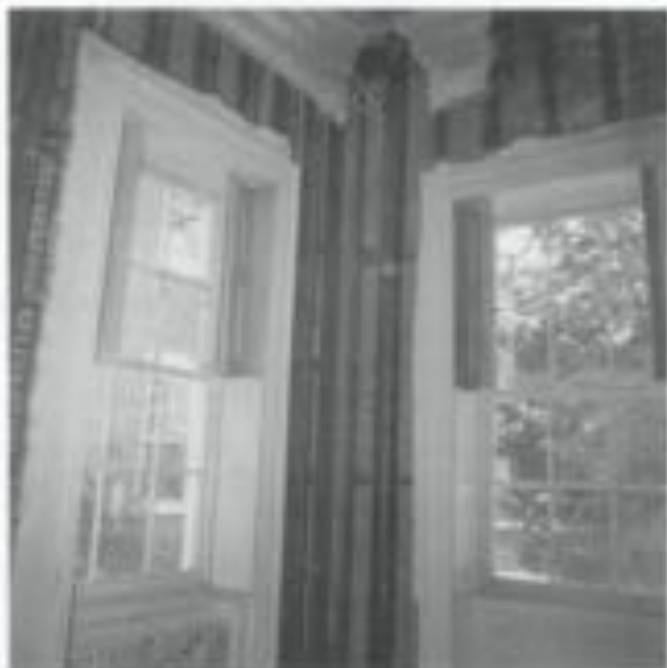
5. The installation of vapor barriers in walls of historic buildings is an effort to control interior moisture and can cause serious damage to historic finishes as shown here. In this example, all the wall plaster and lath have been stripped in preparation for a vapor barrier prior to replastering. Controlling interior temperature and relative humidity can be more effective than adding insulation and vapor barriers to historic perimeter walls. Photo: David A. Conrad, P.E.

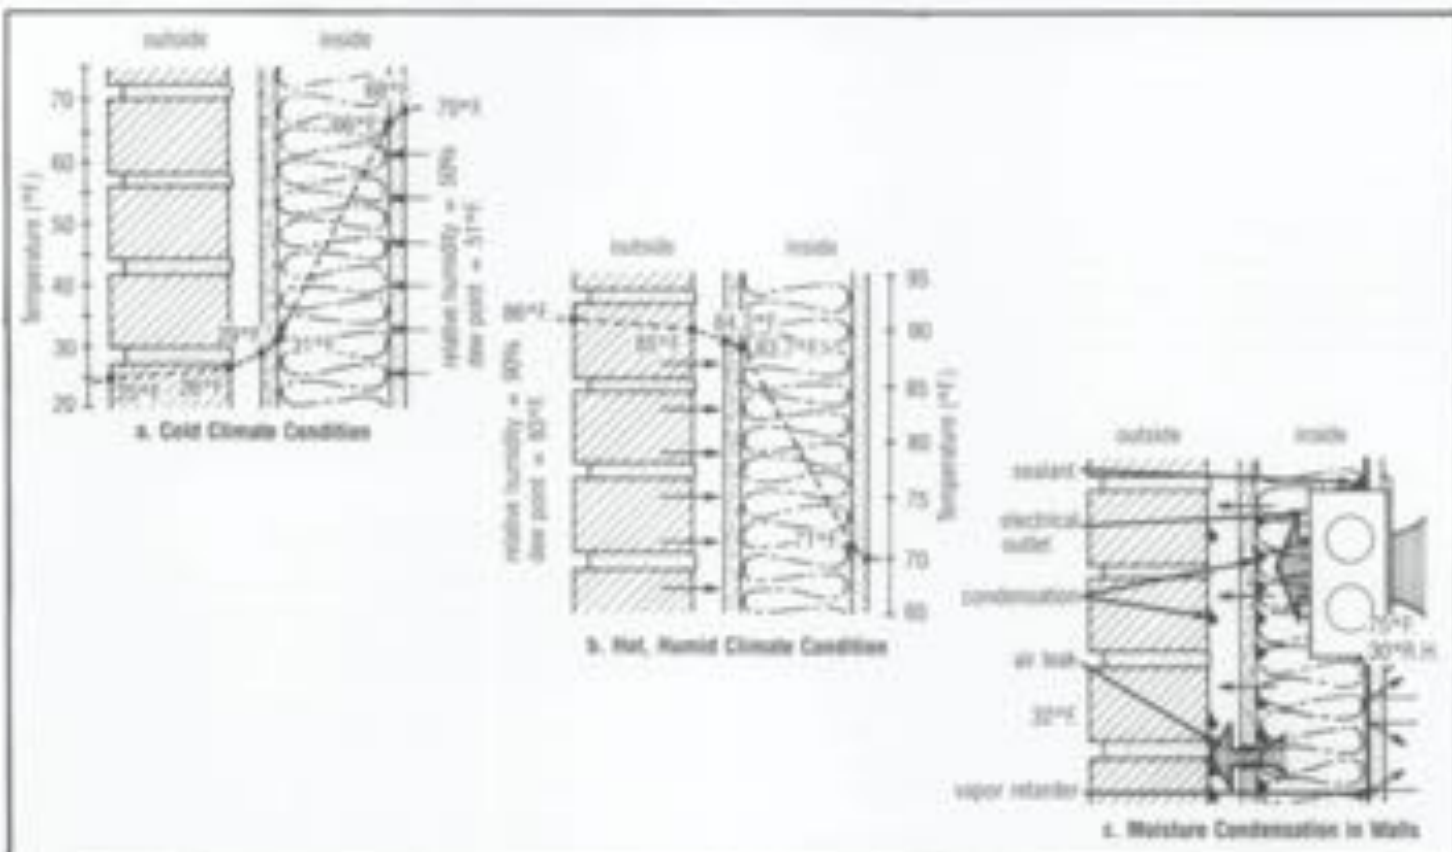
4. Mechanical heating and cooling systems change the interior climate of a building. Moisture in the air will dissipate from the warmer area of a building to the colder area and can cause serious deterioration of historic materials. Condensation can form if the dew point occurs within the building wall, particularly one that has been insulated (see a and b). Even when vapor barriers are installed (c), any non-continuous areas will provide spaces for moisture to pass. Wall Section Drawings: NPS files

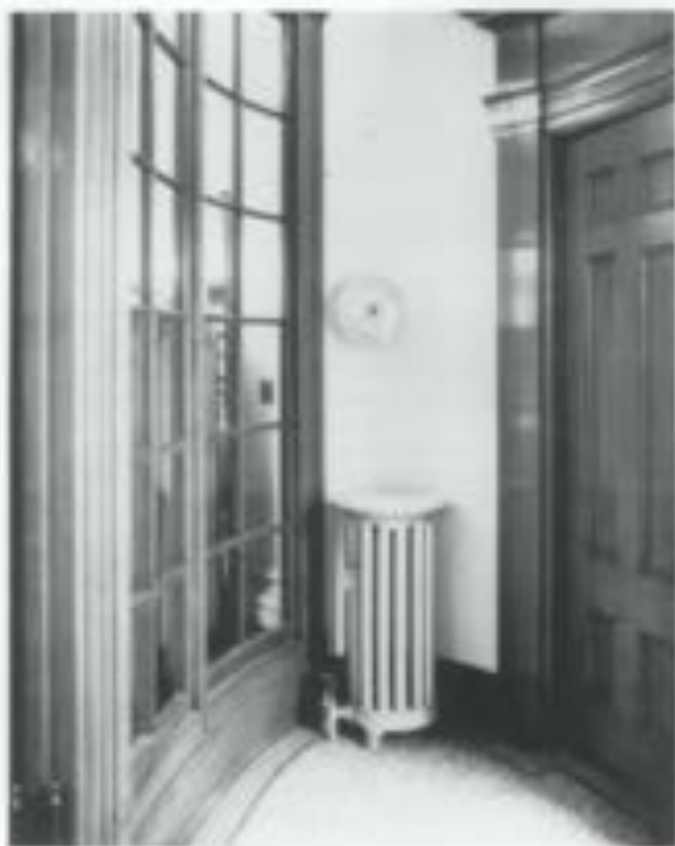
6. A condition assessment during the planning stage would identify this ornate radiator in a small oval-shaped niche as a significant element of the historic heating system. In upgrading the mechanical system, the radiator should be retained. Photo: Michael C. Hovig, P.E., AIA.

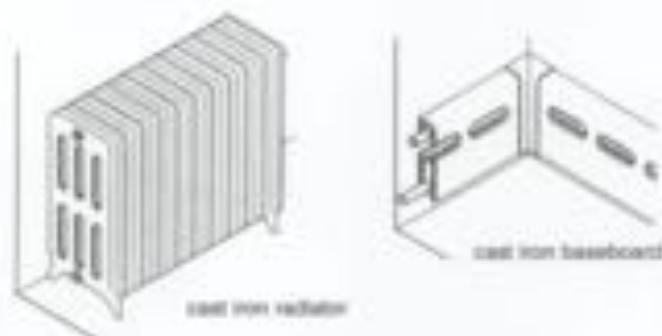
Fan Coil Units: Fan coil systems use terminal cabinets in each room serviced by 2, 3, or 4 pipes approximately 1-1/2" each in diameter. A fan blows air over the coils which are serviced by hot or chilled water. Each fan coil cabinet can be individually controlled. Four-pipe fan coils can provide both heating and cooling all year long. Most piping is steel. Non-cabinet units may be concealed in closets or custom cabinetry, such as benches, can be built.

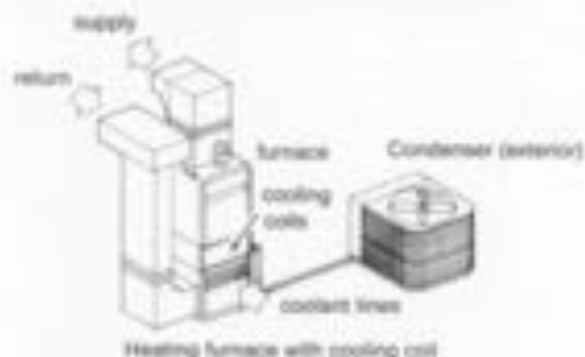
Basic Heat Pump/Air System: The heat pump is a basic HVAC system as described above except for the method of generating hot and cold air. The system operates on the basic refrigeration cycle where latent heat is extracted from the ambient air and is used to evaporate refrigerant vapor under pressure. Functions of the condenser and evaporator switch when heating is needed. Heat pumps, somewhat less efficient in cold climates, can be fitted with electric resistance coil.

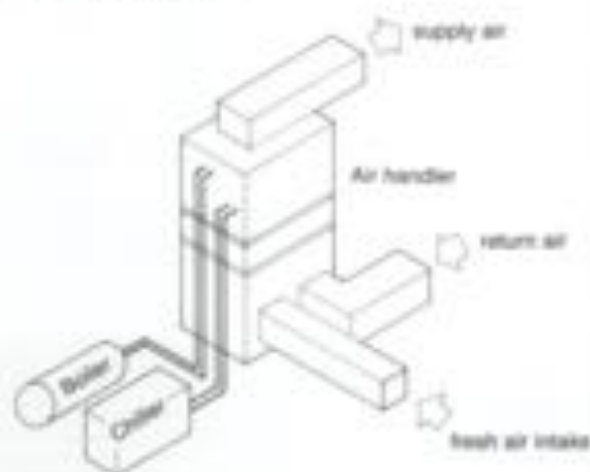
Typical Systems Layout:

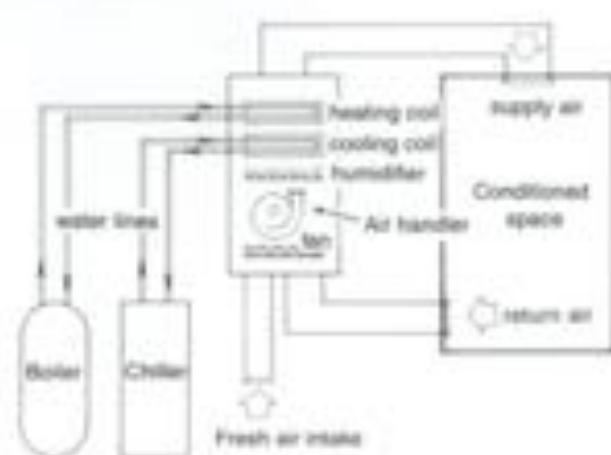
OTHER SYSTEM COMPONENTS

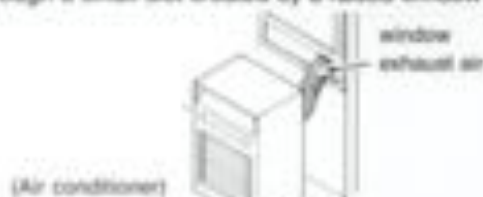
Fans: Fans should be considered in most properties to improve ventilation. Fans can be located in attics, at the top of stairs, or in individual rooms. In moderate climates, fans may eliminate the need to install central air systems.

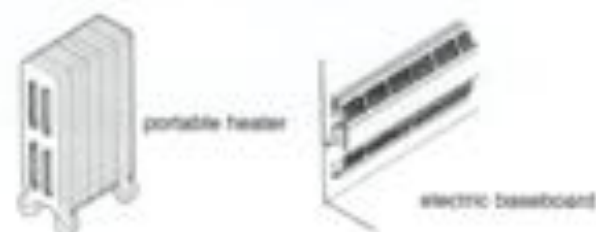
4. **Prioritize architecturally significant spaces, finishes, and features to be preserved.** Significant architectural spaces, finishes and features should be identified and evaluated at the outset to ensure their preservation. This includes significant existing mechanical systems or elements such as hot water radiators, decorative grilles, elaborate switchplates, and non-mechanical architectural features such as cupolas, transoms, or porches. Identify non-significant spaces where mechanical equipment can be placed and secondary spaces where equipment and distribution runs on both a horizontal and vertical basis can be located. Appropriate secondary spaces for housing equipment might include attics, basements, penthouses, mezzanines, false ceiling or floor cavities, vertical chases, stair towers, closets, or exterior below-grade vaults (see figure 8).

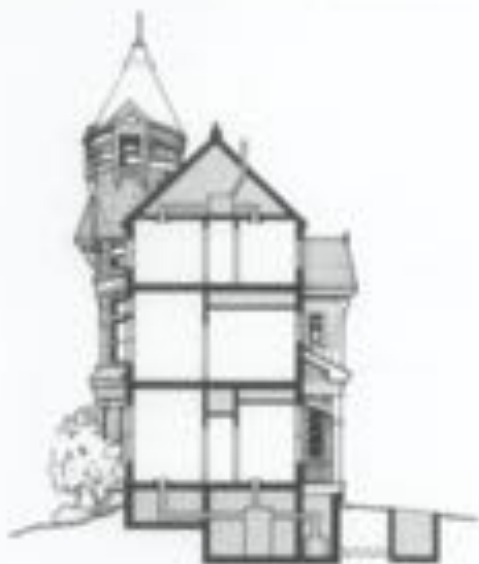
8. In considering options for new systems, existing spaces should be evaluated for their ability to house new equipment. This sketch shows several areas where new mechanical equipment could be located to avoid damaging significant spaces. Sketch: NPS files

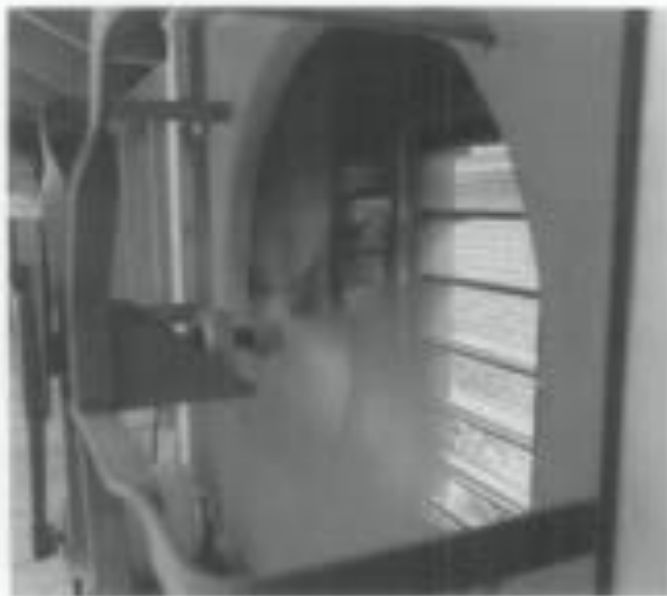
9. Improving ventilation through traditional means should not be overlooked in planning new or upgraded HVAC systems. In mild climates, good exhaust fans can often eliminate the need for air conditioning or can reduce equipment size by reducing cooling loads. Photo: Ernest A. Conrad, P.E.

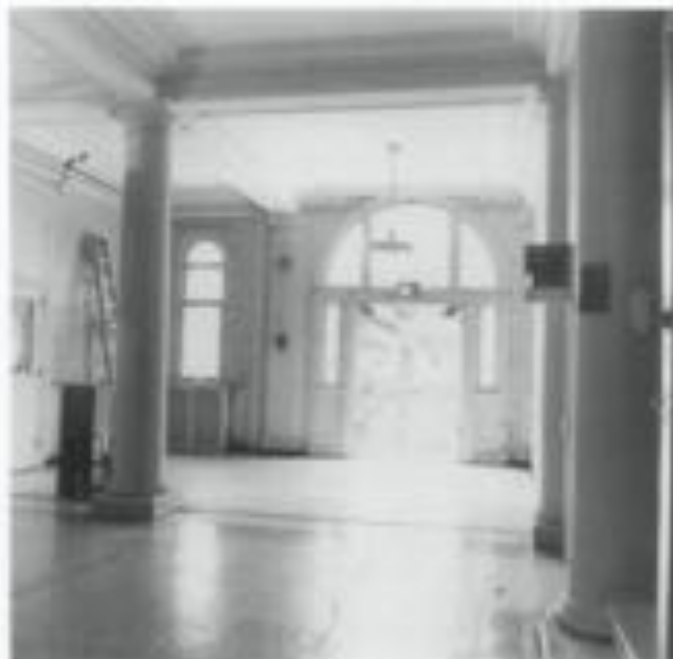
18. The following photographs illustrate recent preservation projects where careful planning and design retained the historic character of the resources.

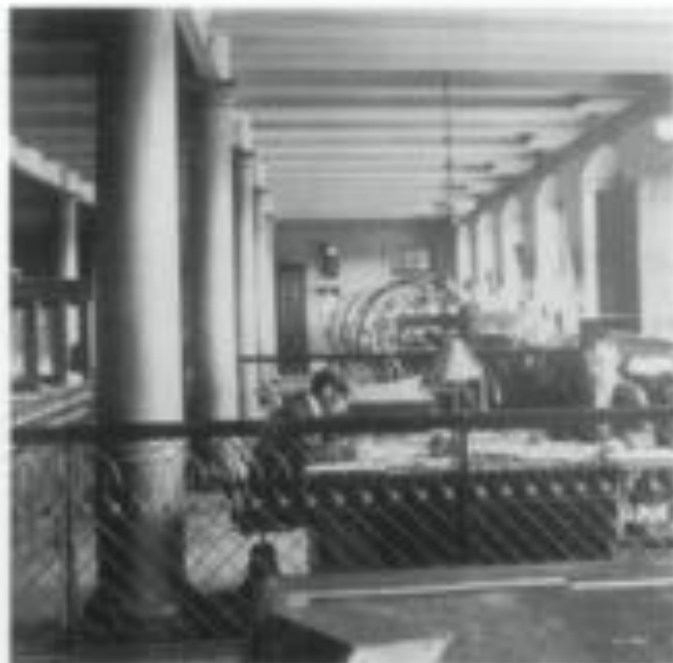
c. Before and after of a circa 1900 school entrance. The radiators have been replaced with a two-pipe fan coil system built into bench seats. The ceiling was preserved and no exposed elements were required to add air conditioning. Piping runs are under the benches and there was no damage to the masonry walls. Photos: Nutter Finegold + Alexander Inc. and Lustman Photography, Washington.

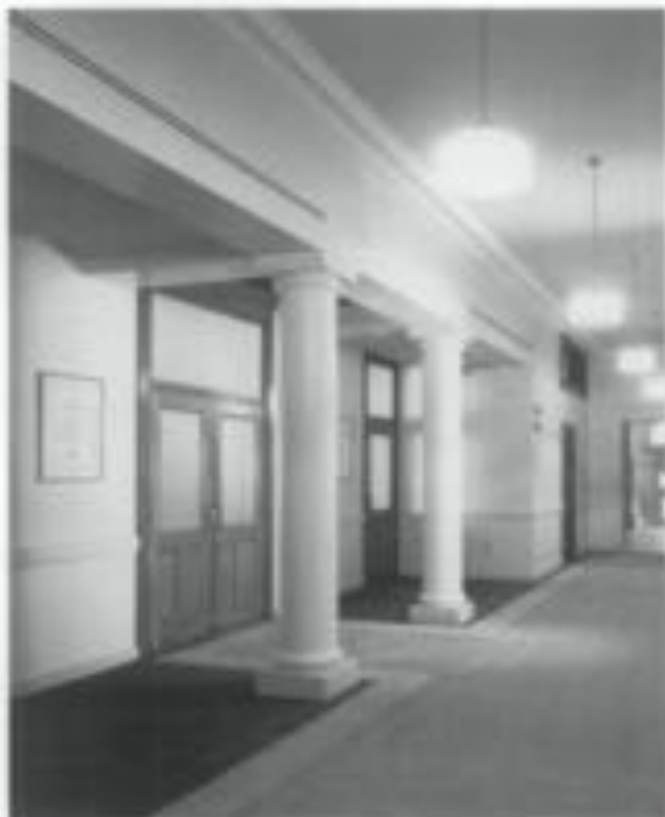
8. Central air conditioning was installed in the corridors of this circa 1900 school building by adding an air handler over the entrance from a rooftop. The custom-designed slot registers provide linear diffusion without detracting from the architecture of the space. Photo: Lautman Photography courtesy of Nitter Finegold + Alexander Inc.

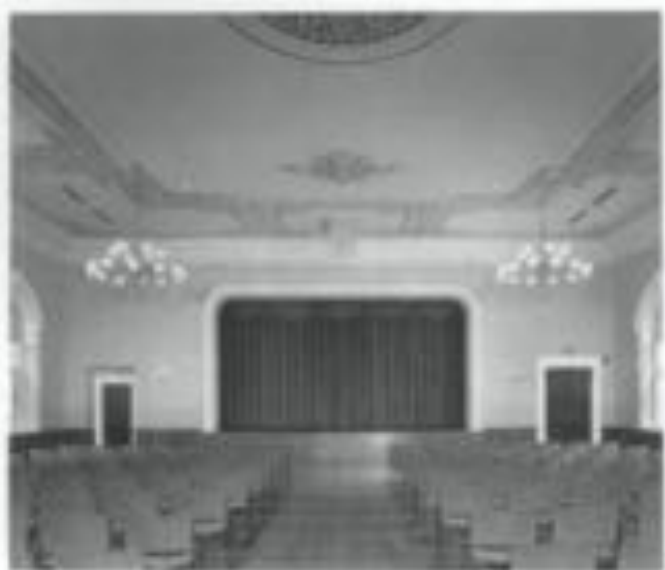
9. Town Hall, Andover, MA. The upstairs auditorium was restored and new mechanical systems were installed. Perimeter baseboard radiative heat and air handlers, located in the attic space provide air conditioning. The cast iron ceiling grille was adapted for return air and the supply registers were installed in a symmetrical and regular manner to minimize impact on the historic ceiling. Photo: David Hewitt/Anna Garrison for Ann Beha Associates.

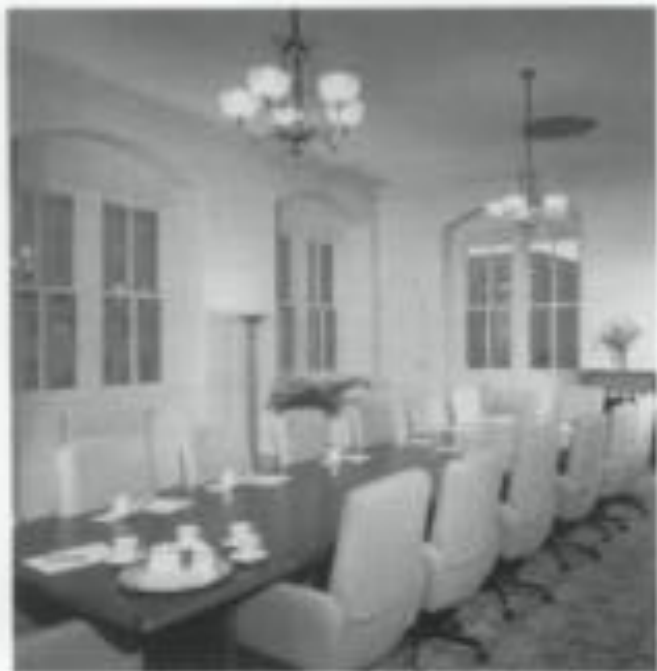
10. Conference room, Auditors Building, Washington, D.C. The historic steam radiators were retained for heating. The cast iron ceiling register was retained as a decorative element, but made inoperable to meet fire codes. Photo: Kenneth Wyer Photography courtesy of Nitter Finegold + Alexander Inc.

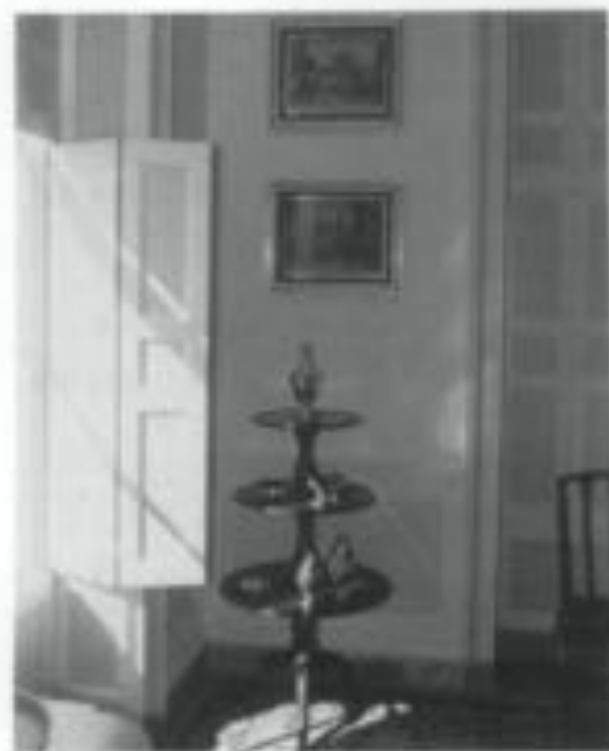
11. Homewood, Baltimore, MD. This elegant circa 1800 residence is now a house museum. The registers for the forced air ducted system were behind the table legs, are painted to blend with the historic baseboards. The HVAC system uses a radiator system where chilled water and steam heat are converted to conditioned air. Photo: Courtesy Homewood Museum, Johns Hopkins University.

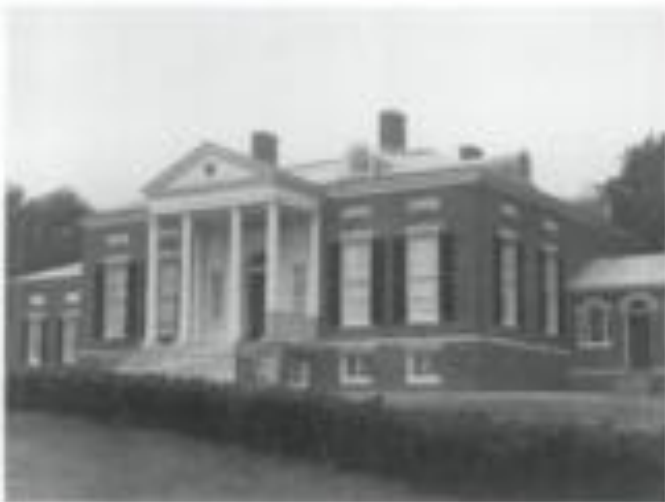
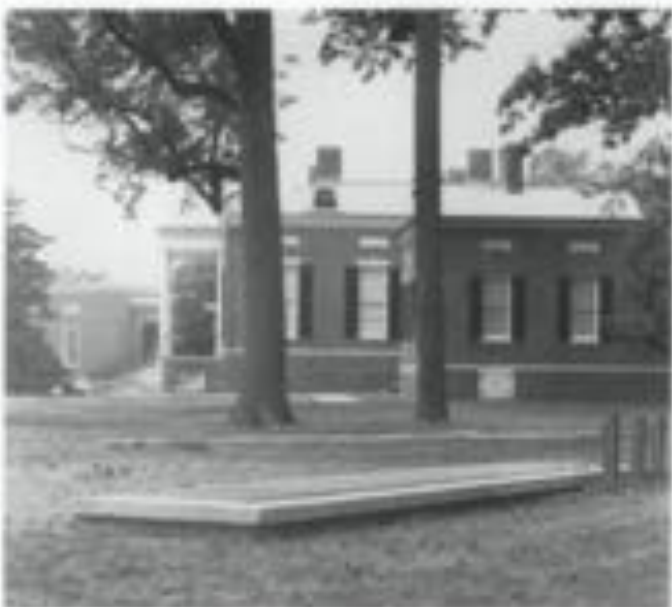
11. During the restoration of this 1806 National Historic Landmark (photo a), a new climate control system was installed. The architects removed all the earlier mechanical equipment from the house and installed new equipment in a 30' x 40' concrete vault located underground 150 feet from the house itself (photo b). Only conditioned air is blown into the house raising much of the circa 1830s ductwork. Photos: Thomas C. Jester.

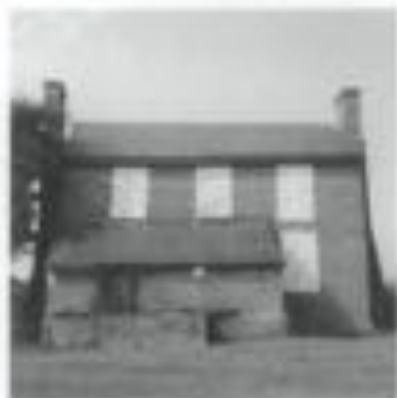
U.S. Department of the Interior
National Park Service
Cultural Resources
Heritage Preservation Services

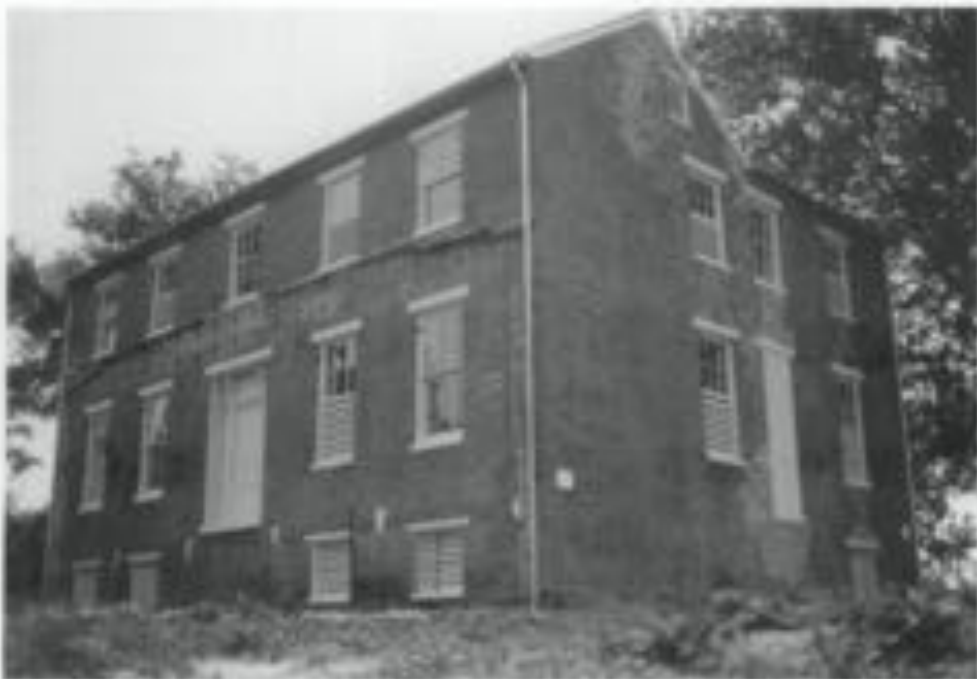
Figure 1. Proper mothballing treatment: This building has been successfully mothballed for 10 years because the roof and walls were repaired and structurally stabilized, ventilative louvers were added, and the property is maintained. Photo: Charles E. Fisher, NPS.

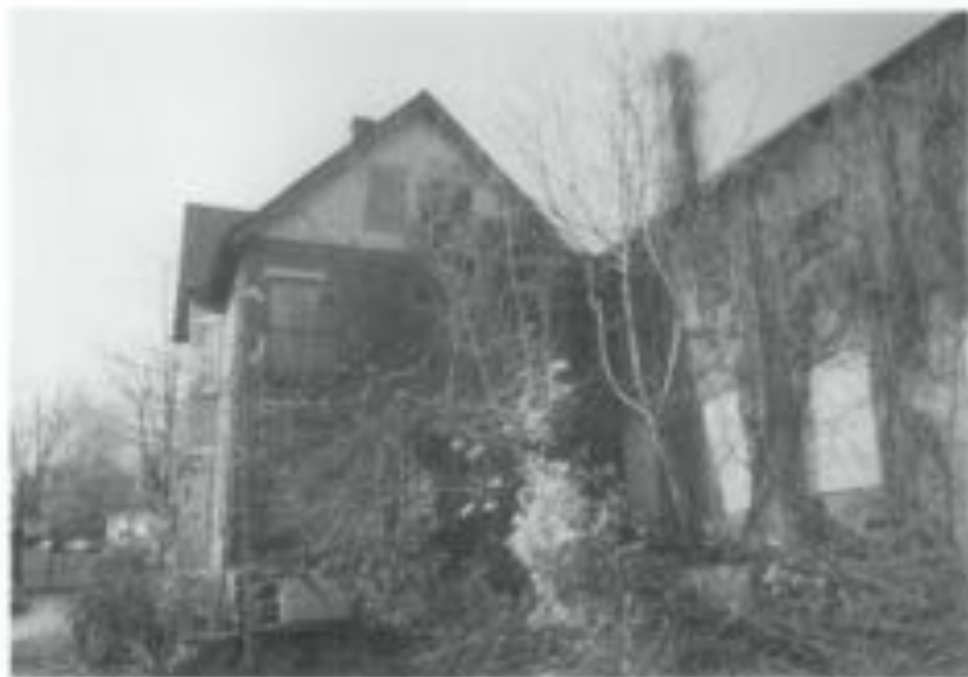
Figure 2. Improper treatment: Boarding up without adequate ventilation, lack of maintenance, and neglect of this property have accelerated deterioration. Photo: NPS file.

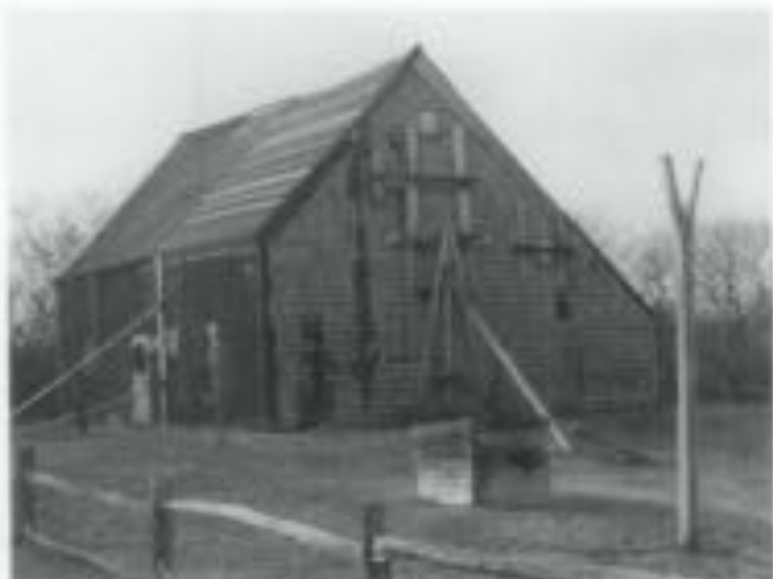
Figure 3. Buildings seriously damaged by storms or deterioration may need to be shored before architectural evaluations can be made. Joffin Coffin House. Photo: John Miller Architects.

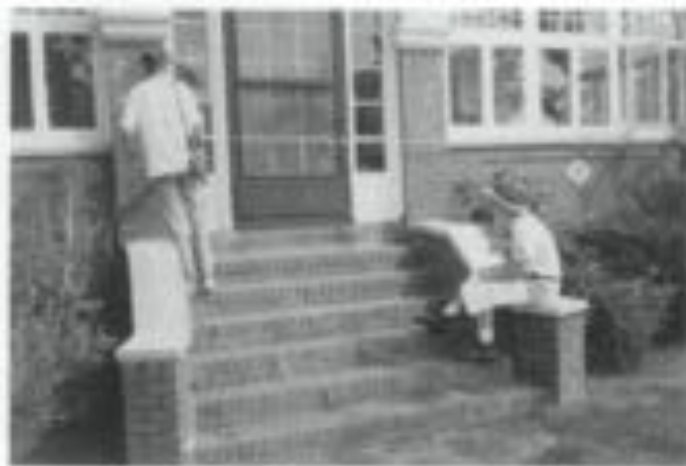
Figure 4. Documenting the building's history, preparing schematic plans, and assessing the condition of the building will provide necessary information on which to set priorities for stabilization and repair prior to securing the building. Photo: Frederick Lindstrom, NARS.

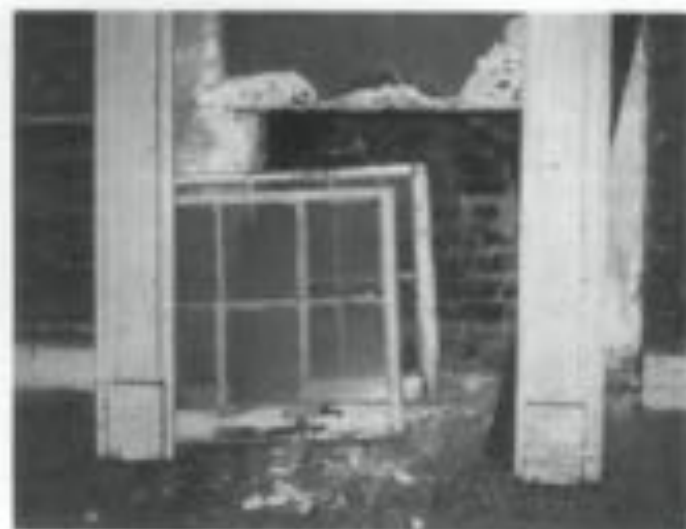
Figure 5. Loose or detached elements should be identified, tagged and stored, preferably on site. Photo: NPS files.

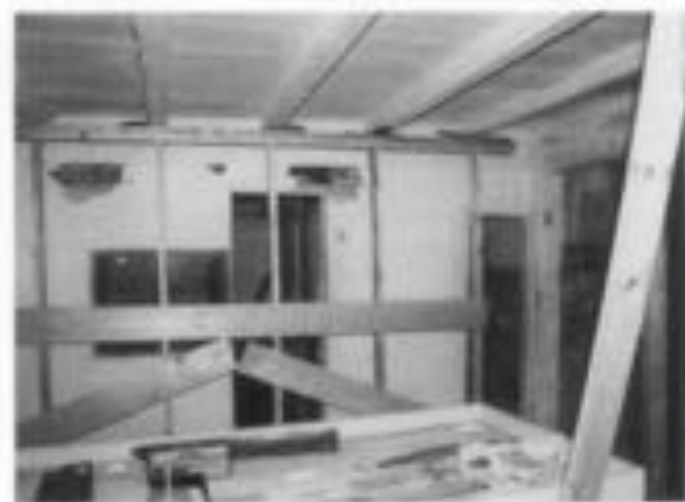
Figure 6. Interior bracing which will last the duration of the mothballing will protect weakened structural members. *Jellie Coffin House. Photo: John Miller Architects.*

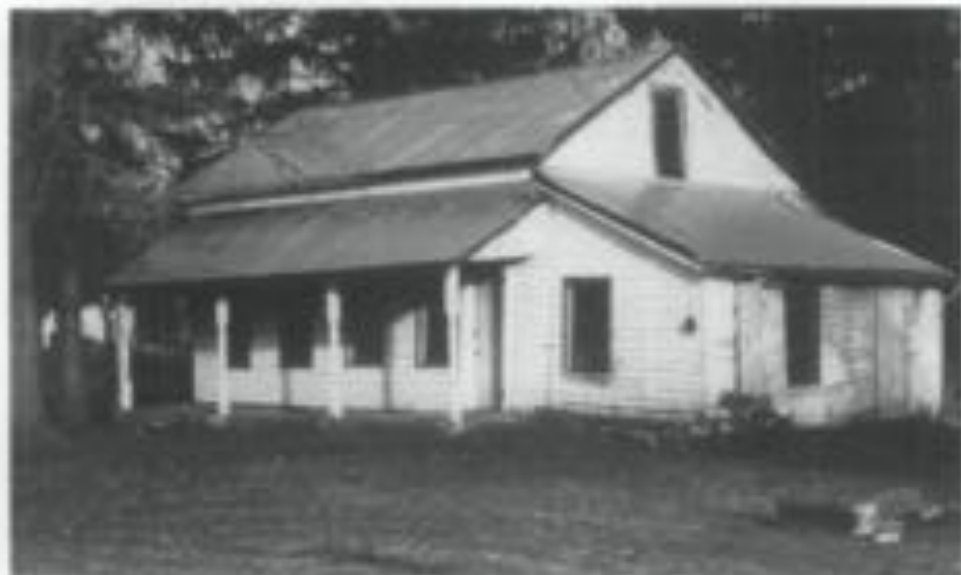
Figure 7. Non-historic materials are appropriate for mothballing projects when they are used to protect historic evidence remaining for future preservation. This lightweight aluminum channel frame and roofing covers the historic wooden shingle roof. Galvanized mesh panels across the window openings protect from intrusion by raccoons and other unwanted guests. Photo: Williamsport Preservation Training Center, NPS.

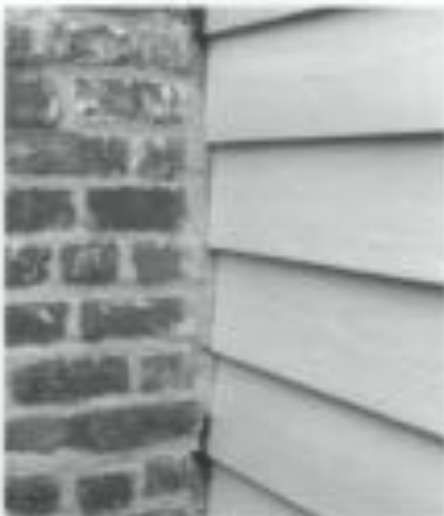
Figure 8. Appropriate mortar mix should be used when masonry repairs are undertaken. In this case, a soft lime based mortar is used as an infill between the brick and wooden elements. When full repairs are made during the restoration phase, this soft mortar can easily be removed and missing bricks replaced.

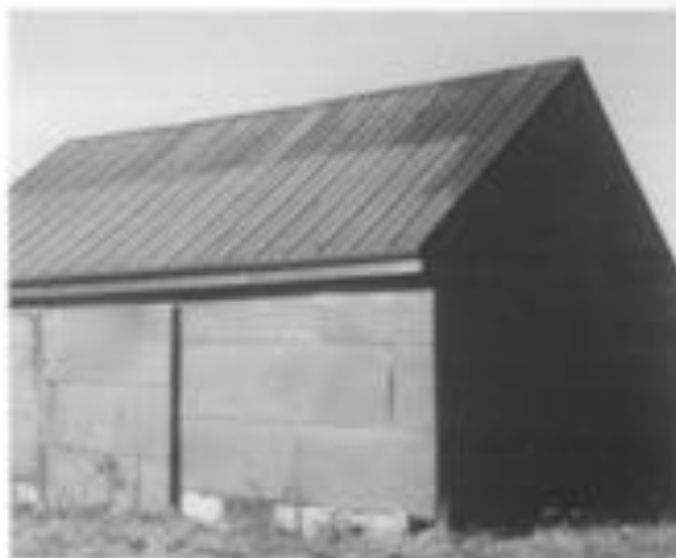
Figure 9. Severely deteriorated wooden siding on a farm building has been covered over with painted plywood panels as a temporary measure to eliminate moisture penetration to the interior. Foundation vents and floor floor boards allow air to circulate inside.

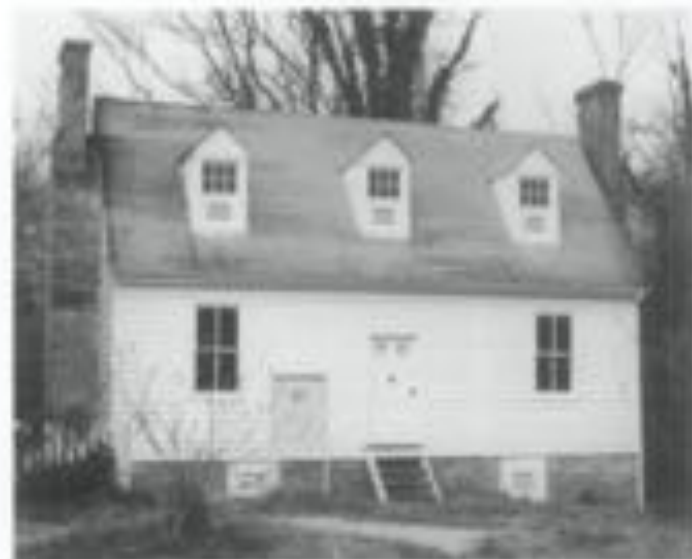
Figure 10. Regrading around the Tucker Troncent at Colonial Williamsburg has protected the masonry foundation soil from excessive damp. This building has been successfully mothballed for over 20 years. Note the attic and basement vents, the temporary stairs, and the information sign interpreting the history of this building.

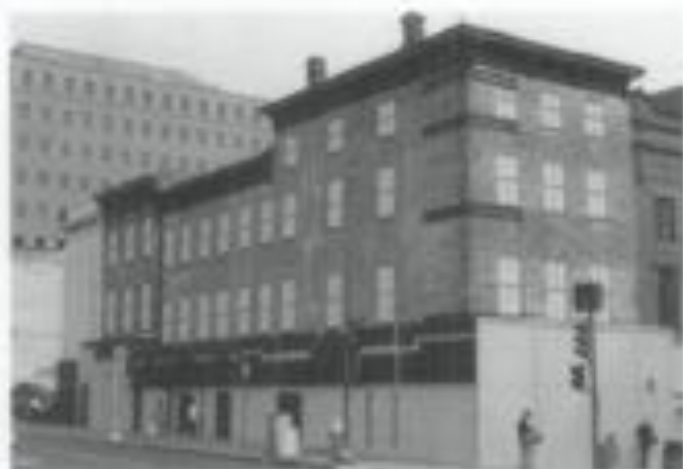
Figure 11. Urban buildings often need additional protection from unwanted entry and graffiti. This commercial building was painted plywood panels to cover expensive glass storefronts and chain link fencing is applied on top of the panels. The upper windows on the street sides have been covered and painted to resemble 18th century sash. Photo: Thomas Jester, NPS.

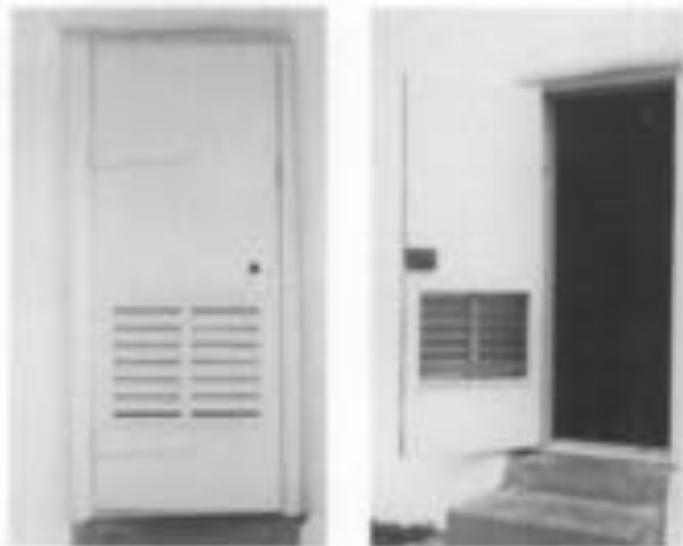
Figure 13. If historic doors would be damaged by adding extra locks, they should be removed and stored and new security doors added. At this lighthouse, the historic door has been replaced with a new door (new both inside and outside) with an inset vent and new deadbolt locks. The heavy historic hinges have not been damaged. Photo: Williamsport Preservation Training Center, NPS.

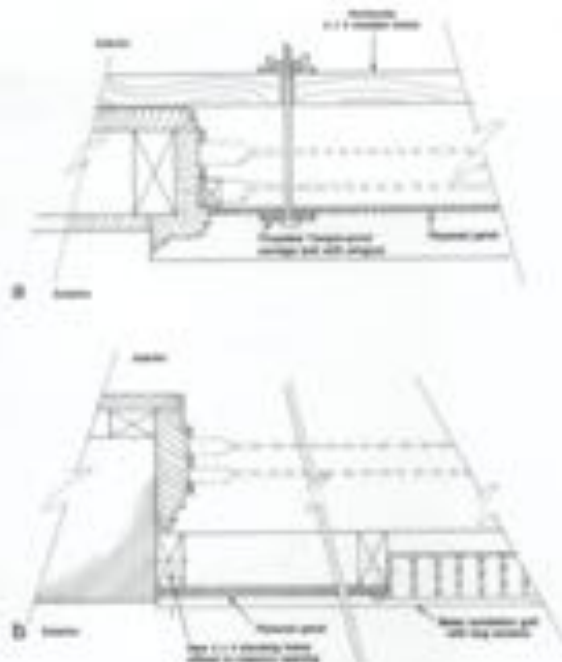
Figure 14. A: Plan detail showing plywood security panel anchored with carriage bolts through to the inside horizontal bracing, or strong backs. B: Plan detail showing section of plywood window panel attached to a new pressure treated wood frame set within the masonry opening. Ventilation should be included whenever possible or necessary.

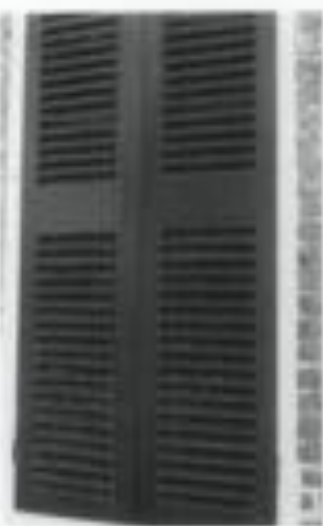
Figure 16. Historic louvered shutters make excellent security closures with passive ventilation.

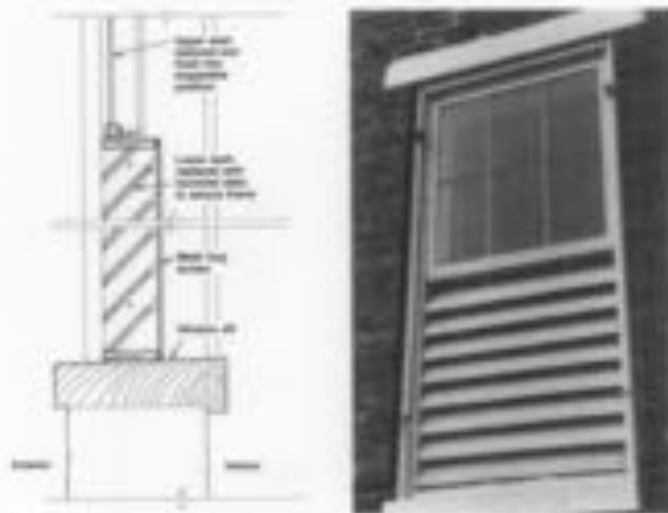
Figure 18. Heavy duty wooden slatted louvers were custom fabricated to replace the deteriorated lower sash. The upper sash were rebuilt to retain the historic appearance and to allow light into this vacant historic building. Refer back to Fig. 1 for a view of the building. Photo: Charles E. Fisher, NPS. Drawing by Thomas Vilnius.

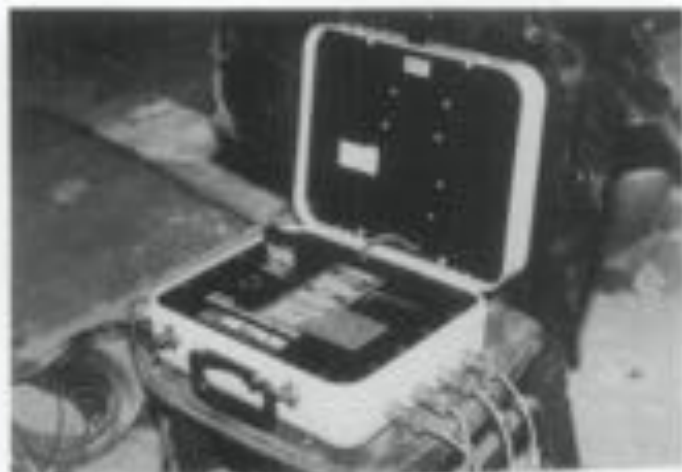
Figure 20. Portable monitors used to record temperature and humidity conditions in historic buildings during mothballing can help identify ventilation needs. This data can be downloaded directly into a lap top computer on site. These monitors are especially helpful over the long term for buildings with significant historic interiors or which are remaining furnished. If interiors are remaining damp or humid, additional ventilation should be added or the source of moisture controlled.
