GEORGETOWN STEAM PLANT
HISTORIC STRUCTURE & CULTURAL LANDSCAPE REPORT

OCTOBER 9, 2013

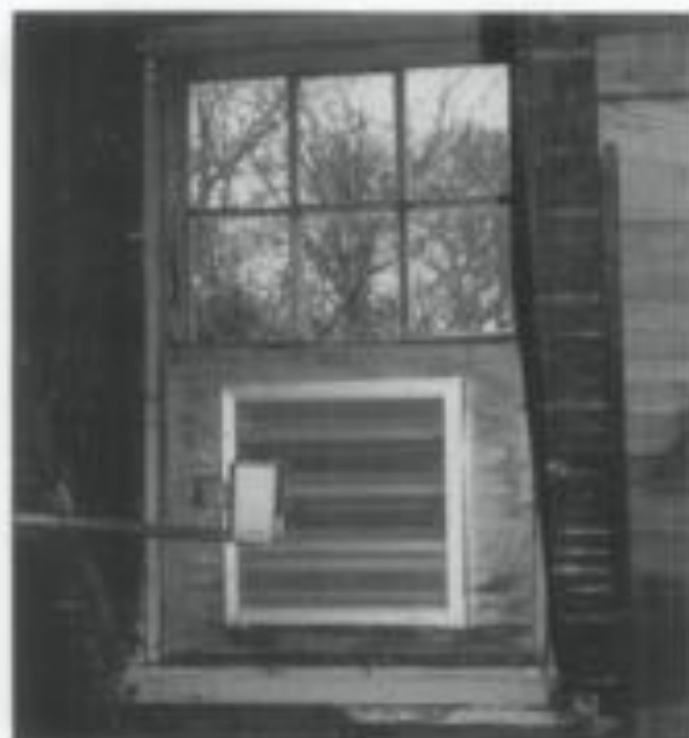
Figure 21. This electric thermostat/humidistat mounted in the attic zone controls a modified ducted air/fan system. The unit uses temporary expandable metal ducts to pull air through the building and exhaust it out of the basement. For over ten years this fan system in combination with 18" x 28" professional louvers in selective windows has kept the interior dry and with good air exchange.

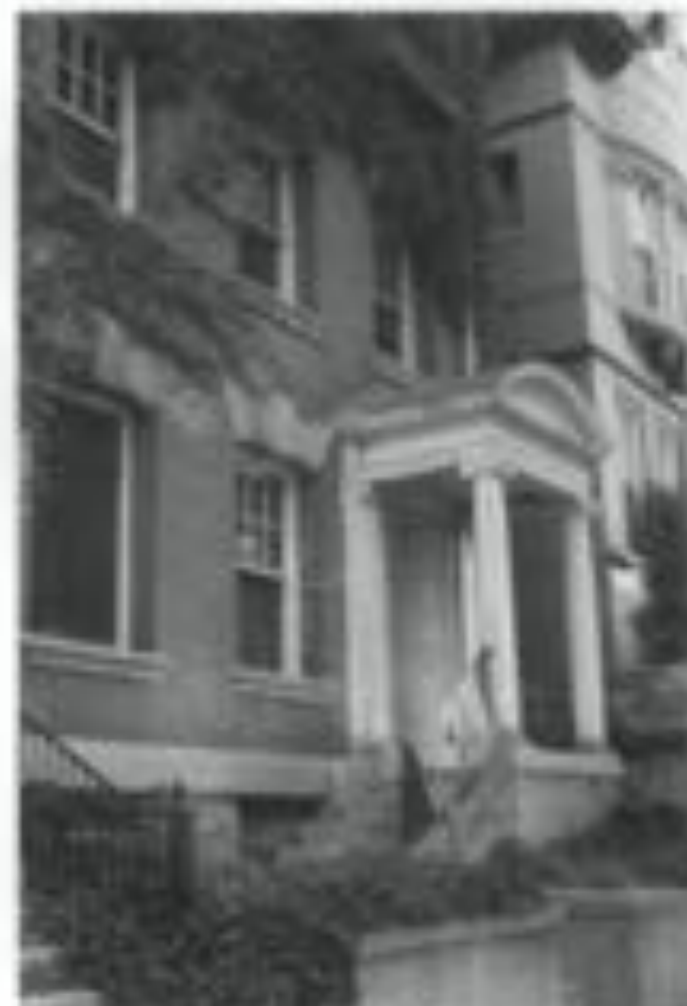
Figure 20. All systems except temporary electric have been shut off as the maintenance effort has been restricted over 20 years. The electrical meter and 100 amp panel has been been set as a physical guard at the front of the building. It is used for interior lighting and vacuum down systems. The building, however, is showing signs of moisture problems with glass several stories up. The masonry indicating the need for gutter maintenance and additional surveillance for the interior. The negligence of the walls, although permanent, large structure and is damaging to the masonry. Photo by Wood Joint, 2014.

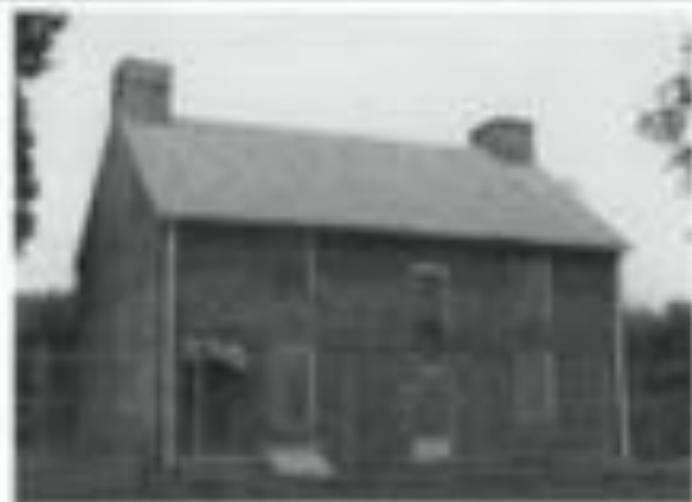
a. A view showing the exterior of the home in its mothballed condition.

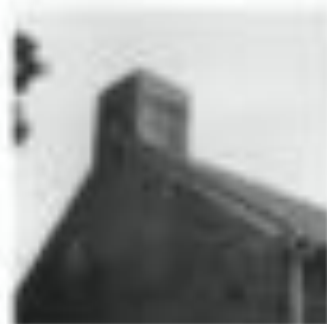
b. Perforated metal grill installed for drainage, from the gate area.

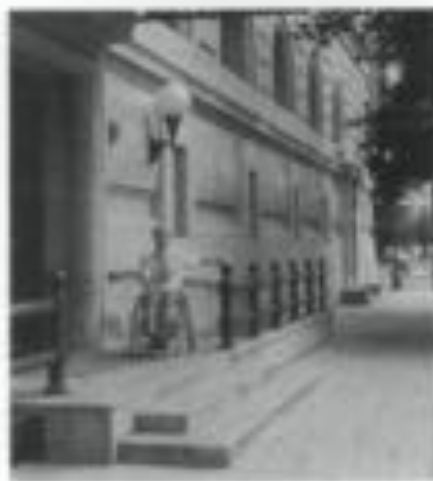
copies of the nomination file and are also resources for additional information and assistance. Review of the written documentation should always be supplemented with a physical investigation to identify which character-defining features and spaces must be protected whenever any changes are anticipated. If the level of documentation for a property's significance is limited, it may be necessary to have a preservation professional identify specific historic features, materials, and spaces that should be protected.

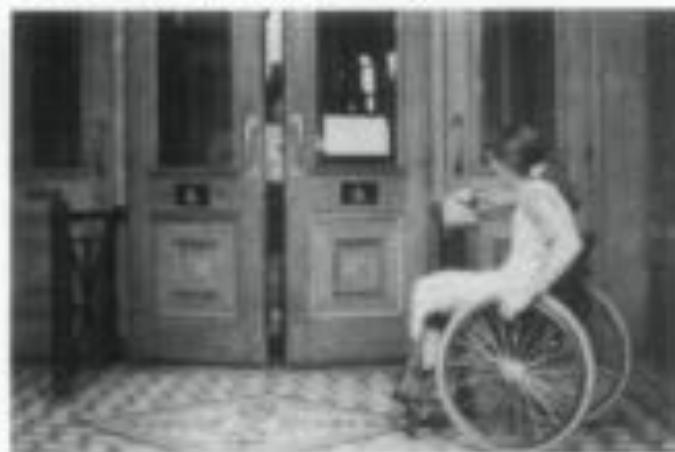
Figure 5. A universal access symbol clearly marks the Arts and Industries Building in Washington, D.C., and a push plate (right) engages the automatic door opener. Photo: Thomas Jester.

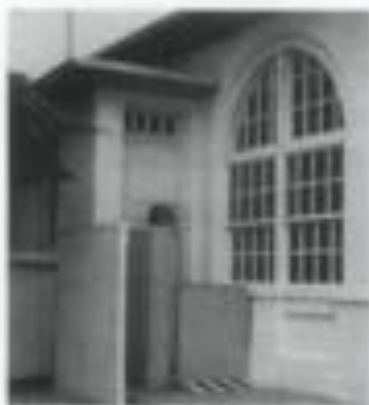
Figure 13. Platform lifts like the one used on this building require minimal space and can be removed without damaging historic materials. Shielded with lattice work, this lift is also protected by the roof eaves. Approach path should be stable, firm, and slip resistant. Photo: Sharon Park.

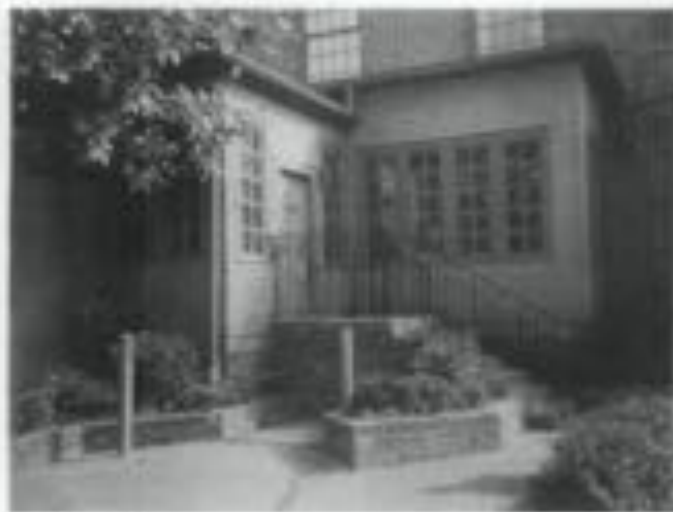
Figure 14. At the Lieutenant Governor's Mansion in Frankfort, Kentucky, a retracting lift (R) was installed to minimize the visual effect on this historic building when not in use (L). Photo: Aging Technology Incorporated.

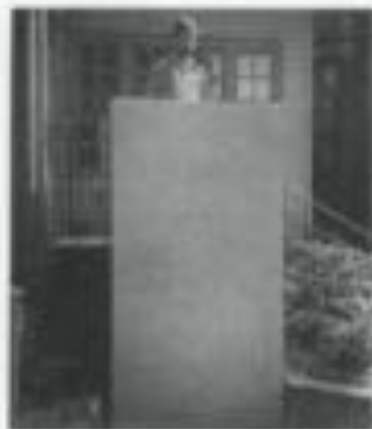
Figure 15. A new entrance to the elevator lobby replaces a window at Federal Hall in Boston, Massachusetts. The new entrance is appropriately differentiated from the historic design. Photo: Paul Hoffa.

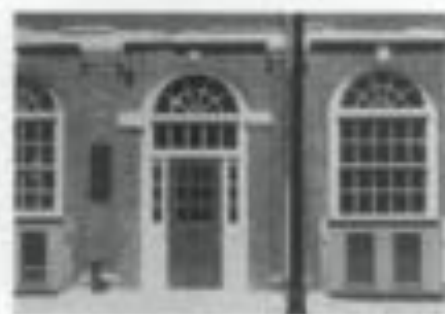
(operated by push buttons, mats, or electronic eyes) and power-assisted door operators can eliminate or reduce door pressures that are accessibility barriers, and make single or double-leaf doors fully operational (See Figure 16).

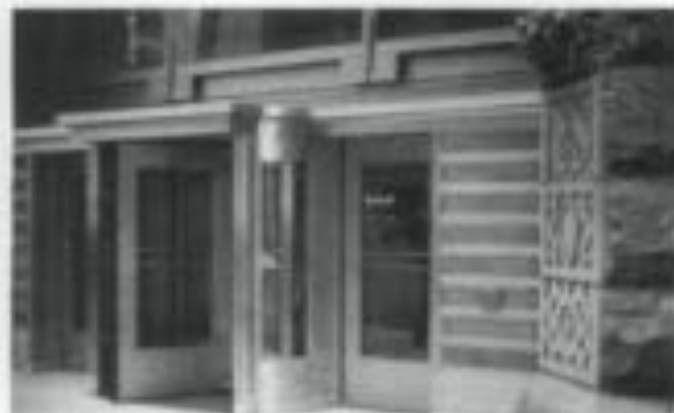
Figure 16. During the rehabilitation of the bakery in Chicago, the original entrance was modified to create an accessible entrance. Two existing doors were replaced with a new one flanked by new doors, one of which is operated with a push-plate door opener. Photo: Thomas Jester.

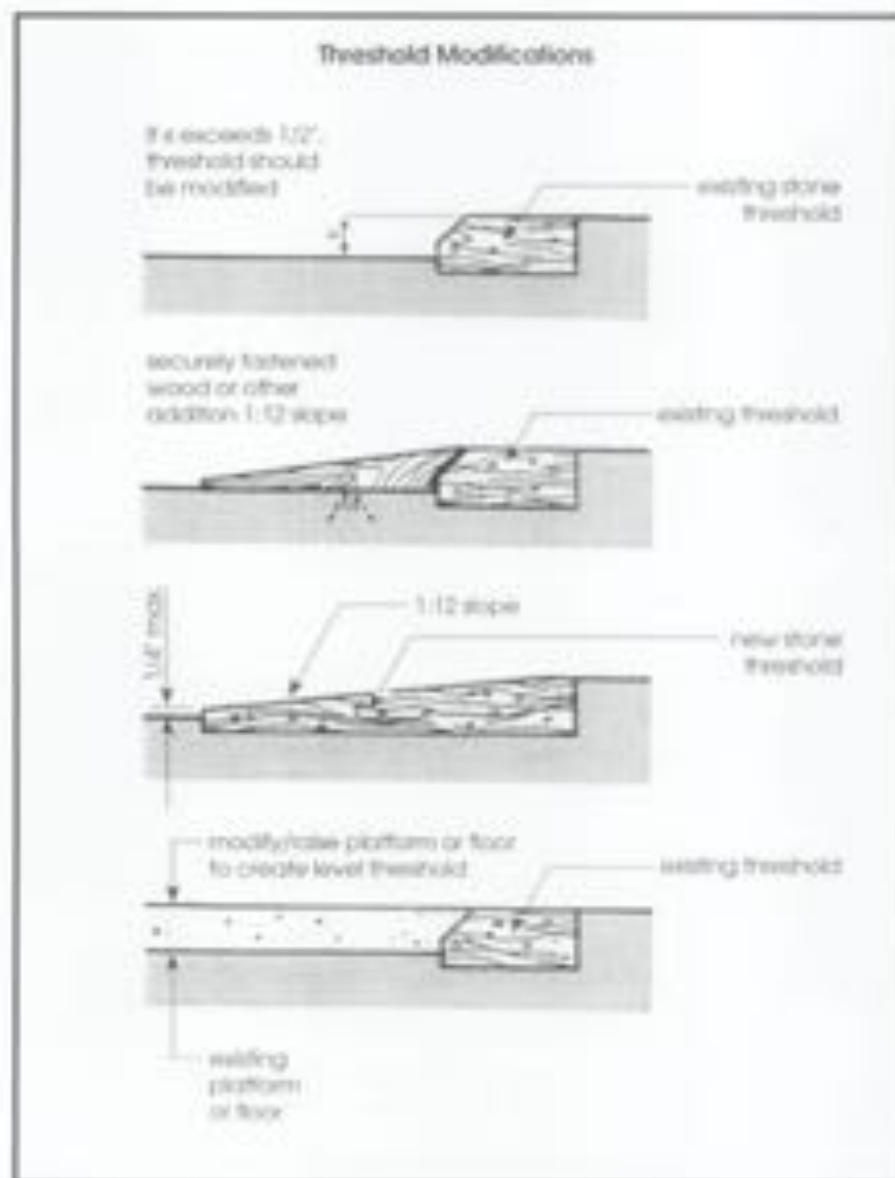
Figure 17. Thresholds that exceed allowable heights can be modified several ways to increase accessibility. Source: *Uniform Federal Accessibility Standard (UFAS) Retrofit Manual*.

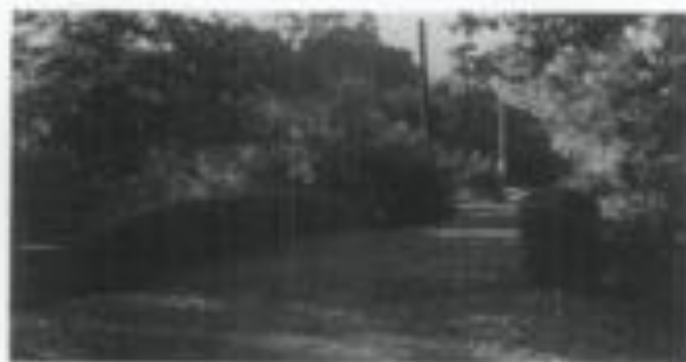
(a.) To improve accessibility in Boston's Emerald Necklace Park, standard asphalt paving was replaced in selected areas with an imbedded aggregate surface that is more in keeping with the landscape's historic appearance. Photo: Charles Birdman.

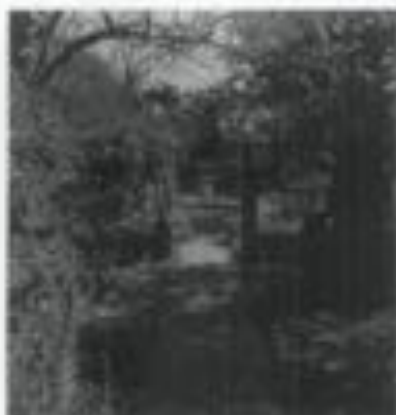
(b.) The Friendly Garden at Rancho Las Alamos, a historic estate with designed gardens in southern California, was made accessible with limited widening of its existing approach path. Photo: Rancho Las Alamos Foundation.

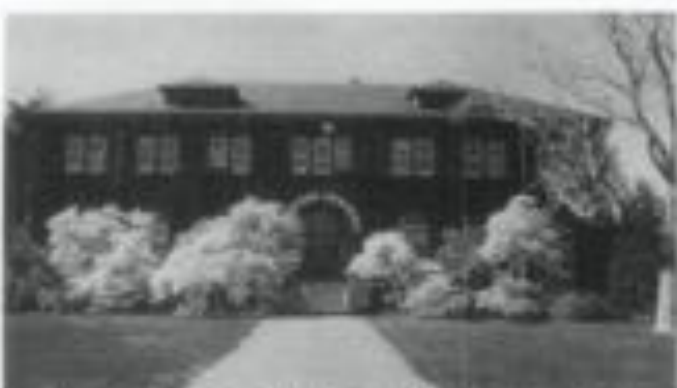
(c.) Harnswell Visitor's Center before rehabilitation, revealing the altered landscape. Photo: Jennifer Jones, Carol R. Johnson and associates.

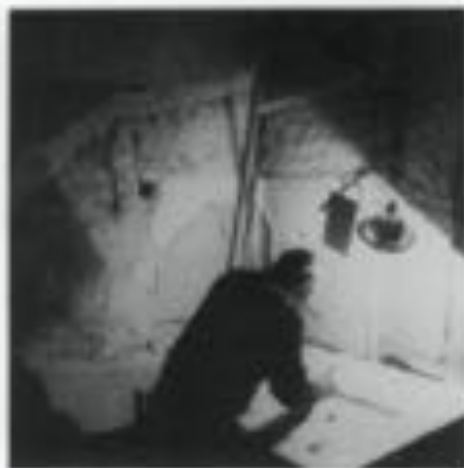
If you have ever felt a sense of excitement and mystery going inside an old building—whether occupied or vacant—it is probably because its materials and features resonate with the spirit of past people and events. Yet excitement about the unknown is heightened when a historic structure is examined architecturally, and its evolution over time emerges with increasing clarity to reveal the lives of its occupants. Architectural investigation is the critical first step in planning an appropriate treatment—understanding how a building has changed over time and assessing levels of deterioration.

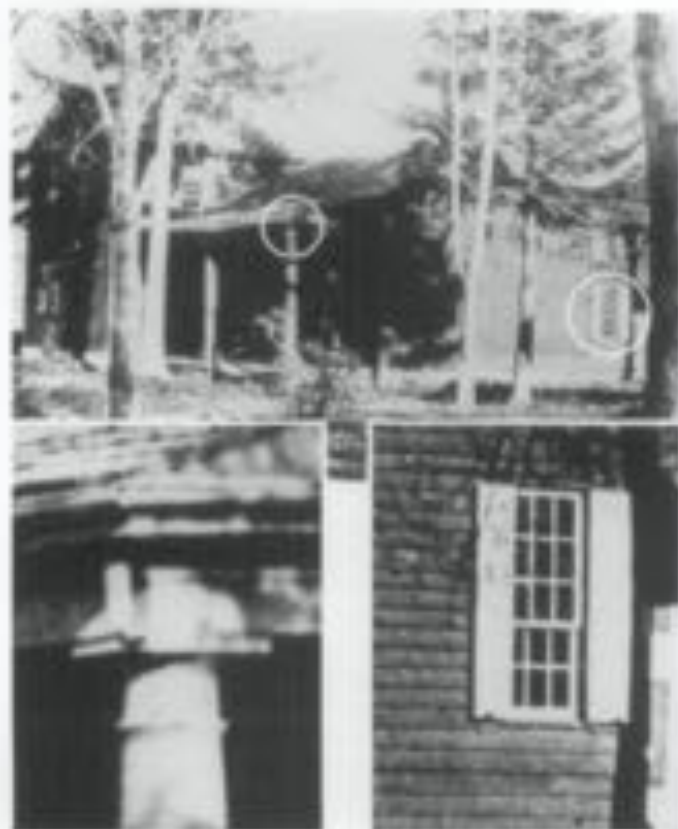
Figure 2. Early photographs discovered during historical research can be enhanced through photo-micrography to accurately recreate missing elements and details during restoration. The enlargements helped clarify questions about the porch column detail and the type of similar hardware photo: E. C. Stanton House, courtesy Seneca Falls Historical Society, New York; inset: NPS North Atlantic Cultural Resource Center, Building Conservation Branch.

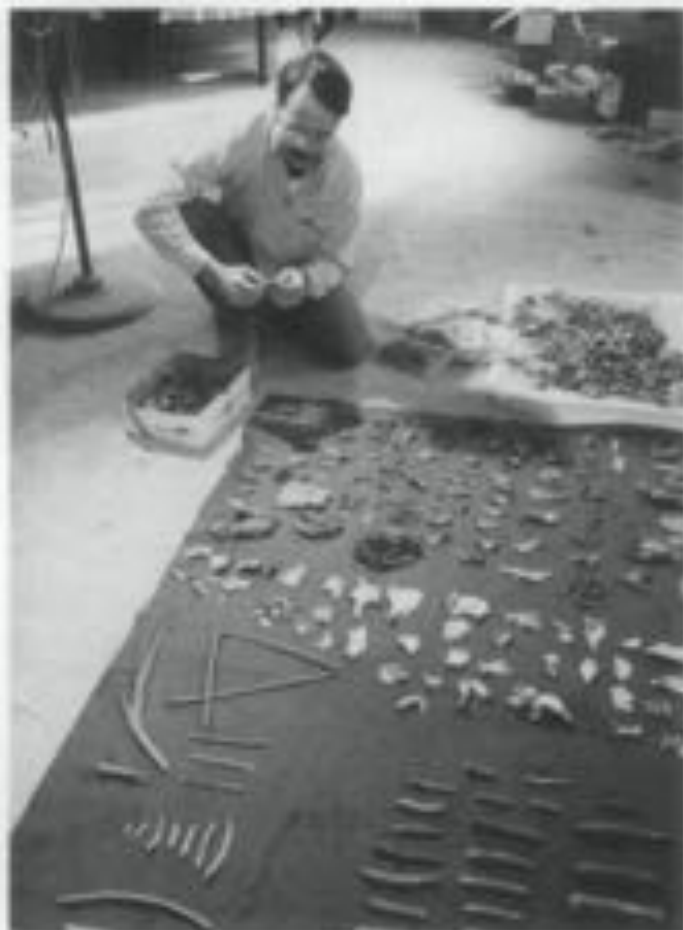
Figure 4. An inventory of animal nests found within hidden spaces of a structure may yield unexpected evidence, such as information about food, decorative arts, and cultural or social traditions of every day life. Typical items of paper, fabric and wood are important artifacts which are generally not found during archeology digs in the ground. photo: Tom Gannon, Jr., courtesy Jefferson's Poplar Forest.

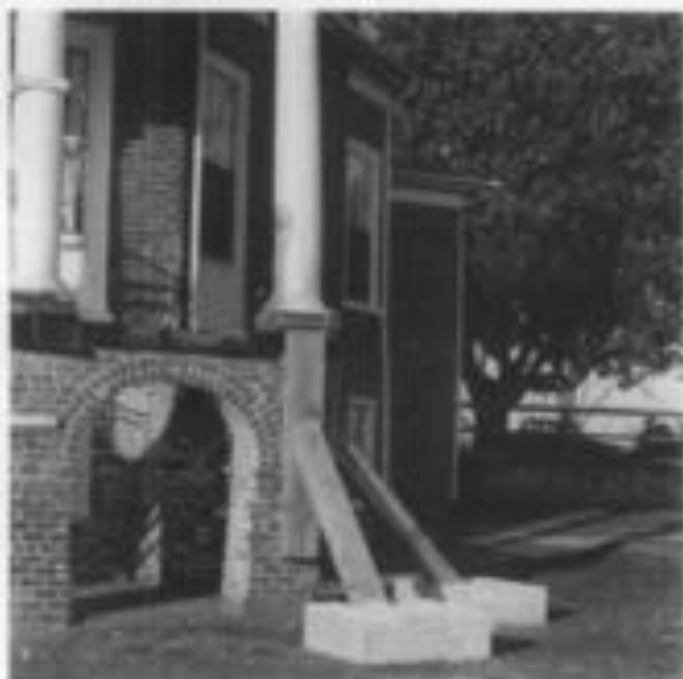
Figure 5. Investigation frequently identifies urgent needs of stabilization. Priority must be given to issues of safety and structural integrity. Supplemental support, such as temporary shoring, may be required to prevent collapse and should be reviewed by a structural engineer.

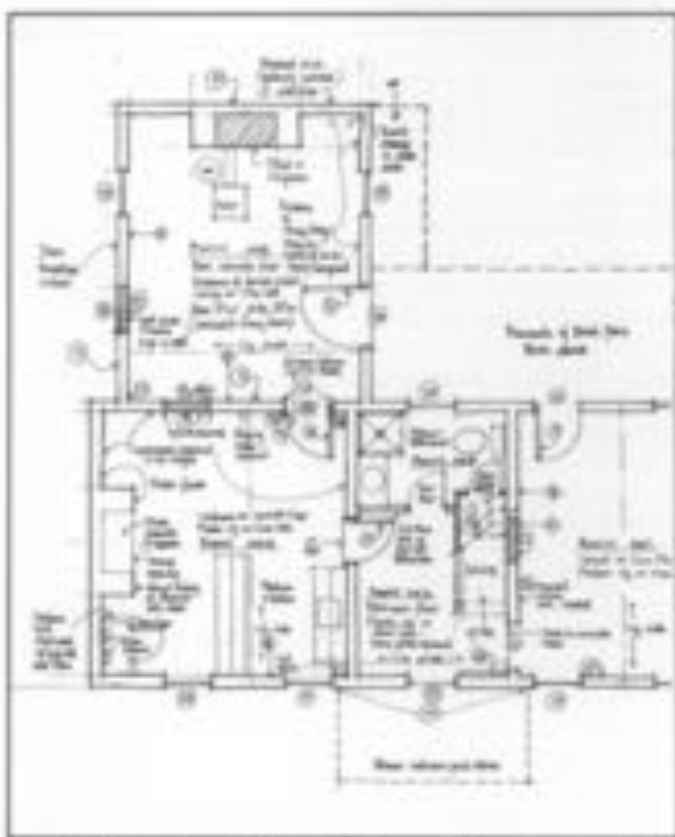
Figure 8. During the initial visit, the architectural investigator may be able to resolve many questions about the building's condition and chronology while recording their observations through field notes and annotated sketches. Drawing by Marianne Graham, courtesy Jefferson's Poplar Forest Restoration Field School.

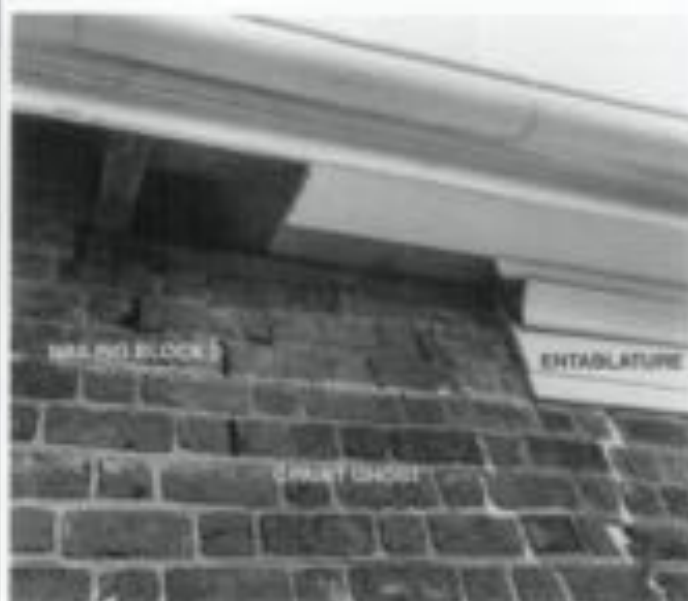
Figure A. Careful examination of the masonry reveals different periods of construction and repair through the composition and detailing of bricks and mortar. Depending upon location, open vertical joints may indicate the location of walling blocks for decorative trim or weeps for drainage. These open joints at the building's cornice show evidence of an earlier window rehabilitation extending down two courses below the present trim. The paint ghosts below the lowest bricks confirm the entablature's existence and provides clues to its size and finish.

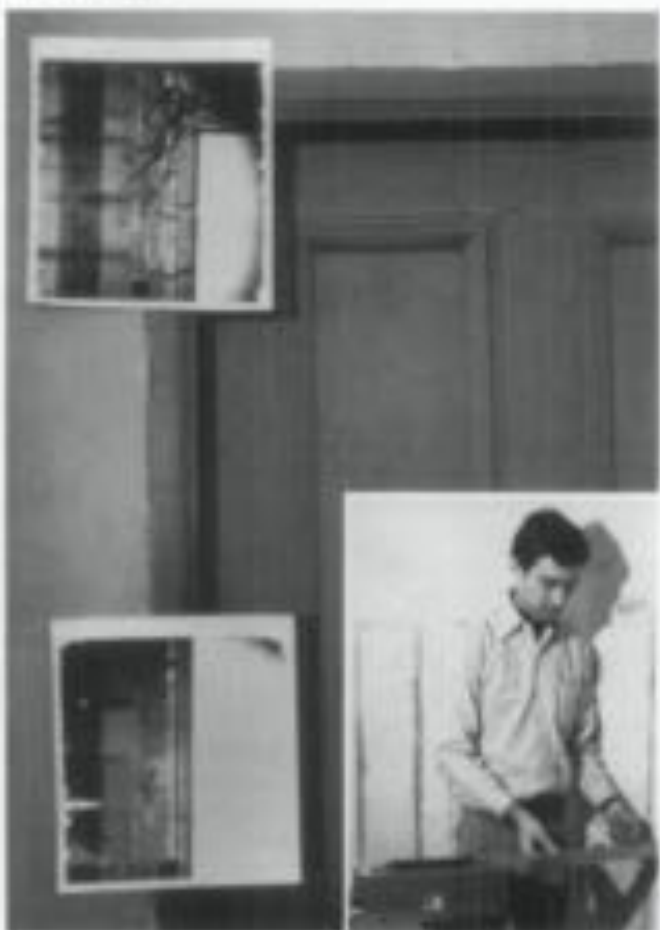
Figure B. Without damaging or altering historic fabric, X-ray images of wood connections provide internal clues of construction materials and techniques. These x-ray images show walls being used to form the connections of a door opening in a wood stud wall covered with plaster and cut woodie lath. A single technician can operate the portable equipment and develop the film on site for immediate analysis. photos: NPS North Atlantic Cultural Resource Center, Building Conservation Branch.

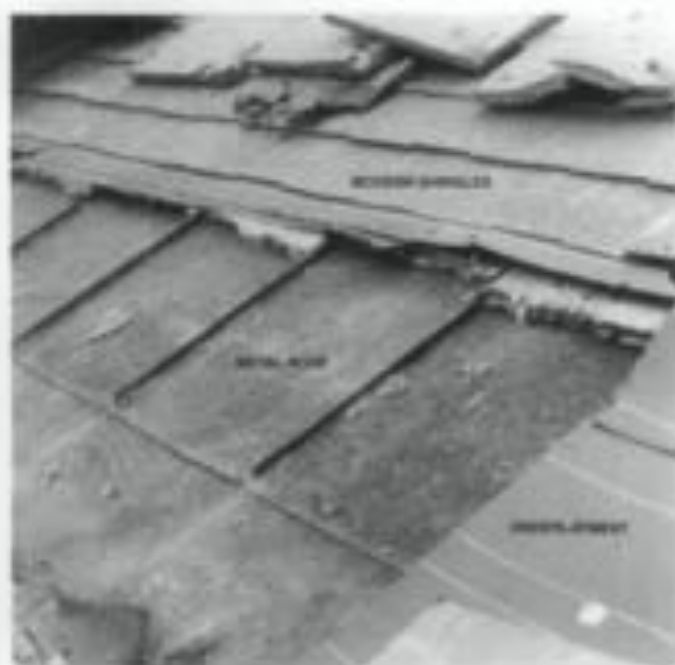
Figure C. In many cases, new materials or coverings are placed directly over existing exterior features, preserving the original materials underneath. Here, the removal of a modern shingle roof and its underlayment revealed an historic standing seam metal roof. photo courtesy, Phillips and Opperman, P.A.

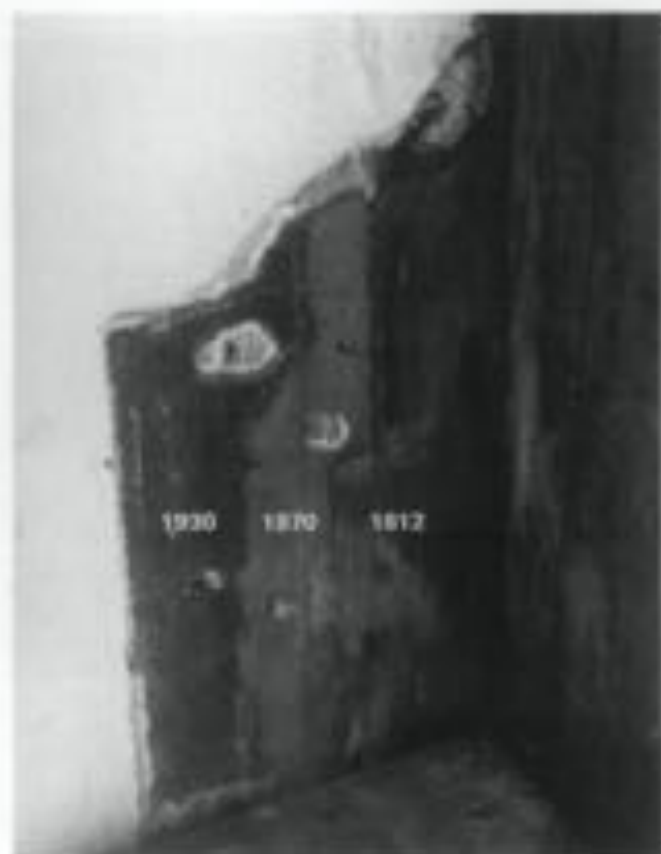
Figure D. Building styles change over time as moldings and trim are added and removed. The ghosts of the previous woodwork are often left behind and preserved under the new trim. This photograph shows distinct profiles of architectural trim from three successive periods. photo courtesy, Valentine Museum, Richmond, Virginia.

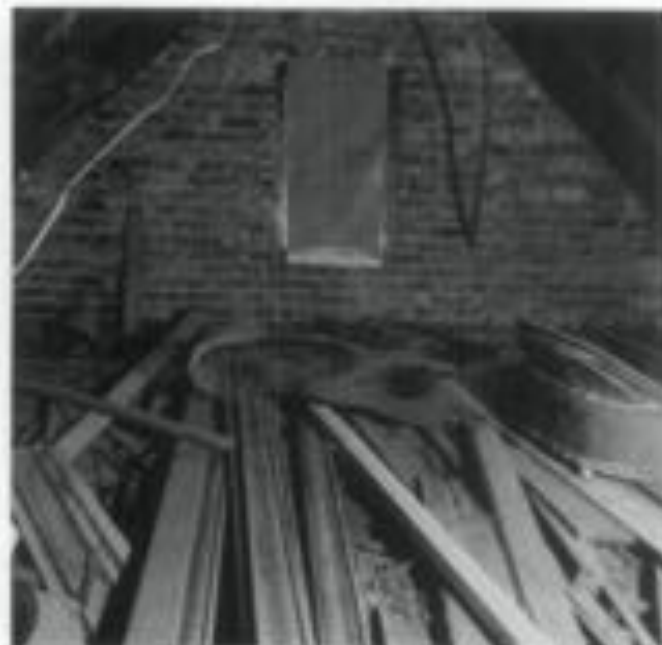
Figure E. Discarded items are routinely stored within attics, then forgotten, only to be discovered during a later investigation. Seemingly worthless clutter and debris may help answer many questions. A thorough inventory should be performed before evaluating any object's usefulness.

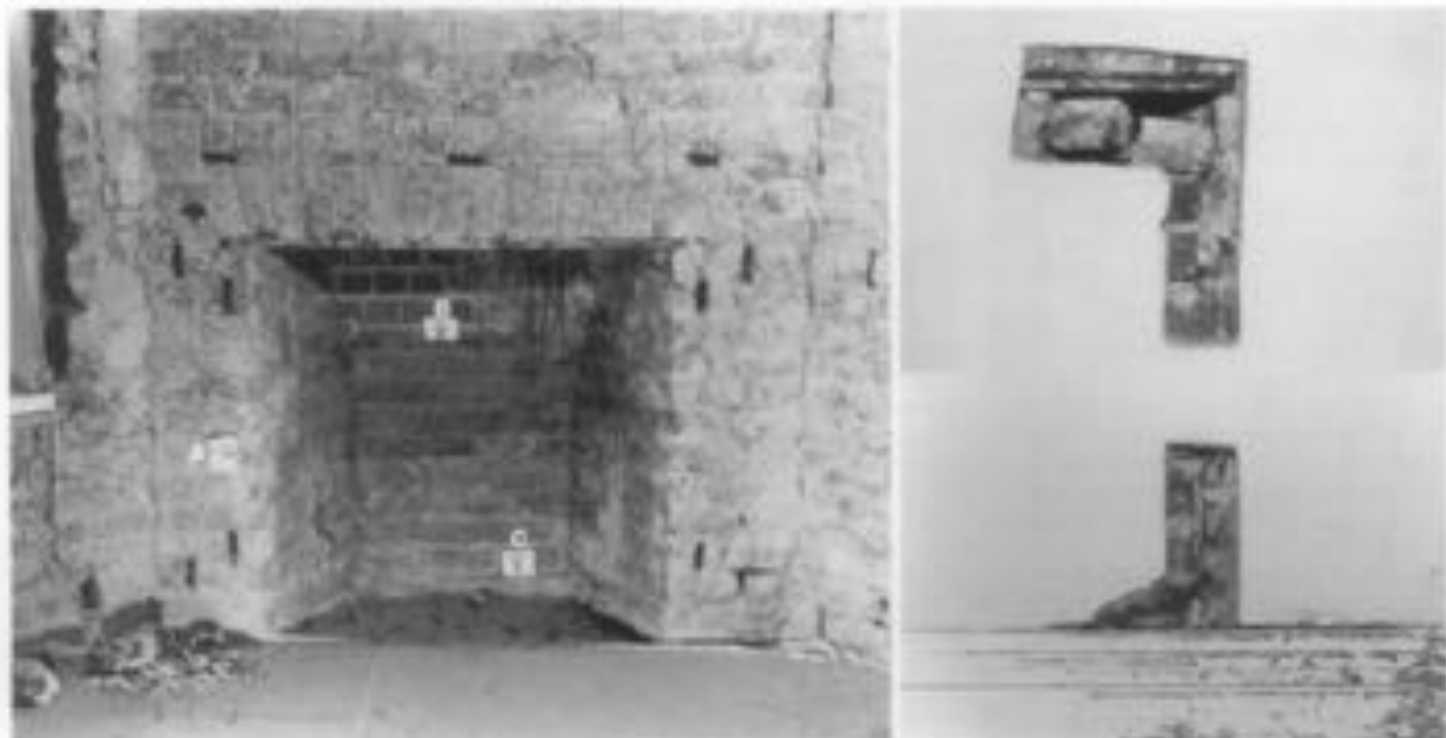
Figure 11. The physical evidence of cracks and patches seen during surface mapping suggested an abandoned fireplace. Right: Exploratory testing was used to verify its location. Left: Mosaic restoration required more detailed probing to discover the original detailing. Plaster and brick were carefully documented and removed to determine the fireplace's type, size, and decoration. The rectangular slots held wooden nailing blocks supporting the mantel and surround. A indicates the inside edge of the mantel; B points to the ghost from an iron fireback and C shows the original floor level of the hearth.

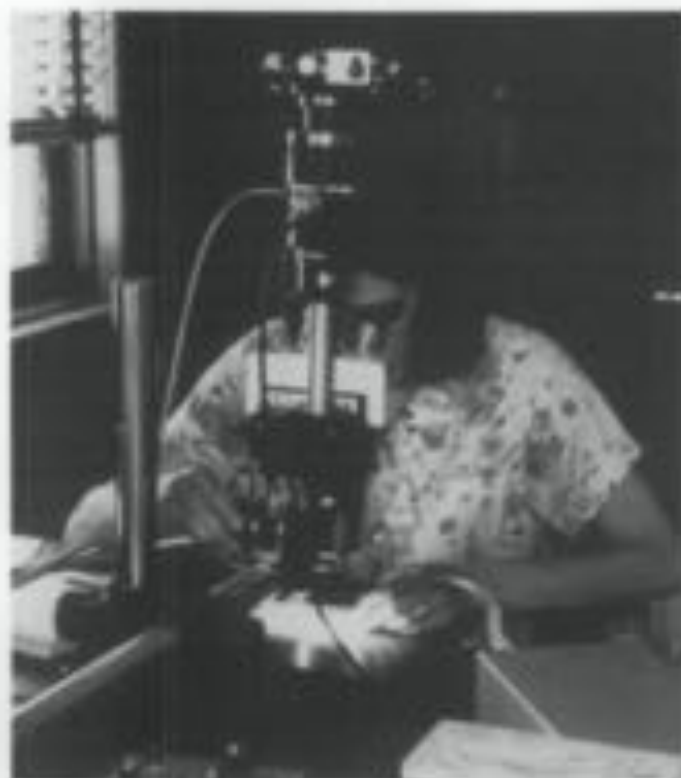
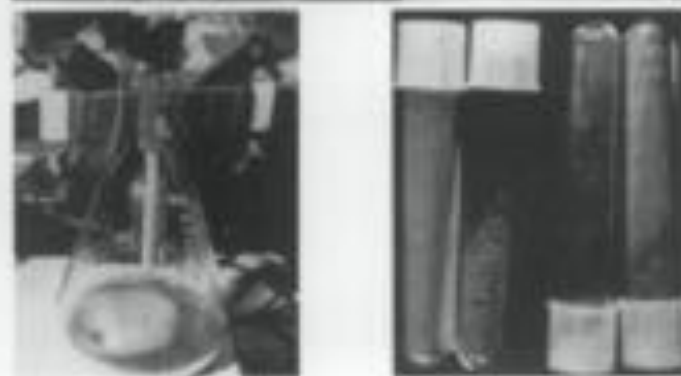
Figure 12. During a thorough investigation, the mortar sample is viewed under a microscope using various lighting to find the presence of coatings or additives. It is then ground and washed in an acid bath to separate and free the sand and fines. After further cleaning, these fines are stored and used for comparison in matching or dating repairs and alterations. photo: NPS North Atlantic Cultural Resource Center, Building Conservation Branch.

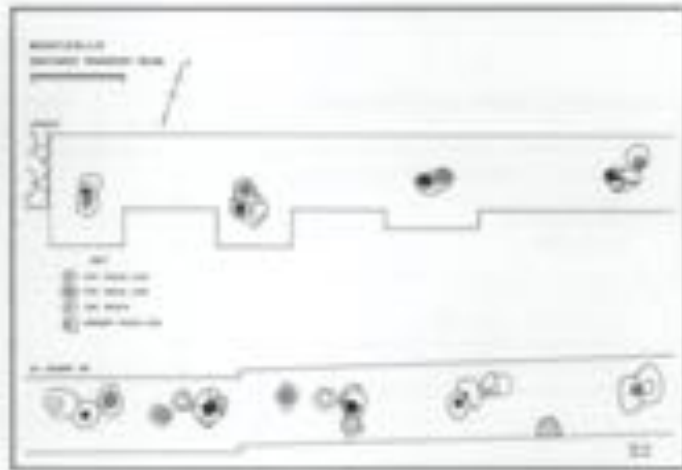
Figure 11: Landscape archeology is an important research tool that can provide location, dating and detail verification for landscape features. At Monticello, the estate of Thomas Jefferson in Charlottesville, Virginia, archeological research has employed both excavational and non-invasive methods. This has included aerial photography, soil resistivity, transect and stratified sampling and photogrammetric recording. As illustrated in the plan above, fence post spacing and alignment can be confirmed with a transect trenching technique.⁷ (courtesy Thomas Jefferson Memorial Foundation)

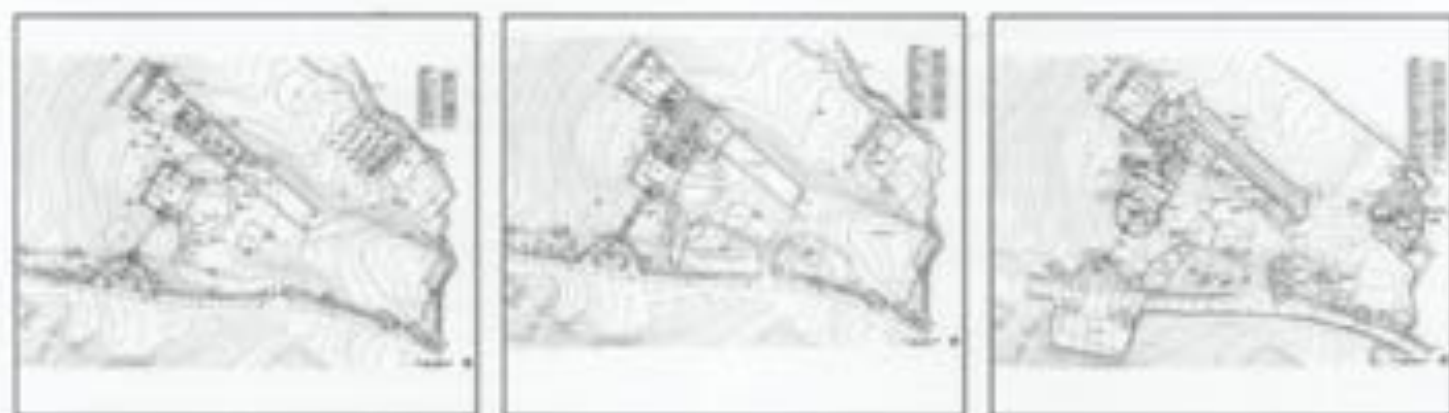
Figure 13: Period plans show the evolution of Aspel, the home of Augustus St. Gaudens, Cornish, New Hampshire. Plans were developed at two scales: first for the entire estate's development, and second for the core area around the house, studio and gardens. For both, plans were generated for five time periods: 1885-1903, 1903-1907, 1907-1926, 1926-1965 and 1965-1992. Illustrated above are the 1885-1903, 1907-1926, and the 1926-1965 plans for the core area. (courtesy National Park Service, North Atlantic Region and Presidy Associates)

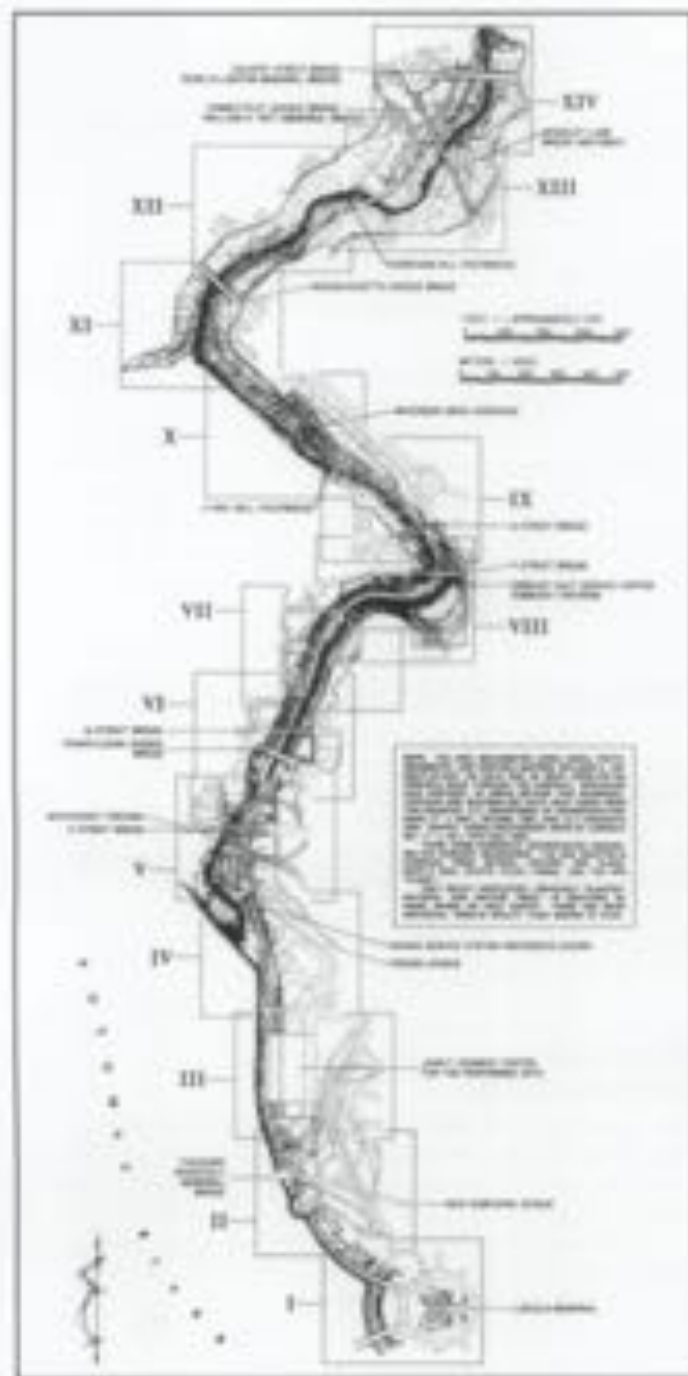
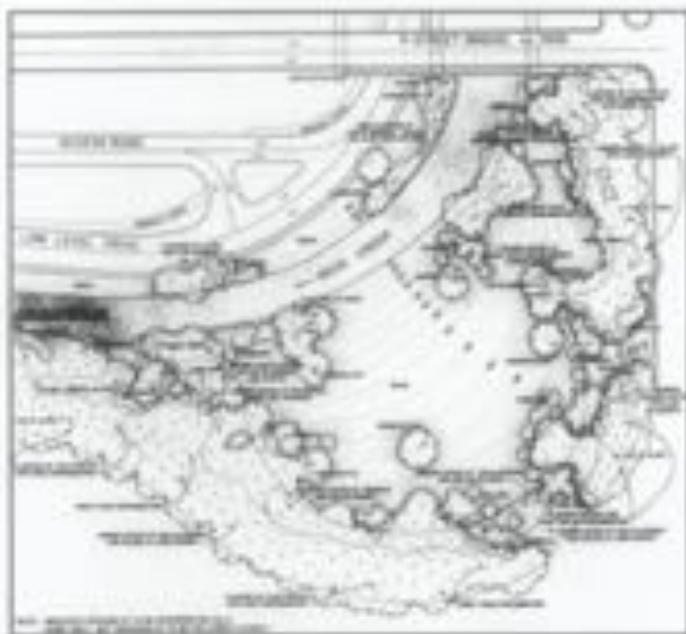
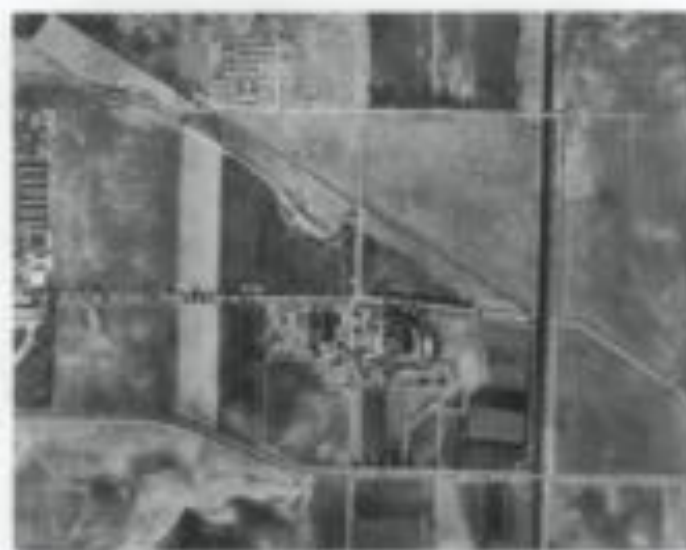
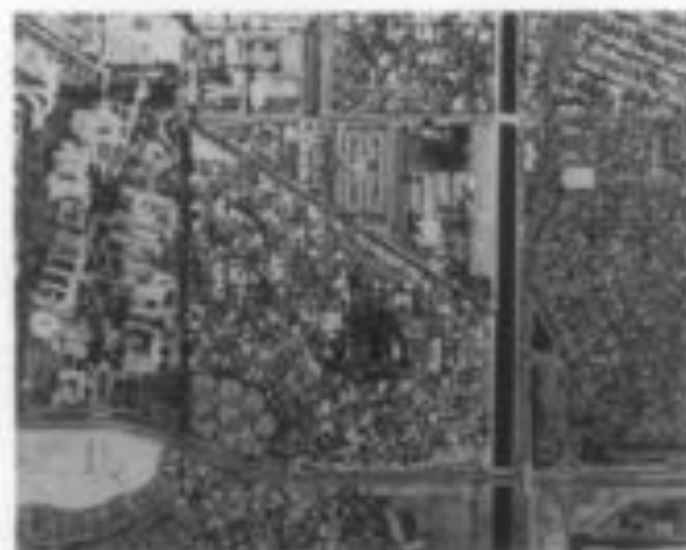
Figures 14 and 15: Existing conditions plans for large curvilinear landscapes can employ a variety of documentation methodologies. For the 2-1/2 mile Rock Creek and Potomac Parkway, Washington, D.C., the Historic American Buildings Survey (HABS) used aerial photogrammetric photographs as the basis for digitized mapping and delineated drawings. Overall documentation was done at a scale of 1" = 40' with a 100' buffer side geographic context. Contours were drawn at 2' intervals, tree canopy with trunk placement for specimen species, bridges take draws in detail, roads, and the creek itself. In all, there are 36 drawings measuring 34" x 44" for the project. These two sample drawings include the index to plans (above) and an area of existing conditions documentation (opposite top). (courtesy Historic American Buildings Survey)

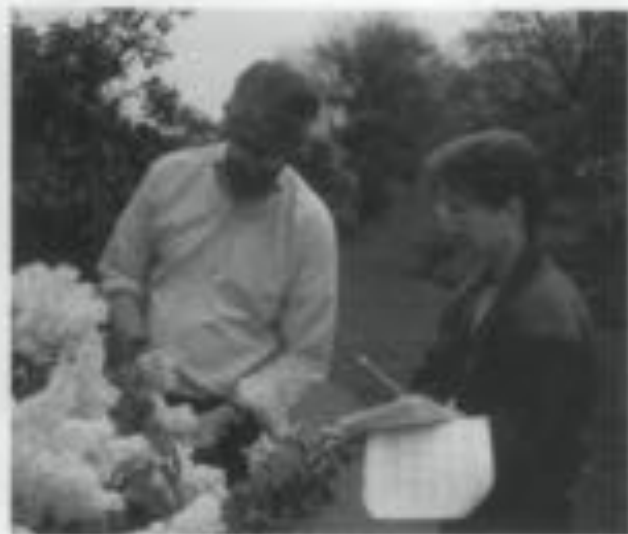
1. The Arnold Arboretum's preservation technician, lilac specialist, and horticulturalist compare lilacs from the Vanderbilt Mansion National Historic Site in Hyde Park, New York with lilac specimens in the Arboretum's living collection. (courtesy Olmsted Center)

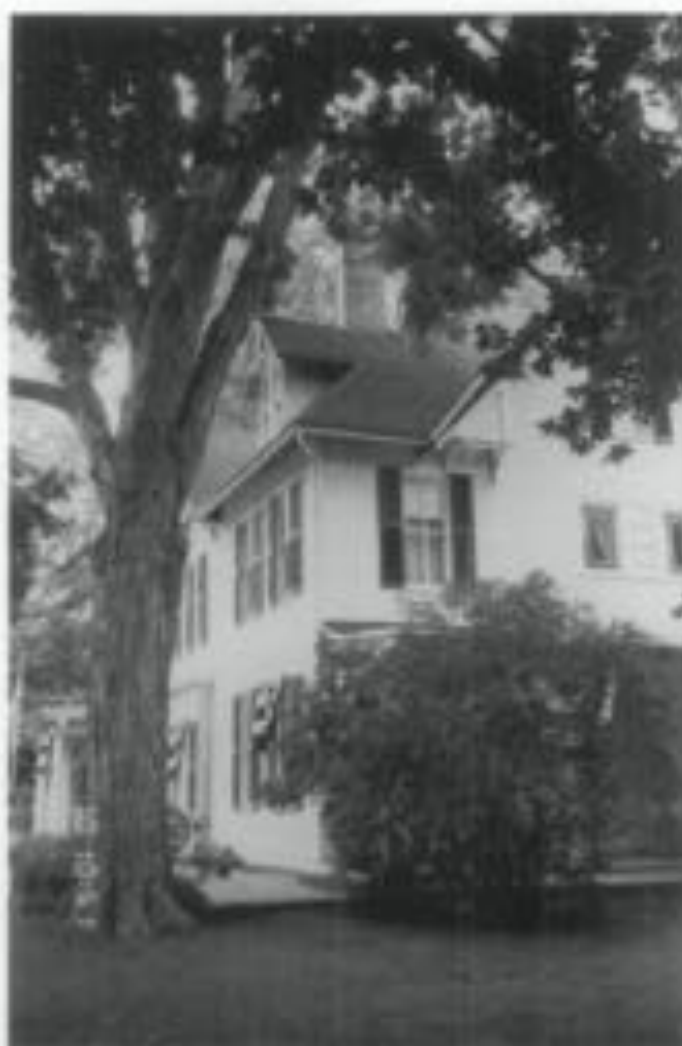
Figure 21: At Laurel Hill, the home of President James A. Garfield near Cleveland, Ohio, the Sugar Maple that shaded the porch during Garfield's 1880 "Front Porch Campaign" is in decline. Cuttings were taken from the historically significant tree by the Holden Arboretum and the National Park Service for eventual in-kind replacement. (courtesy NPS, Midwest Region)

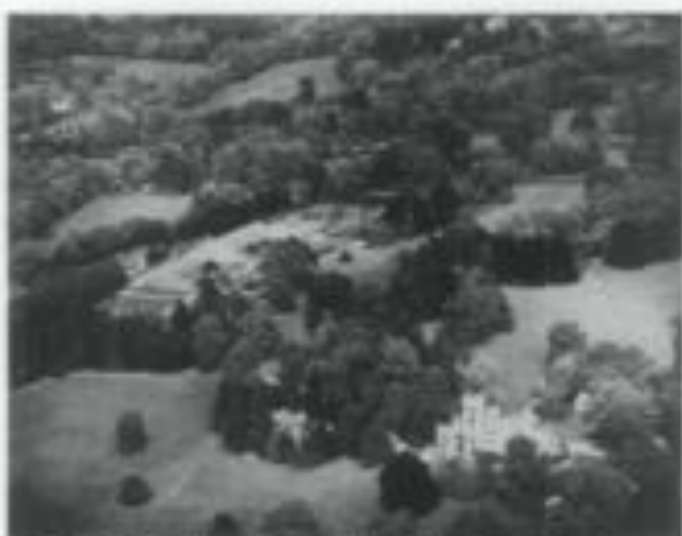
Figure 22: The landscape of Lyndhurst, Tarrytown, New York is significant in American culture and meets Criterion C of the National Register because it embodies the distinctive character of a type and period in American landscape architecture, known as early Picturesque; it possesses high artistic value; and it is the work of a recognized master gardener, Ferdinand Mangold. (courtesy National Trust for Historic Preservation)

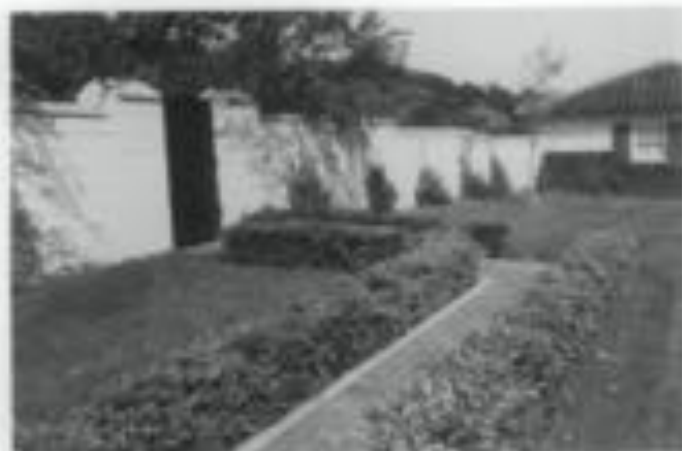
Figure 24. On some occasions, especially larger landscapes, it is possible to have a primary treatment, with discrete, or secondary areas of another treatment. This is most common for an individual feature in a larger landscape. At the Eugene and Carlotta O'Neill Historic Site, Davisville, California the primary treatment selected for the courtyard was restoration. When accommodating universal accessibility requirements, the introduction of a grass paver walk was installed which warranted the removal of a few historic shrubs. This discrete project would be considered a rehabilitation treatment. (courtesy Patricia M. O'Donnell)

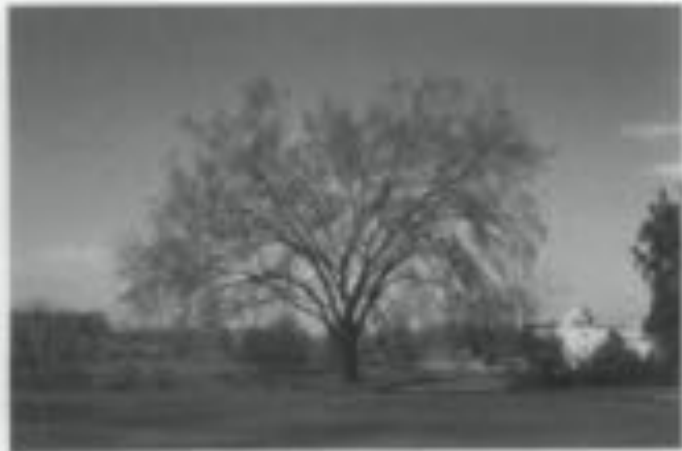
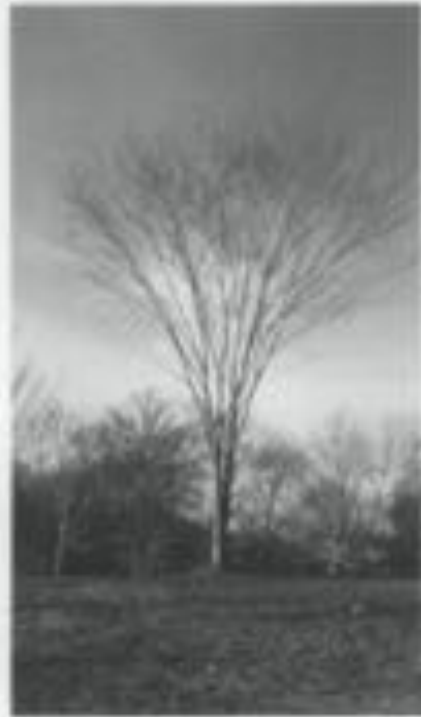
Figures 25 and 26. When the American Elm (*Ulmus americana*) was plagued with Dutch Elm Disease many historic properties relied on the Japanese Zelkova (*Zelkova serrata*) as a substitute plant. As illustrated, the overall form and scale of these trees is really quite different, and would therefore not be an appropriate substitute plant material under a restoration or reconstruction treatment.

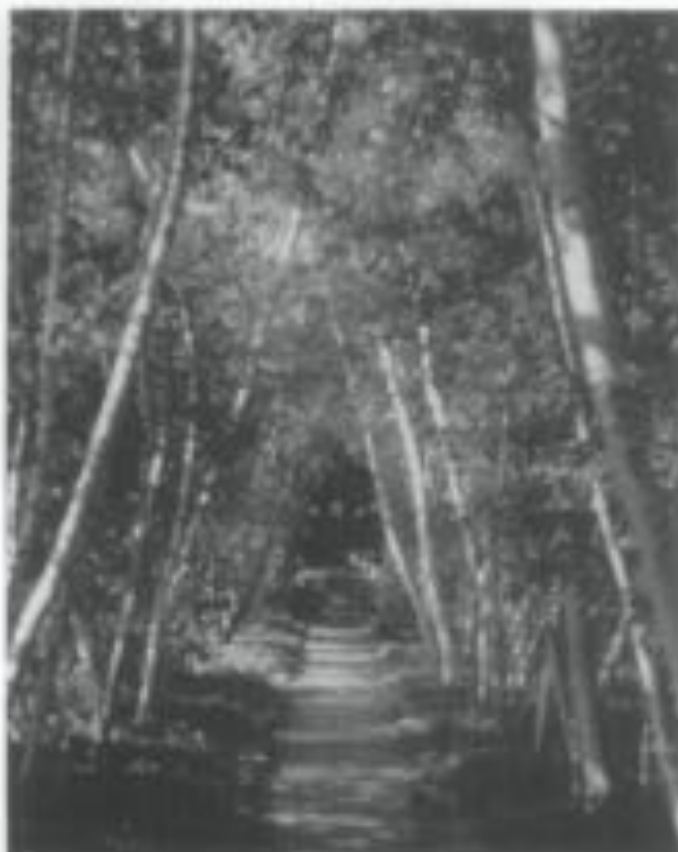
Figure 27: The historic back alley at Stan Hywet Hall, Akron, Ohio was suffering from heavy infestation and leaf miner. Dying trees were topped and basal sprout growth encouraged. Next, trees were selectively thinned, and ultimately, when the new growth matured, older trunks were removed. Original structure and genetic material were preserved. As illustrated, this preservation treatment took fifteen years to realize. (courtesy Child Associates)

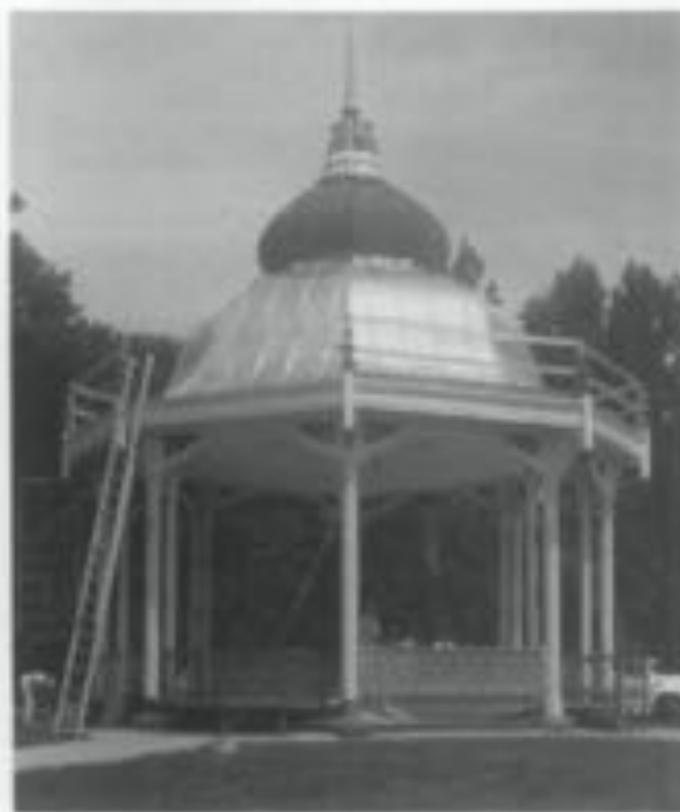
When the most important goal is to portray a landscape and its character-defining features at an exact period of time, restoration is selected as the primary treatment. Unlike preservation and rehabilitation, interpreting the landscape's continuum or evolution is not the objective. Restoration may include the removal of features from other periods and/or the construction of missing or lost features and materials from the reconstruction period. In all cases, treatment should be substantiated by the historic research findings and existing conditions documentation. Restoration and reconstruction treatment work should avoid the creation of a landscape whose features did not exist historically. For example, if features from an earlier period did not co-exist with extant features from a later period that are being retained, their restoration would not be appropriate. (Figures 32-34)

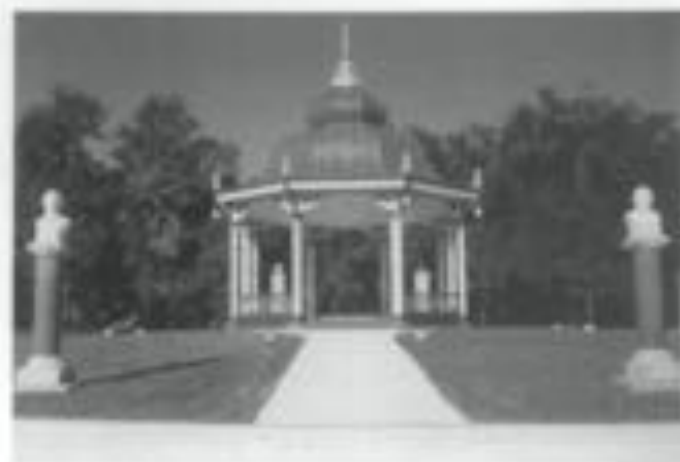
Figure 32-34: Tower Grove Park in St. Louis, Missouri, is a National Historic Landmark. The music pavilion, just north of the main drive is a circular lawn area with radiating walks, white marble busts of eminent composers, walks, and cars. The area was in general decline, especially the marble busts which were suffering from acid rain damage. Based on the excellent documentation in nineteenth-century annual reports, postcards and photographic images, this area was recently restored. Illustrated above are a simple historic view, work in progress and the completed restoration project. (courtesy Tower Grove Park)
