GEORGETOWN STEAM PLANT
HISTORIC STRUCTURE & CULTURAL LANDSCAPE REPORT

OCTOBER 9, 2013

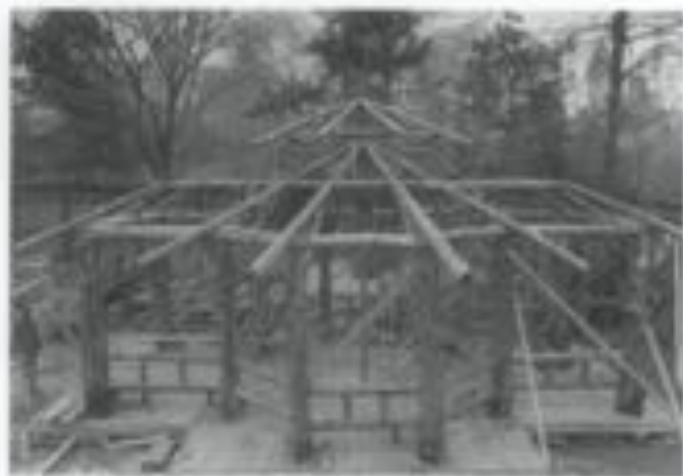
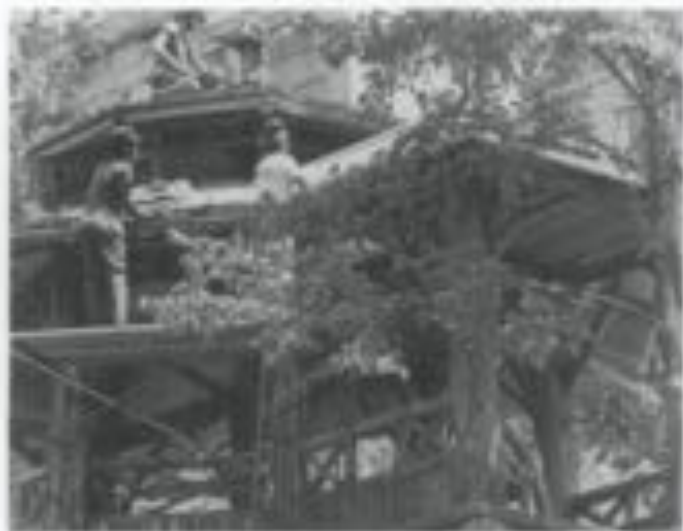
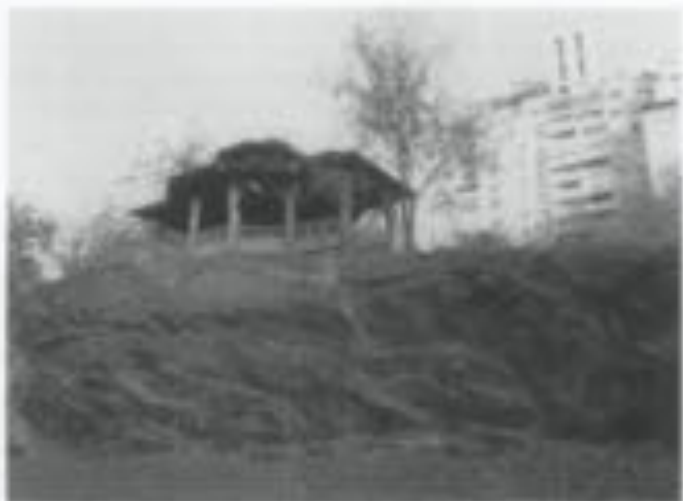
Figure 35-37: Central Park has developed an in-house historic preservation crew to undertake small projects. A specialized crew has been trained to specifically repair and rebuild rustic furnishings. As illustrated, the restoration of the Dewey rustic shelter was achieved by constructing it in the Ramble compound, moving it in place opposite 67th Street and completed. Courtesy Central Park Conservancy.

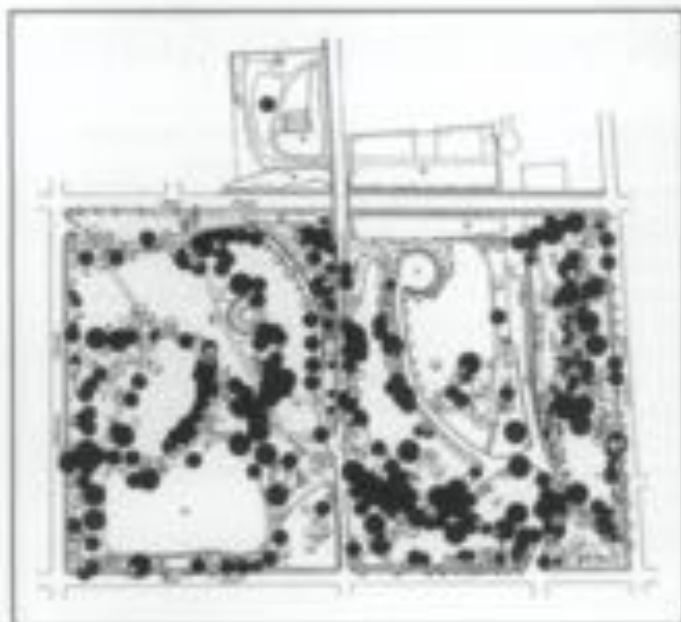
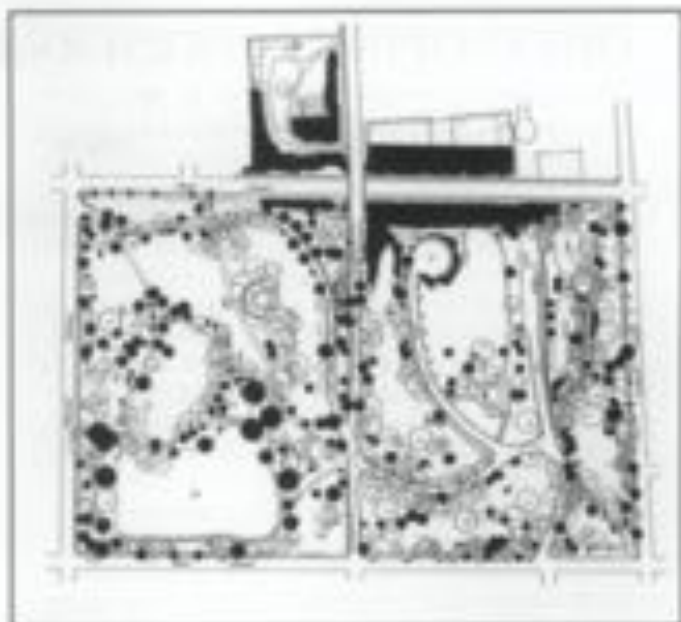
Figure 38 and 39 (above, left and right): The importance of landscape analysis and its ability to inform treatment and maintenance decisions is reflected in these two plans for Denning Park, Newburgh, New York. The plan, rendered in black, top left, illustrates all extant historic plants, while the plan, top right, depicts plantings which are non-historic or intended for removal or relocation outside of the historic park. (courtesy LANDSCAPES)

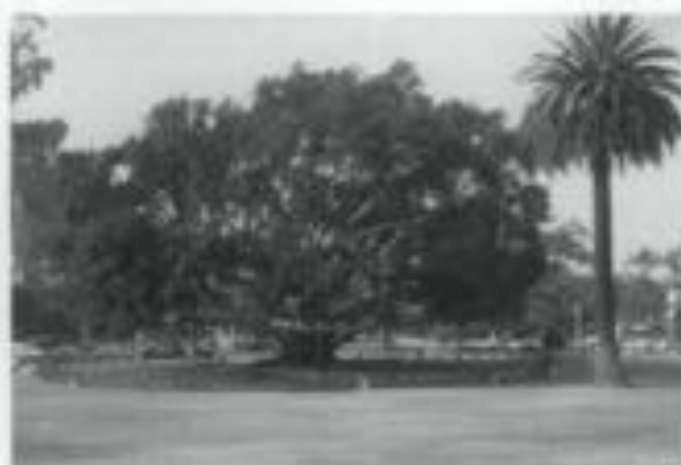
Figure 40: A management decision was made to place a fence around a sentinel tree in Balboa Park, San Diego, California. The fence protects the specimen from root damage—impact from excessive pedestrian compaction or lawn mower damage. (courtesy author)

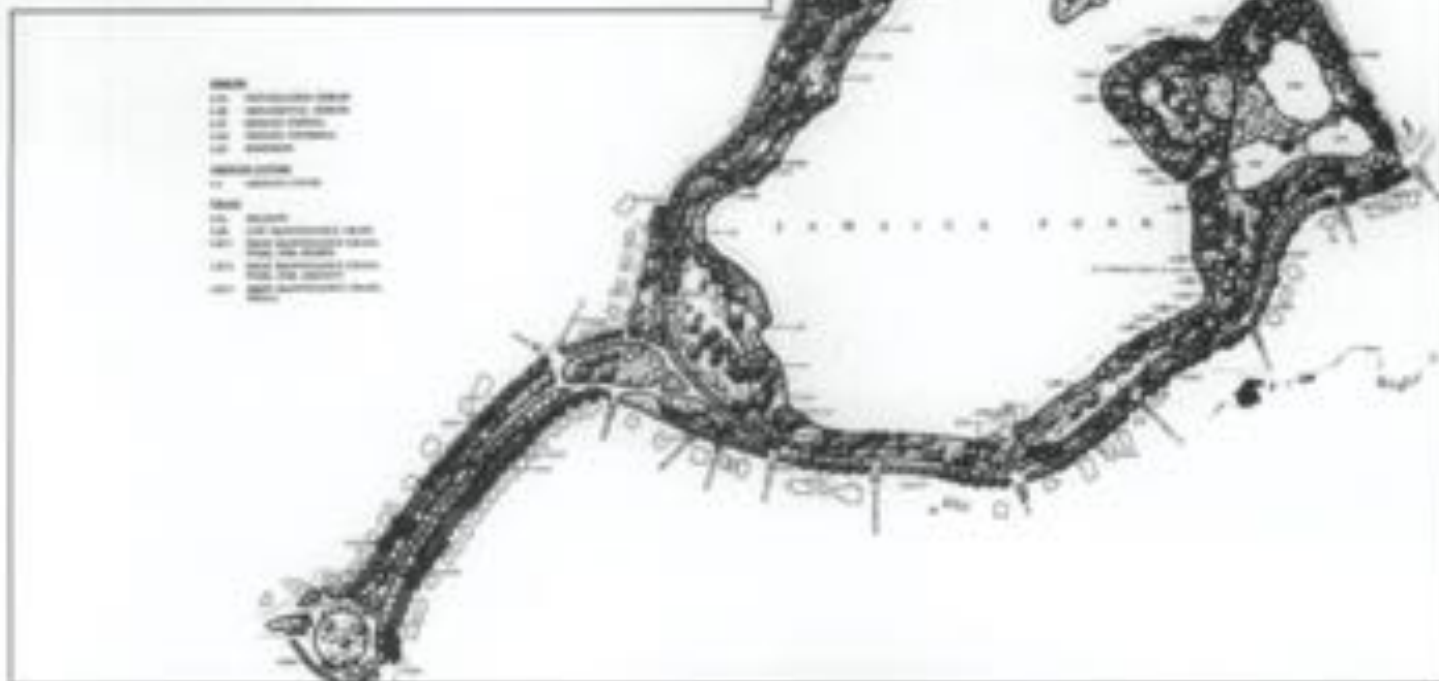
DEVELOPING A PRESERVATION MAINTENANCE GUIDE

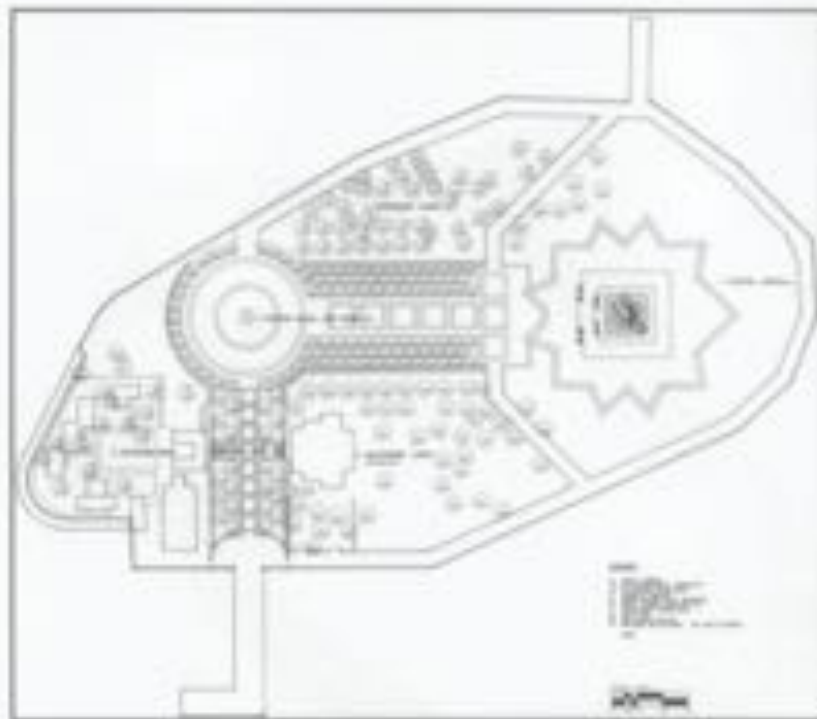
Figure A - Existing Conditions: A map of the existing trees at the Statue of Liberty National Monument is used to indicate necessary preservation maintenance work. (Drawn by Margaret Coffin, 1992)

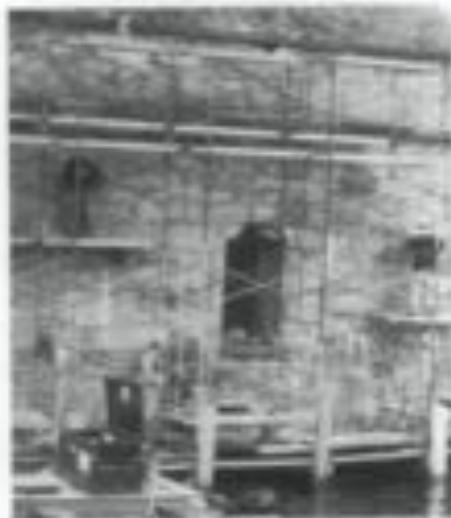
Regardless of who does the work, however, these are the principles that should guide treatment decisions:

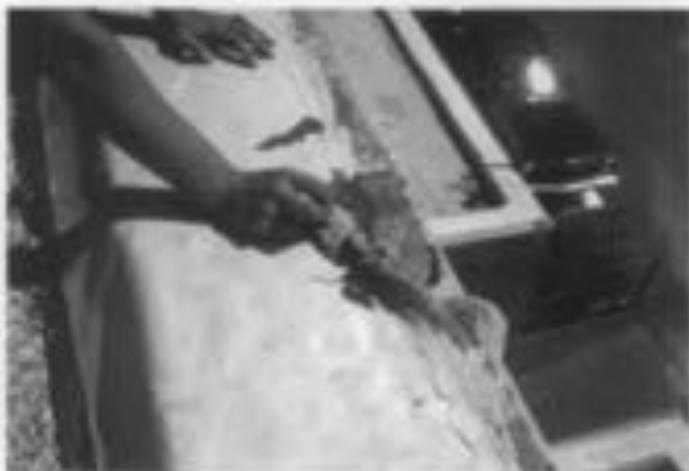
Fig. 1. Moisture problems, if not properly corrected, will increase damage to historic buildings. This waterproof coating trapped moisture from the leaking roof, causing portions of the masonry parapet to fail. Photo: NPS Film.

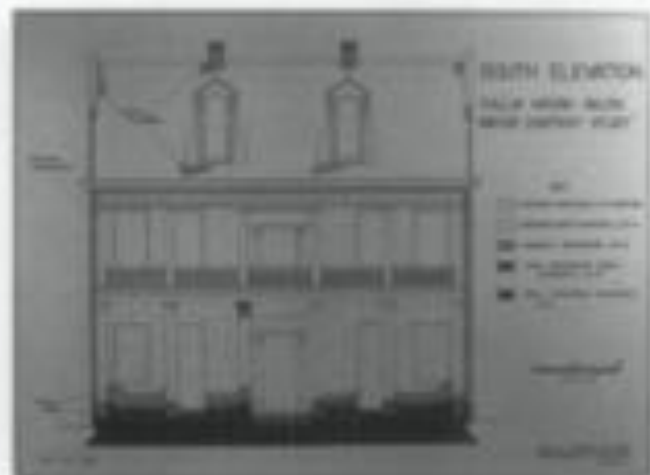
Fig. 2. Historic buildings plagued by dampness problems will benefit from systematic documentation to set a baseline against which moisture changes can be measured. Exterior areas with higher moisture levels may have algae growth or discoloration stains. Drawing: John H. Stubbs.

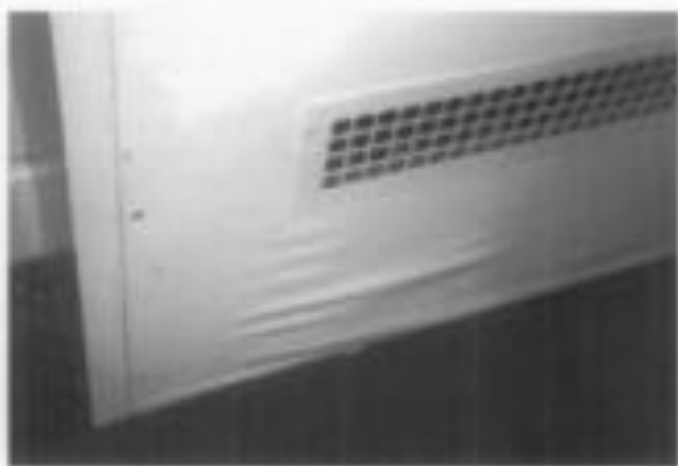
Fig. 3. The deterioration of this vent cover was a sign that water was leaking from the fan coil unit behind. Photo: author.

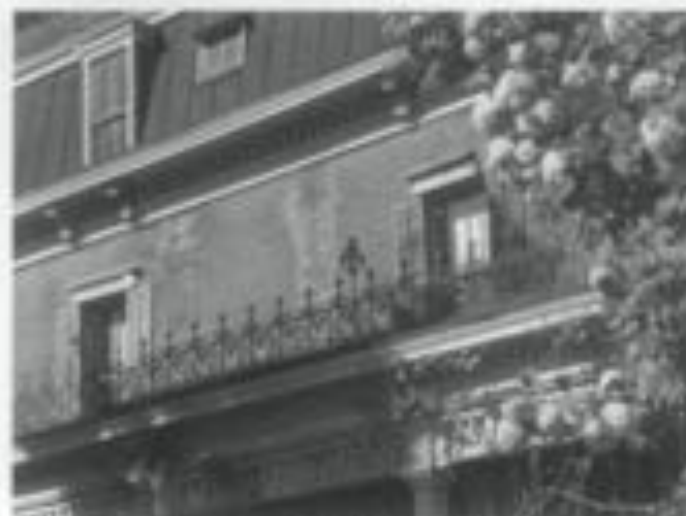
Fig. 4. Deferred maintenance often leads to blocked gutters and downspouts. This cracked gutter system allowed moisture to penetrate the upper exterior wall, erode mortar joints, and rot fascia boards. Photo: NPS files.

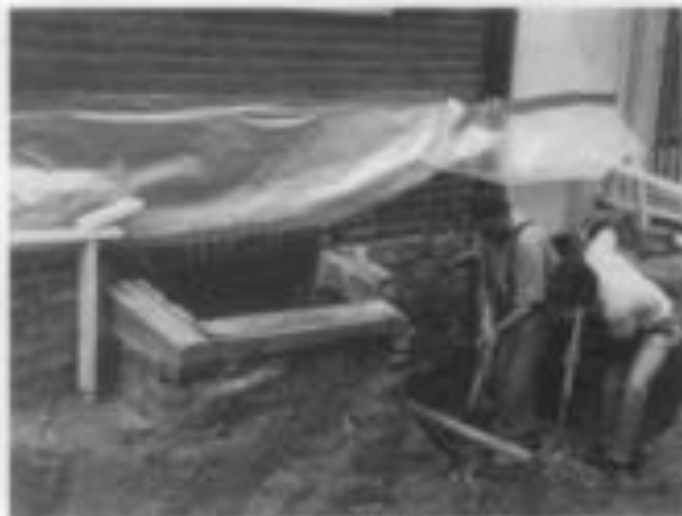
Fig. 5. Excavating this foundation revealed that the downspout pipe had corroded at the "u-trap" and was leaking moisture into the soil. Openings around the horizontal water supply line and cracks in the wall allowed moisture to penetrate the basement in multiple locations. Photo: author.

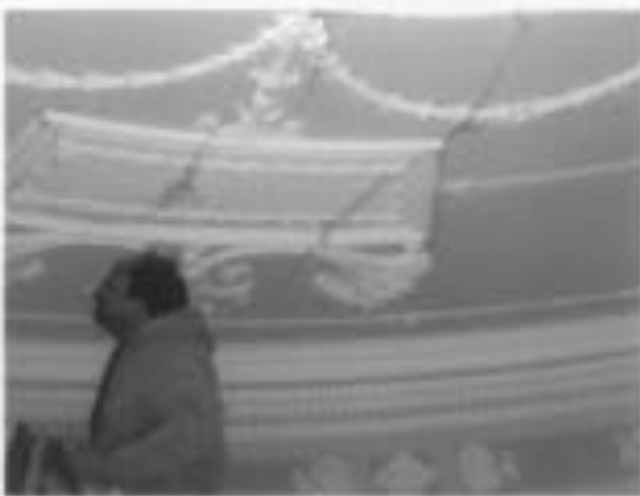
Fig. 6. Uninsulated plumbing pipes close to the exterior wall froze and cracked, setting this ornamental plaster ceiling before the water supply line could be shut off. As a result, limited portions of the ceiling needed retouching. Photo: author.

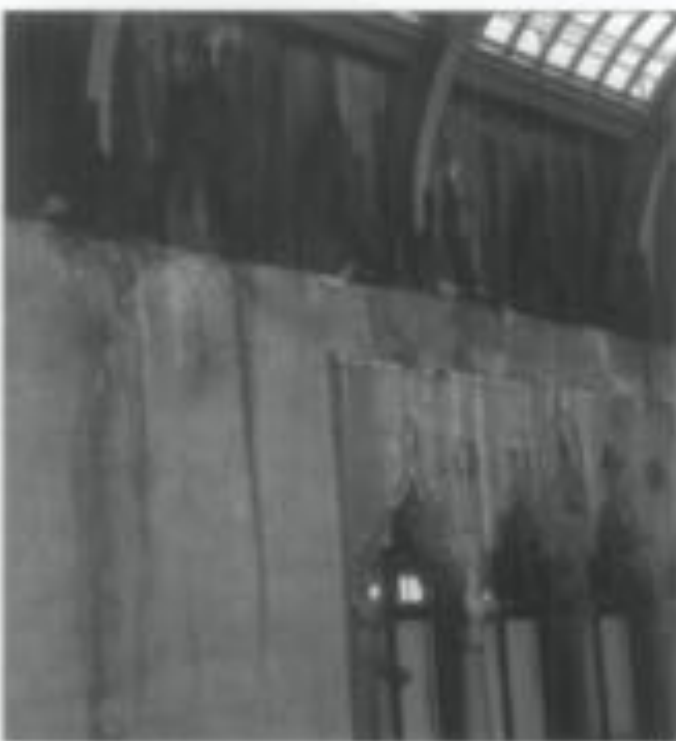
Fig. 7. Condensation dripping from the large overhead courtyard skylight was damaging the masonry in this museum. A new skylight with thermal glazing was installed, replacing the deteriorated single-glazed unit. A new climate control system maintains interior temperature and humidity. Photo © Judith Stewart Gardner Museum, Boston.

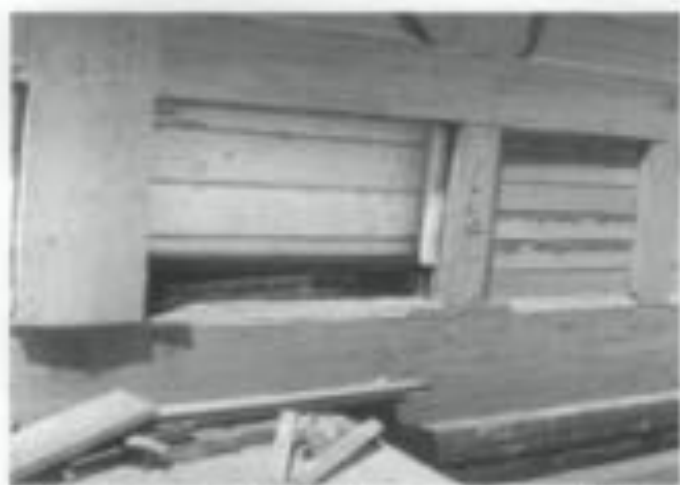
Fig. 8. Damaging moisture conditions can occur during construction. Peeling paint on this newly rehabilitated frame wall was attributed to wall insulation that had become wet during the project and was not discovered. Photo: NPS Files.

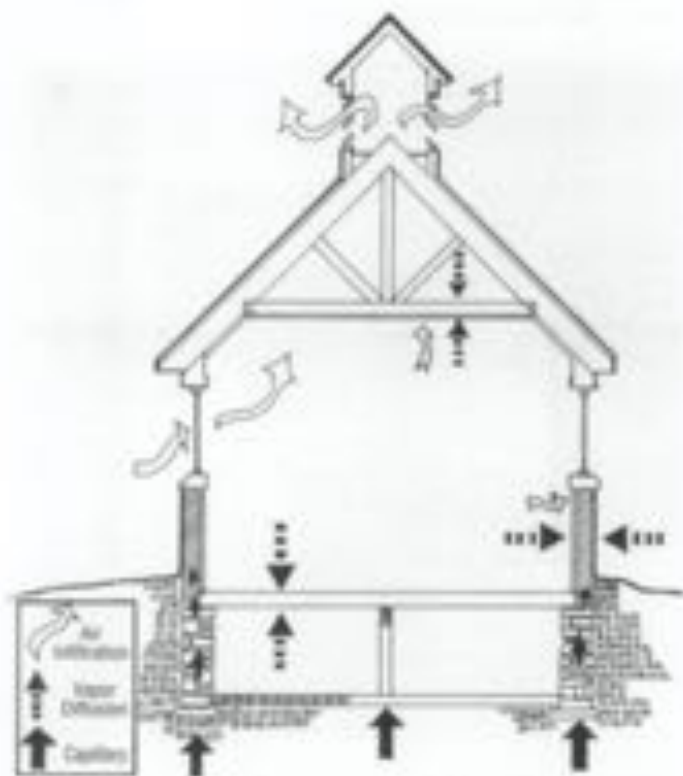
Fig. 9. The dynamic forces that move air and moisture through a building are important to understand, particularly when selecting a treatment to correct a moisture problem. Air infiltration, capillary action, and vapor diffusion all affect the wetting and drying of materials. Drawing: NPS Files.

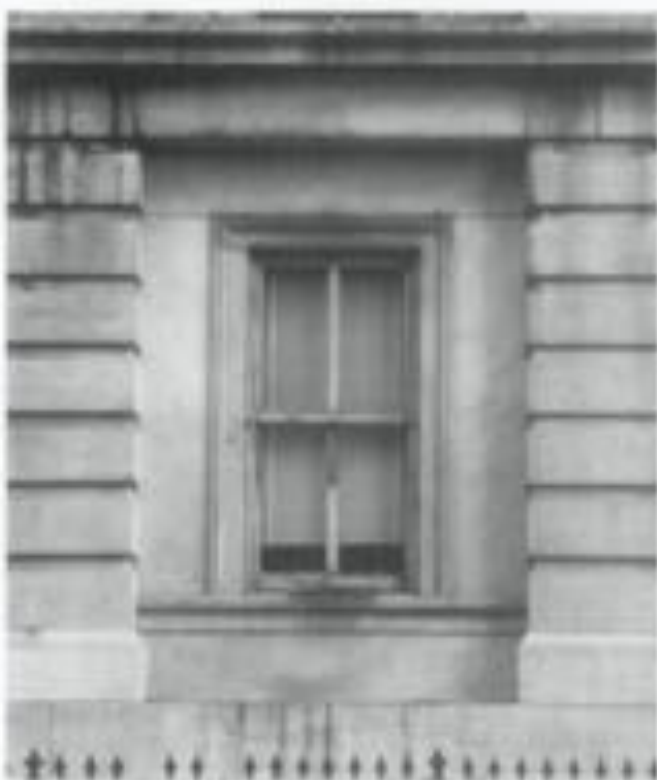
Fig. 10. Infiltration of damp air can occur around loose fitting or deteriorated window sash and through cracks or open joints in building exterior. Photo Ann Brooks Procher.

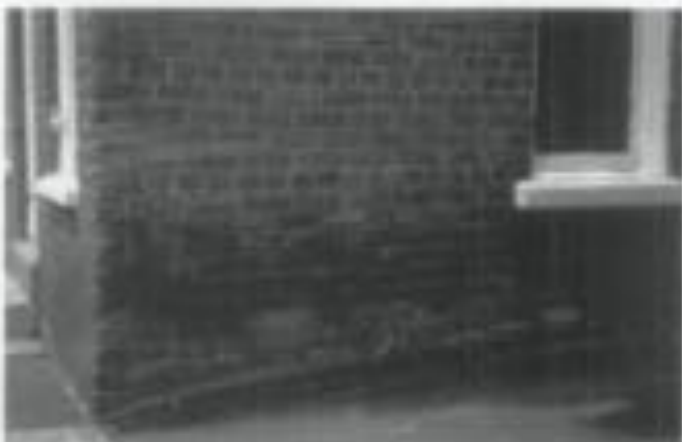
Fig. 11. Capillary rise of moisture in masonry is often accompanied with a horizontal tide-mark line several feet above the grade, as seen here. Removing or redirecting as much ground moisture as possible usually helps reduce moisture within a wall. Photo NPS Files.

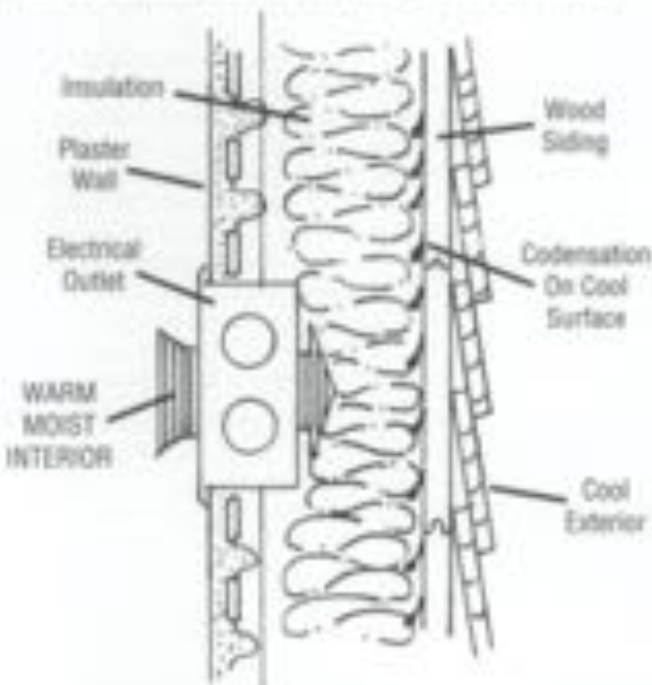
Fig. 12. Vapor diffusion can result in damp air migrating into absorbent materials and condensing on cooler surfaces, thereby wetting insulation, damaging electrical conduits, and causing deterioration of the wooden framing. Drawing: NPS Files.

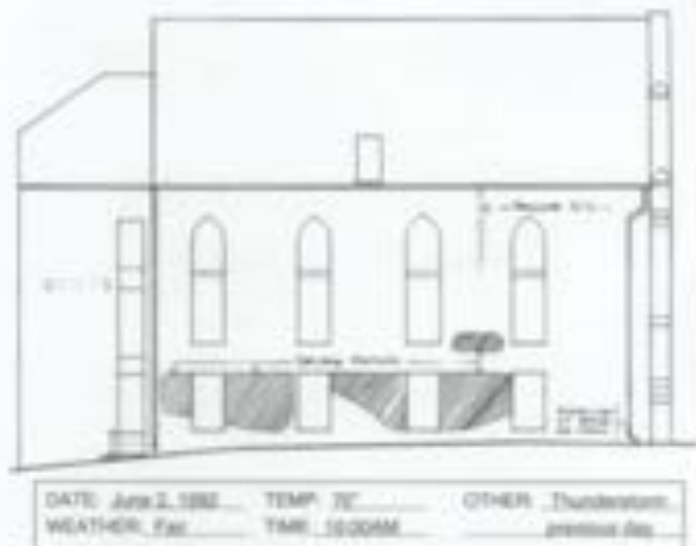
Fig. 13. Using sketch plans and elevation drawings to record the moisture damage along with the date, time, and weather conditions will show how moisture is affecting buildings over time. Drawing: Courtesy, Quinn Evans Architects.

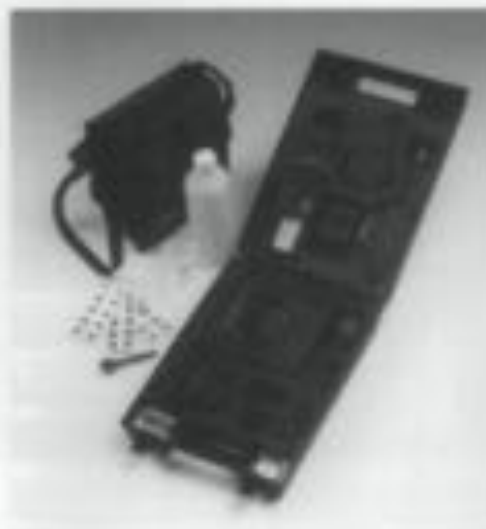
Fig. 14. Using instruments in this dew-check kit can help determine the relative change in wet conditions over time. The includes readings of air temperature, computing dewpoint temperatures, and tracking the moisture content of materials to indicate if they are drying properly. Photo: Dell Corporation.

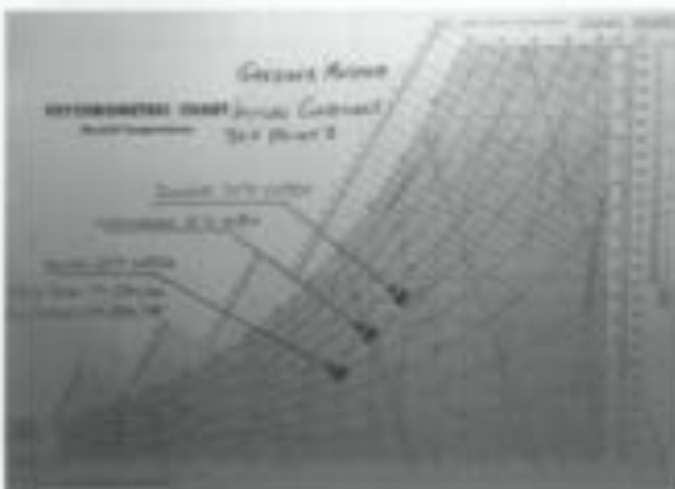
Fig. 15. Psychrometric charts quantify the amount of relative humidity a building can tolerate before dewpoint condensation occurs. This is important when the range of temperature and humidity are critical to both collections management and historic building preservation. Chart: Landmark Facilities Group.

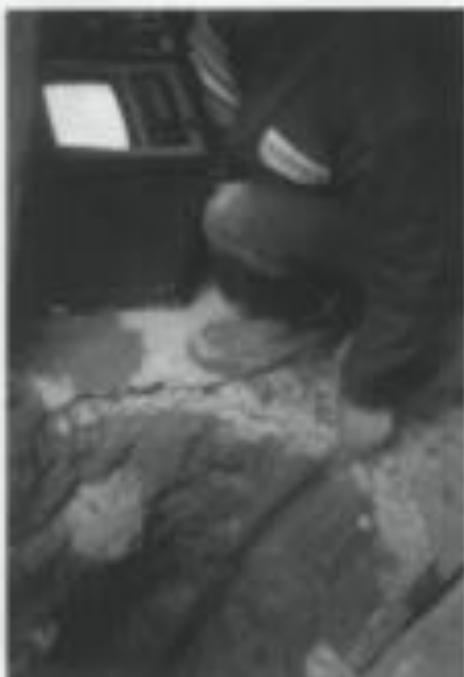
Fig. 16. Contractors specializing in building diagnostics often have video cameras or fiber optic equipment that allow the viewing of inaccessible areas. This is particularly helpful in chimney flues or subsurface drains, as shown here. In the past, these areas would need to be excavated for visual inspection. Photo: Austin.

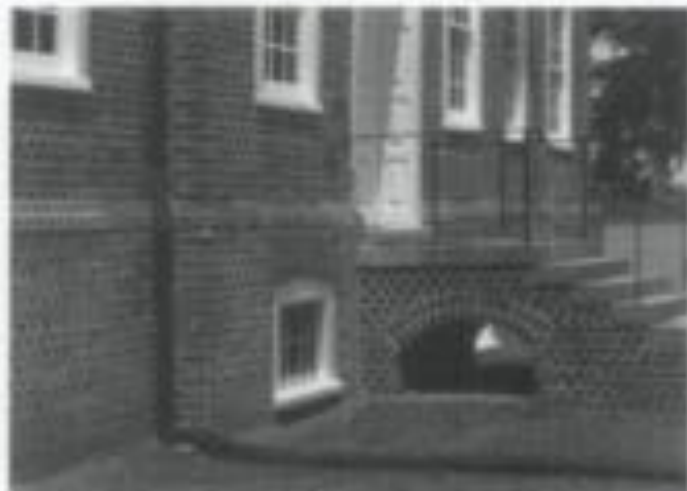
Fig. 17. In testing a theory for the cause of basement wetness, the owner used long black extender pipes to direct roof run-off away from the foundation. This test established that the owner did not need expensive waterproofing of the foundation, but a better drainage system. Photo: David M. Smith.

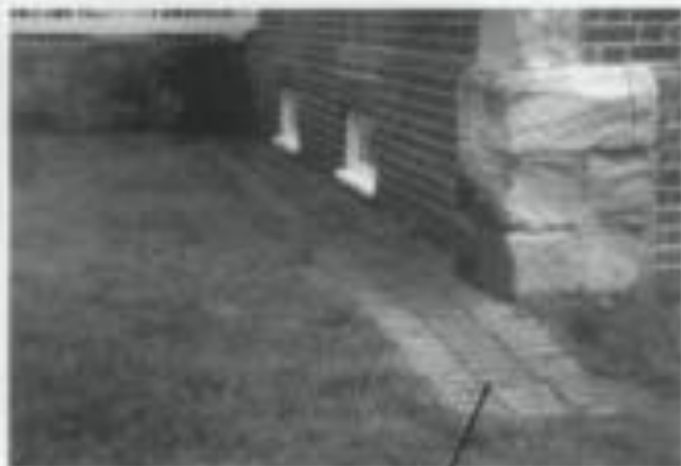
Ongoing maintenance and vigilance to situations that could potentially cause moisture damage must become a routine part of the everyday life of a building. The owner or staff responsible for the upkeep of the building should inspect the property weekly and note any leaks, mustiness, or blocked drains. Again, observing the building during a rain will test whether ground and gutter drainage are working well.

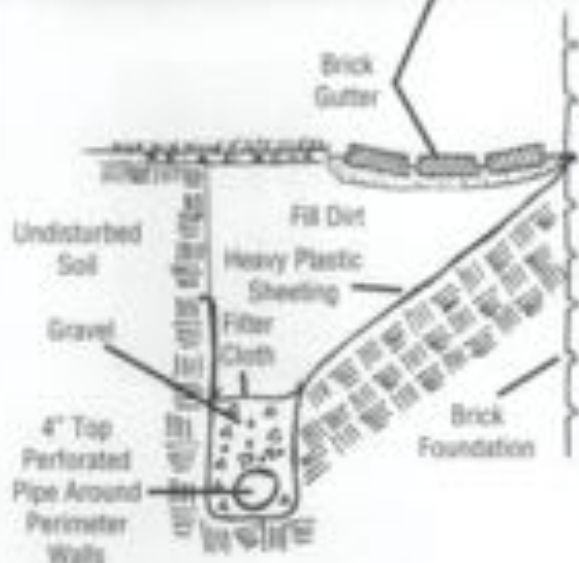
Fig. 18. This detail drawing shows a sub-surface perimeter drain in conjunction with a historic brick ground gutter system to help control roof run-off moisture from entering the historic foundation. Detail: Courtesy, Garden Hill Plantation. Photo: Elizabeth Sauer.

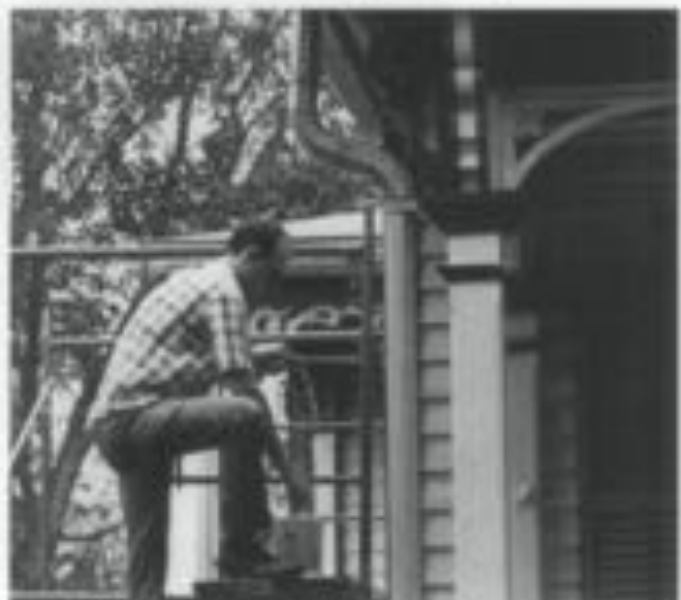
Fig. 19. Maintaining gutters and downspouts in good operable condition, requiring eaves to keep water out, redirecting damaging moisture away from foundations and controlling interior moisture and condensation are all important when holding the line on moisture deterioration. Photo: Nebraska State Historical Society.

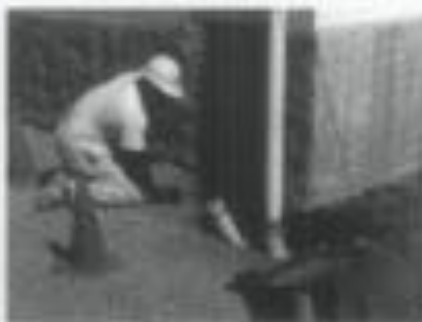
C. Cleaning out gutters and downspouts should be done at least twice a year. Photo: WPTC, NPS.

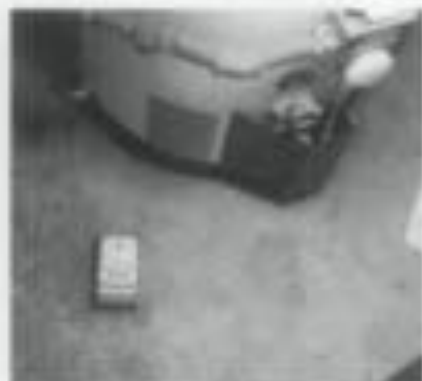
D. Protect the building from damage by maintaining equipment and using alarms, like this floor water sensor. Photo: D&D Corporation.

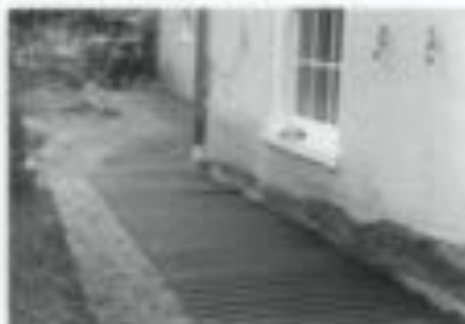
A. Mitigate your drainage with gravel, filter cloth, or the use of subsurface drainage mats under finished paving. Photo: Larry D. Dermody.

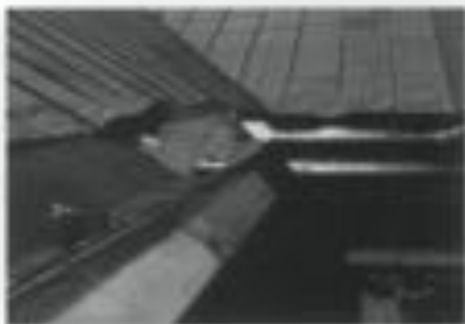
B. Repair roofs and add ice and water shields at eaves and under eutings in cold climates. Photo: Larry D. Dermody.

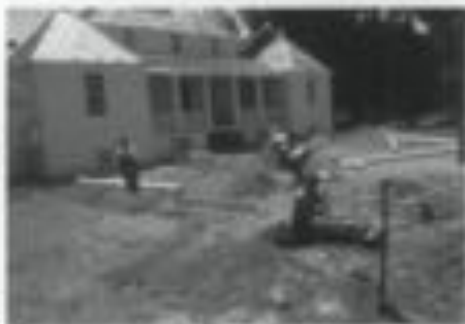
C. Develop new drainage systems for roof run-off that remove moisture from the base of the building. Photo: WPTC, NPS.

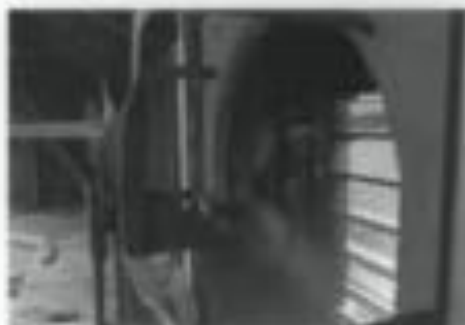
D. Install ventilating fans when additional air circulation will improve damp conditions in buildings or reduce cooling loads. Photo: Ernest A. Conrad, P. E.

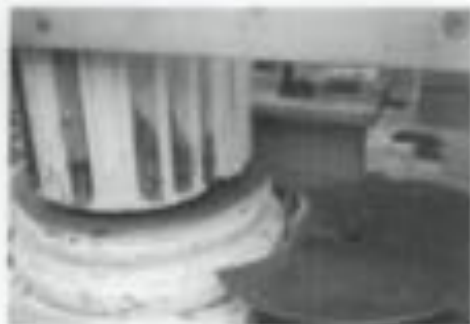
A. This lead sheet was installed at the base of the replacement column to stop rising damp. Photo: Bryan Blundell.

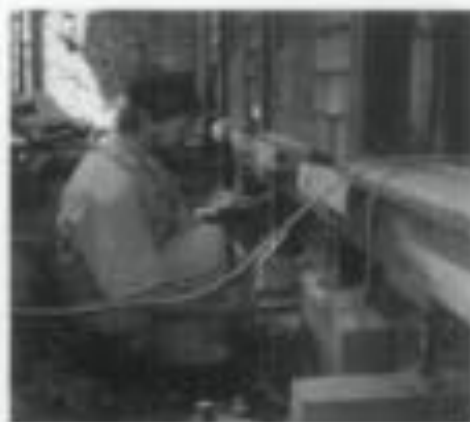
B. Wood sills set on grade were replaced with concrete pier foundation and new wooden sill plates. Changes were not visible on the exterior (see C). Photo: WPTC, NPS.

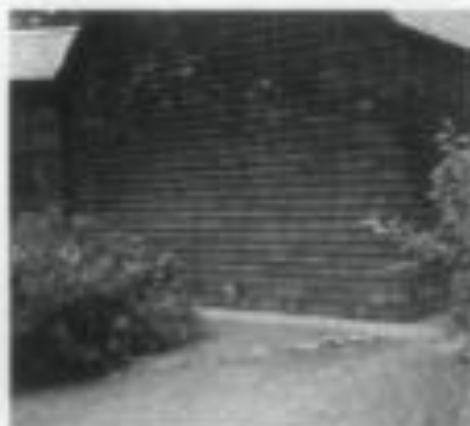
C. The new ground gutter gravel base helps drainage around the concrete foundation (see B above) which is not visible behind the replaced wooden wall shingles. Photo: WPTC, NPS.

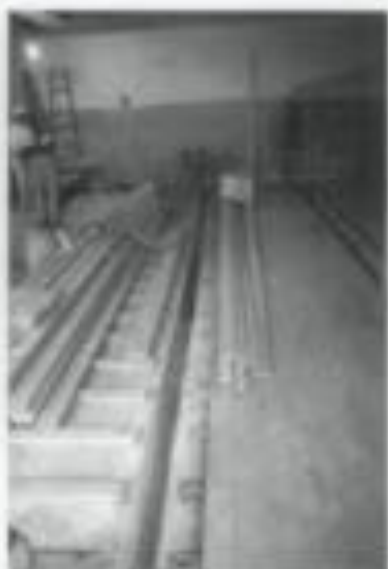
D. In a flood plain, settled joints were replaced with a concrete slab and sleepers designed to drain water. Special flooring allowed drainage and room for damp wood to swell without buckling. Harper's Ferry Center, NPS.

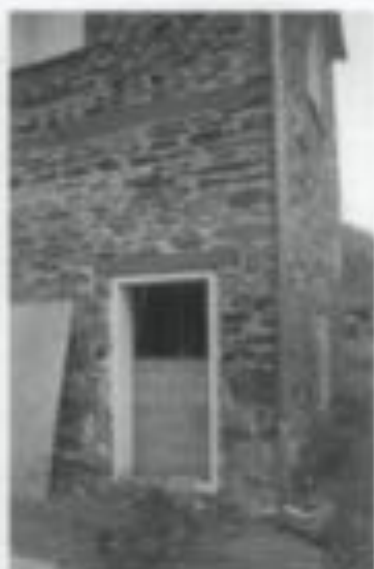
E. Mechanical systems on the lower level were placed on platforms above the flood line. Harper's Ferry Center, NPS.

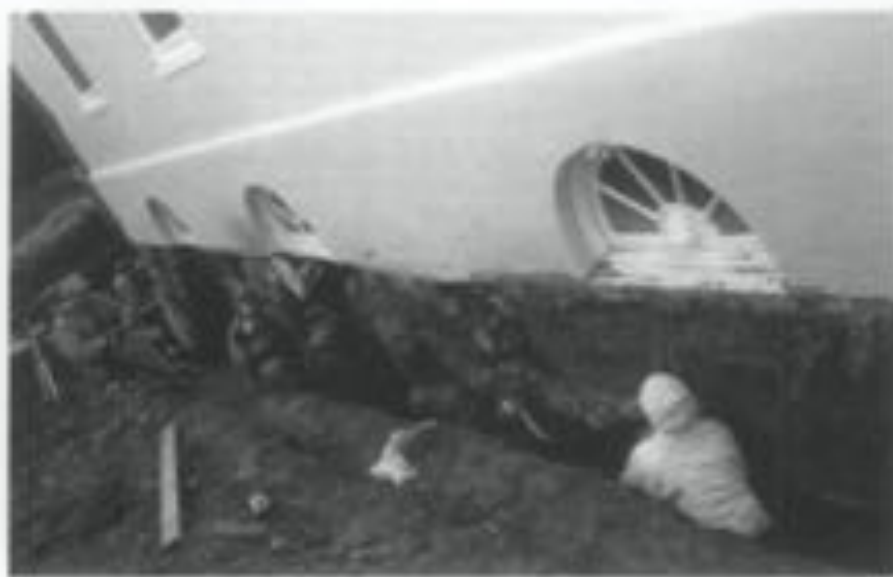
I. Critically damp foundation walls were protected with a layer of bentonite clay to reduce moisture penetration. This work was in combination with new drainage pits that were connected to drainage basins that deposited captured roof run-off away from the foundation. Photo: Courtesy, Larry D. Dornosky and the National Trust for Historic Preservation.

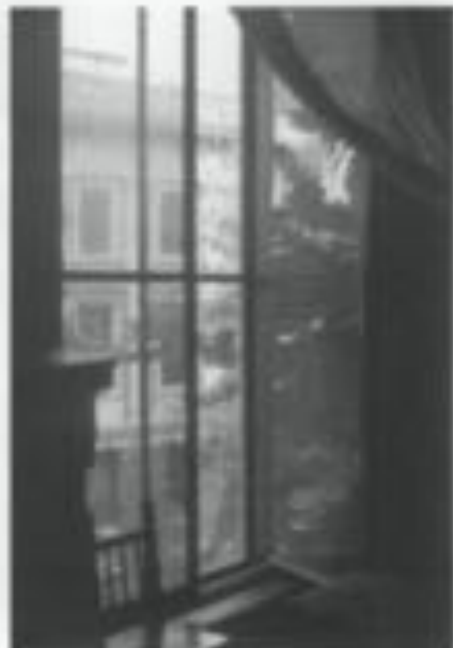
F. Triple glazed windows replaced the originals to control condensation. Photo: © Isabella Stewart Gardner Museum, Boston.

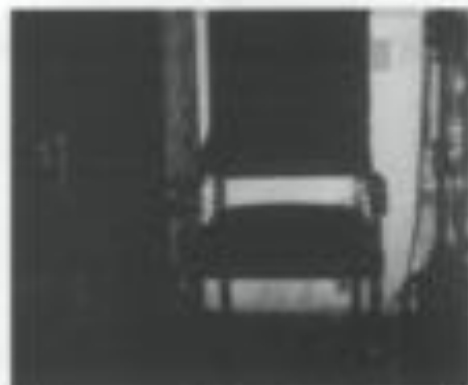
G. New sensors which monitor temperature and relative humidity are located throughout the museum and tied to a computer that controls the climate control system. Photo: © Isabella Stewart Gardner Museum, Boston.

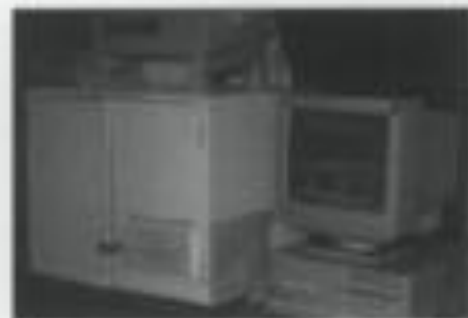
M. New computers tie a variety of monitoring and security features into a comprehensive system which provides warning and backup alerts when any of the system components are not functioning properly. Photo: © Isabella Stewart Gardner Museum, Boston.

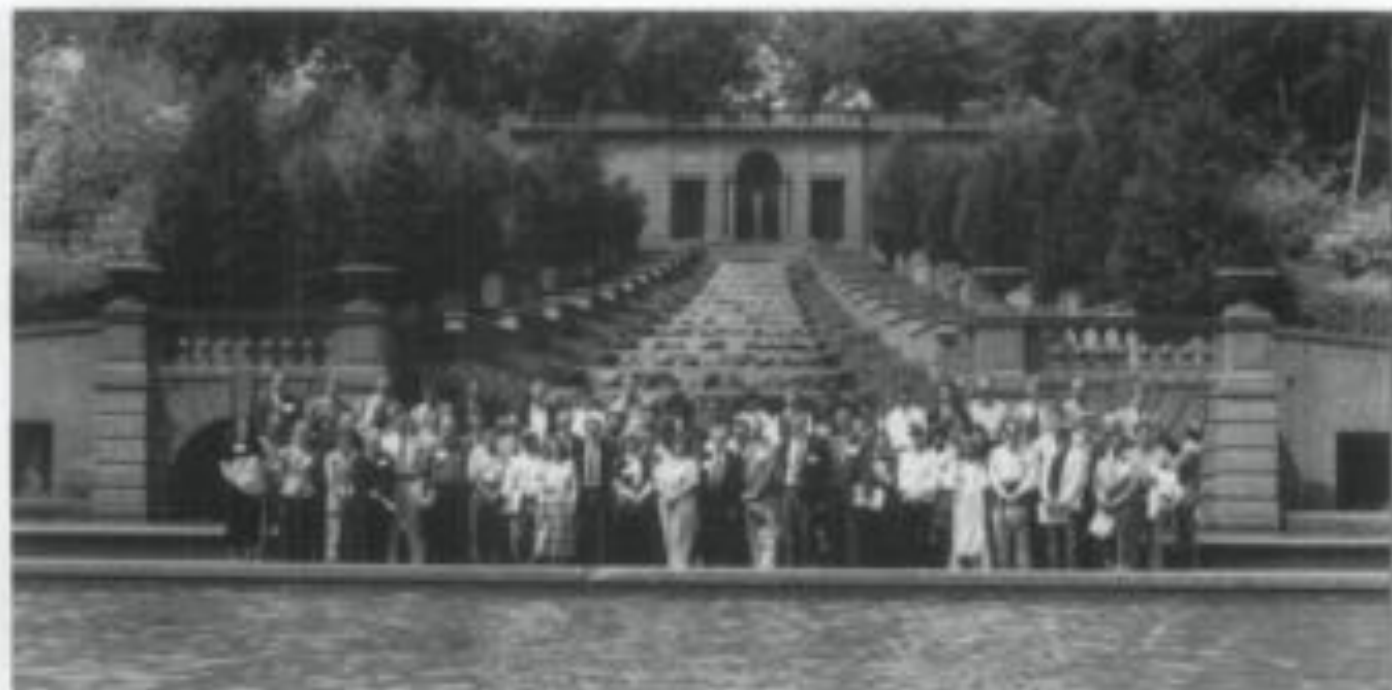
Back Cover: The Diagnosing Moisture in Historic Building Symposium held in Washington, DC, May, 1996, brought together practitioners in the field of historic preservation to discuss the issues contained in this Preservation Brief. Attendees are standing in front of the cascading fountain at Meridian Hill Park, a National Historic Landmark. Photo: Eric Auer.

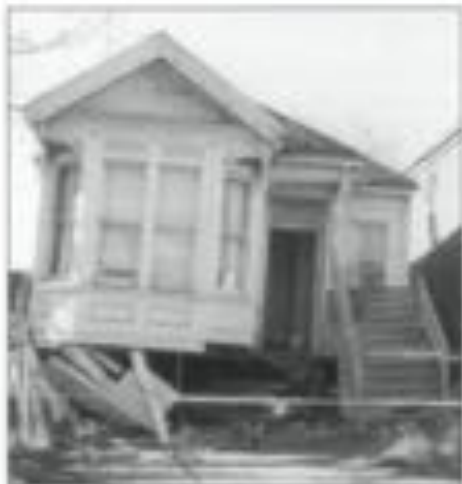
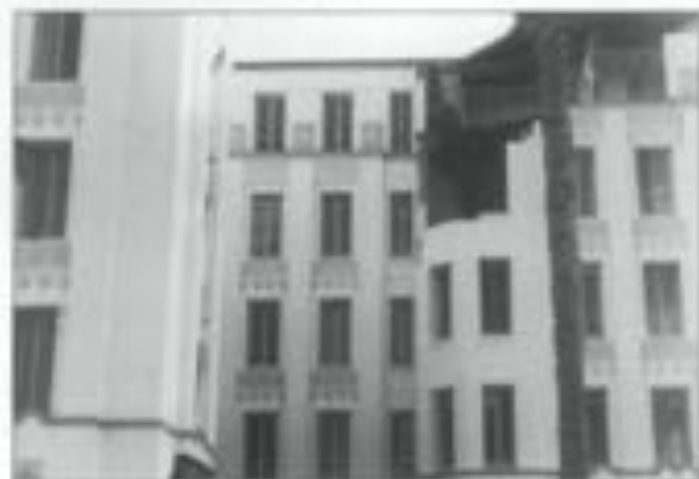
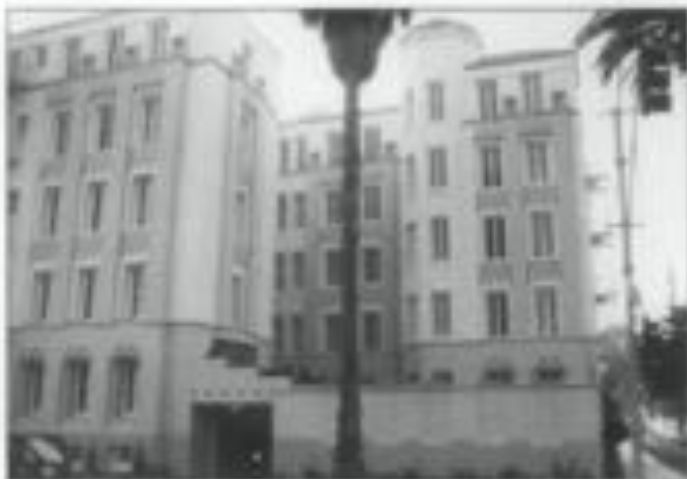
1. Earthquake damage to historic buildings can be repaired in a manner sensitive to their historic character as seen in this ca. 1920 five-story apartment building. The owners used a combination of federal rehabilitation tax credits, community development block grants, and post-earthquake grants to fund a portion of the rehabilitation and seismic upgrade costs. Photos: Historic Resources Group, Los Angeles.

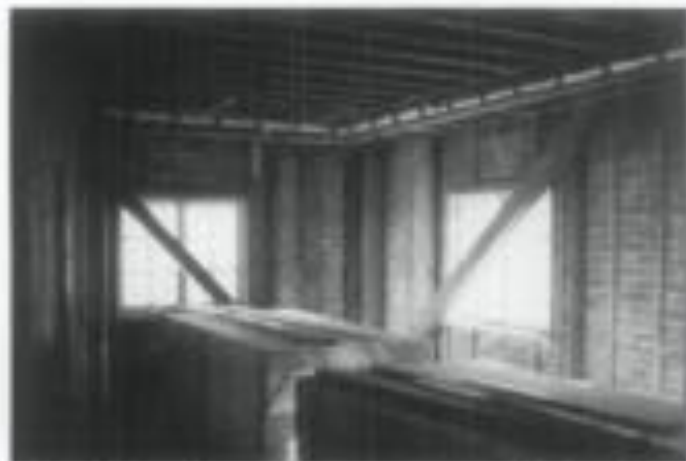
2. Standard approaches to seismic retrofit, as seen with the diagonally braced frame crossing in front of the historic windows, are visually intrusive. Solutions, such as using hidden moment frames around the perimeter of the windows, will meet the goals of historic preservation and seismic retrofit. Photos: Strand Design.

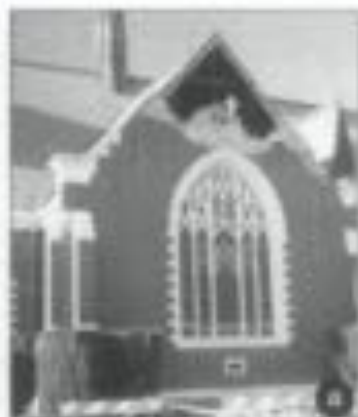
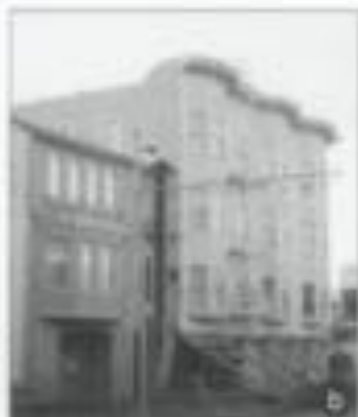
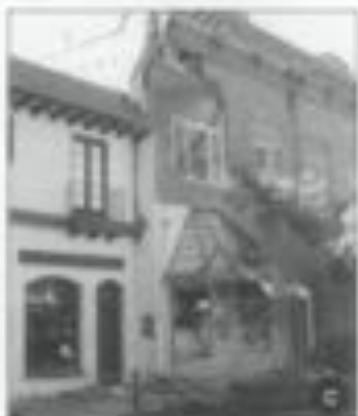
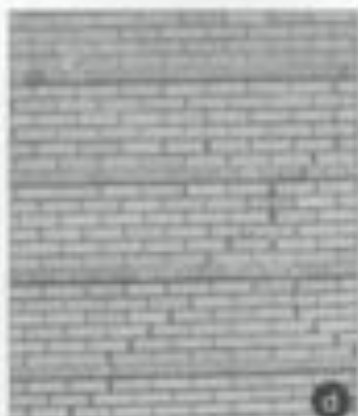
3. Forces from moderate to serious earthquakes caused a) the gable to fall, b) the first floor to collapse (a crack from the preceding effect of adjacent buildings), and c) and diagonal cracks in exterior masonry between windows in town. Photos: David Leck.

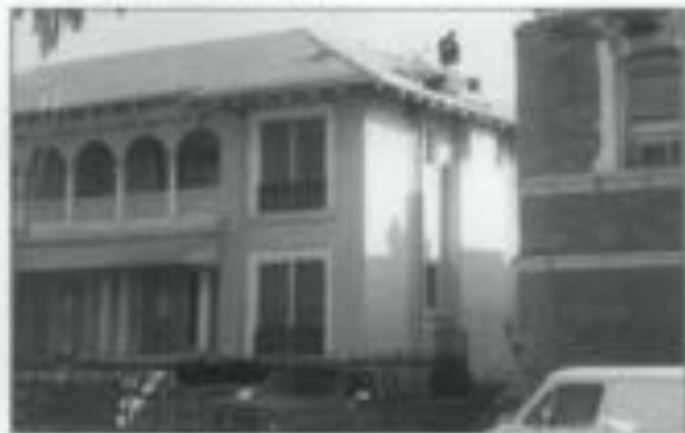
4. The compact size and good condition of the masonry building on the left withstood the earthquake except for the loss of the unsupported chimney at the roof line. The brick building on the right appears to have sustained more damage. Photo: Steve Crisp.

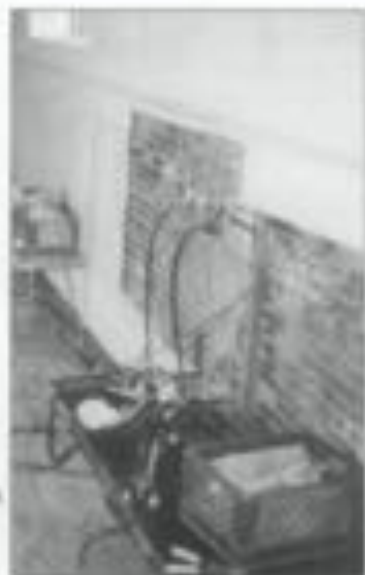
Evaluating local and state codes and requirements. Few codes consider historic buildings, but the California State Historical Code and the Uniform Code for Building Conservation provide excellent models for jurisdictions to adopt. Code officials should always be asked where alternative approaches can be taken to provide life safety if the specified requirements of a code would destroy significant historic materials and features. Some jurisdictions require the removal of parapets, chimneys, or projecting decoration from unreinforced masonry buildings which is not a preservation approach. Professionals on the team should be prepared with alternatives that allow for mitigating potential damage to such features while retaining them through reattachment or strengthening.

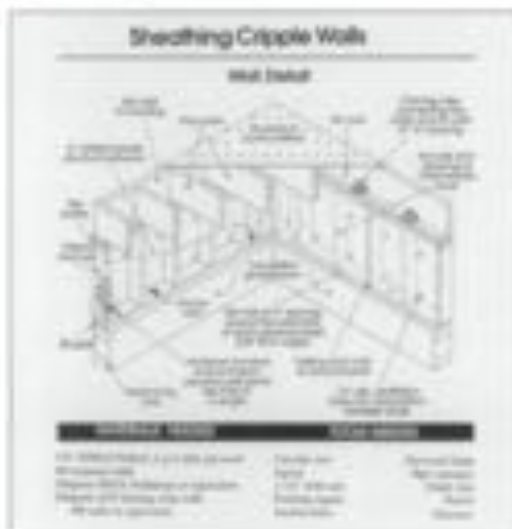
6. Often simple approaches, such as nailing plywood stiffeners between cripple studs and onto floor joist above and bolting sill plates to foundations can make a dramatic difference in protecting a building from seismic damage. Illustration: Reproduced with permission from Home Earthquake Preparedness Guide, EQE Incorporated, San Francisco, CA.

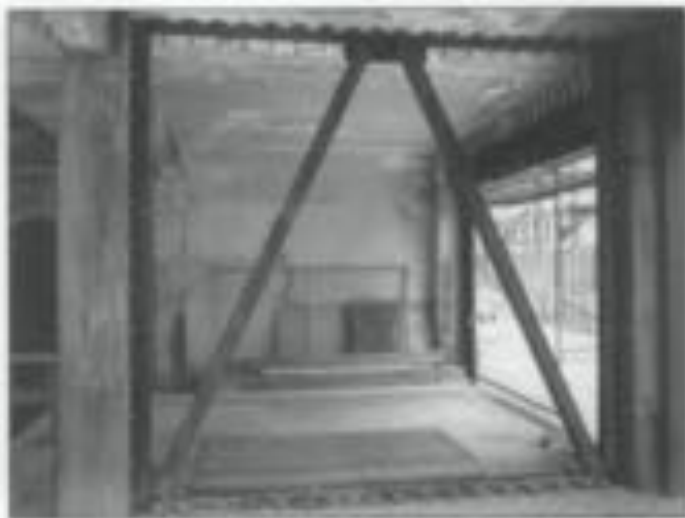
7. More extensive seismic issues can be addressed through structural reinforcement, the most common methods using anchor ties and braces. Shown here is an interior diagonal frame. As the ceiling, which will dampen and transfer seismic loads in a designed path from foundation to roof. Photo: David Leck.

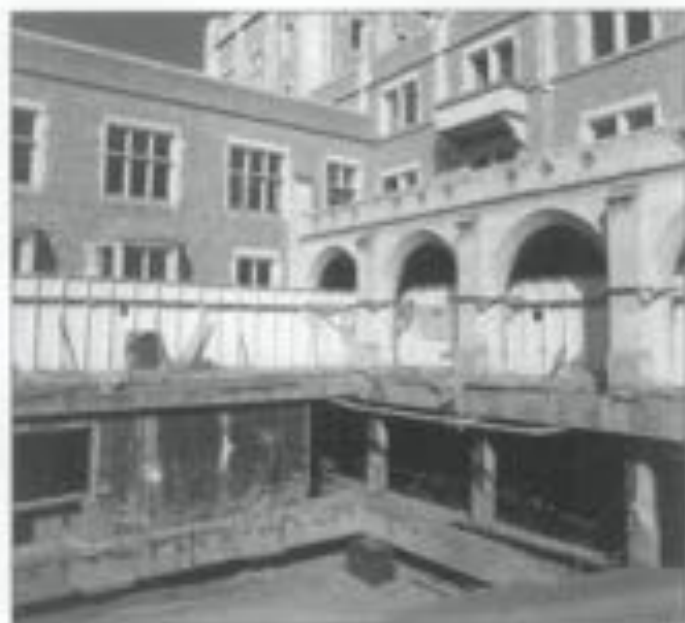
8. Full seismic restructuring to ensure that buildings survive a major earthquake with a minimum of damage may involve extensive reinforcement. Upon completion, the changes to this ca. 1932 Gothic Revival building to add base isolation at the foundation were not visually apparent. Photo: © Jonathan Farver, courtesy University of California at Los Angeles (UCLA) Capital Program.

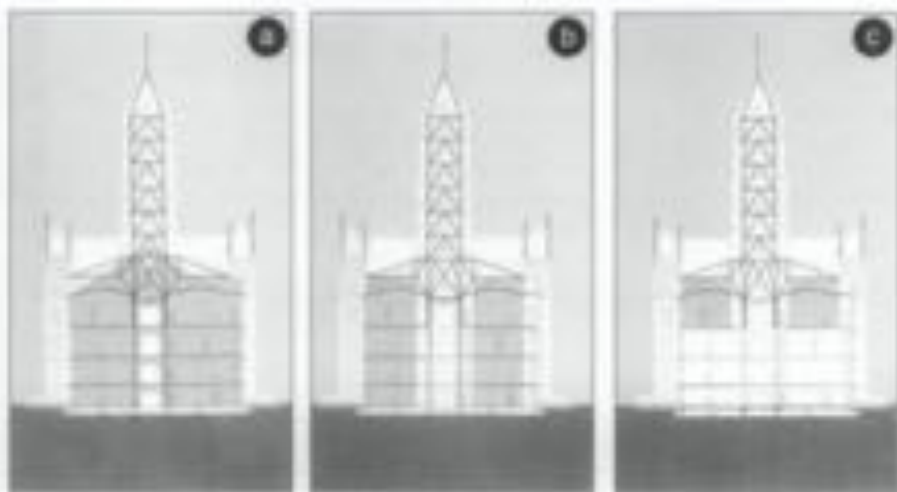
8. These studies for a public building compared, in the shaded areas, the amount of historic material that would be affected by (a) the Uniform Building Code requirements, (b) engineering alternatives that protected significant historic materials, and (c) the use of base isolation systems. The cost for implementing the 3 proposals was similar, and while proposal (c) was selected there were many positive aspects to both (b) and (c). Photos: George Seidman, with permission from Ehrenkrantz, Eckstut, & Krutz Architects.
