GEORGETOWN STEAM PLANT
HISTORIC STRUCTURE & CULTURAL LANDSCAPE REPORT

OCTOBER 9, 2013

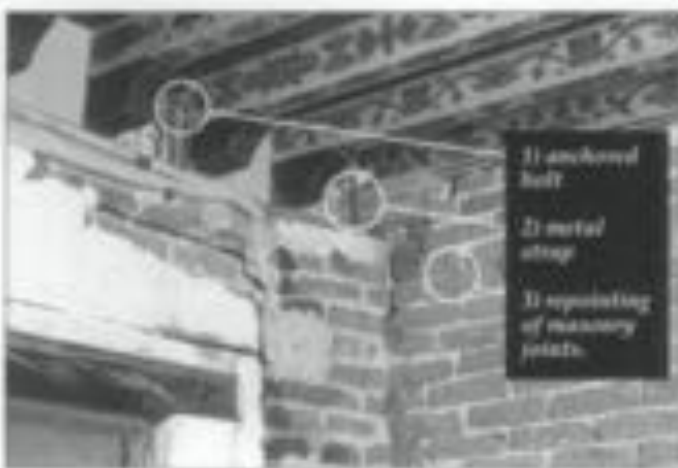
11. Limited intervention should correct obvious structural deficiencies, such as tying vulnerable elements together and repointing masonry. See here in 1) anchored bolt, 2) metal joint strap, and 3) repointing and resurfacing masonry joints. When replastering and painting these reinforcements will not be visible. Photo: Historic Preservation Partners for Earthquake Response.

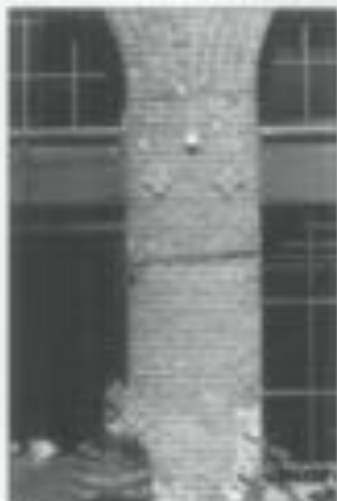
It is important to control rust by painting ferrous metal washers. New washers can be specified as stainless or galvanized steel. In circumstances where washers are visibly intrusive, the preferable solution would be to recess them below the face material. This is particularly applicable to stucco buildings.

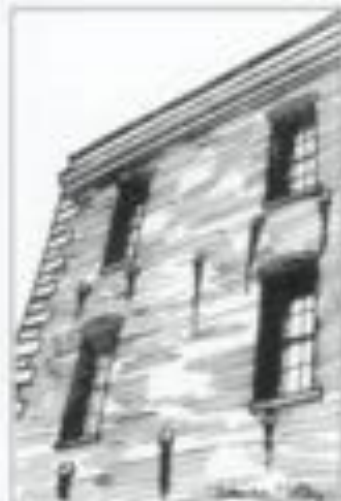
- Use decorative washers in areas with high visibility.
- Align washers to create visually appealing.
- Use stainless or galvanized steel and paint when appropriate to prevent rust stains.
- Attempt to conceal the bolts and washers below the exterior finish, when appropriate.

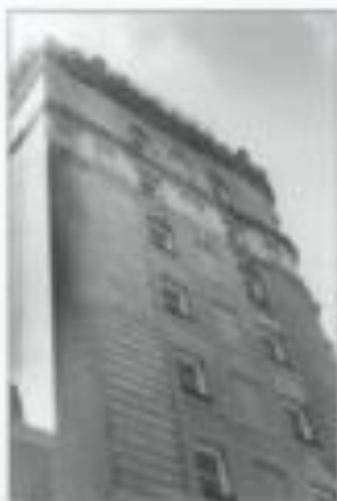
The purpose of filling the openings is to increase the shear capacity and reduce the stresses on the unreinforced masonry wall. It is not adequate to just infill with the same unreinforced masonry, but generally a reinforced concrete, reinforced block or reinforced brick is specified. If infilling the openings appears to be the only realistic method, the design solution should be sensitive, and if possible, limited to secondary elevations. The opening should be set back and the facing material should be compatible with the surrounding material.

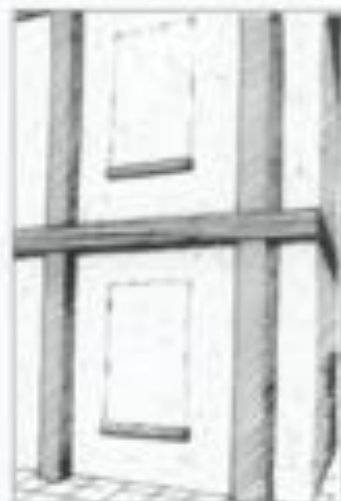
- Infill of windows should be avoided in all cases. Where absolutely required, however, the appearance of a window opening should be retained to suggest the original visual rhythm of the facade.

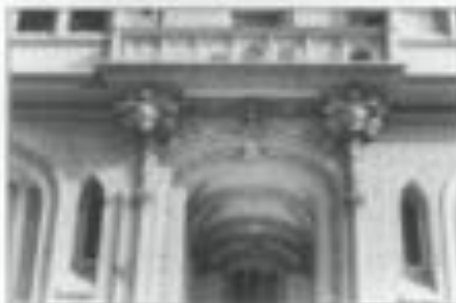
- Can bracing be installed without damaging decorative details or appearance of parapets, chimneys, or balconies?
- Are the visible features of the reinforcement, such as anchor washers or exterior buttresses adequately designed to blend with the historic building?
- Can hidden or grouted bolts be set on an angle to tie floors and walls together, instead of using traditional bolts and exposed washers or roses on ornamental exteriors?
- Are diagonal frames, such as X, K, or struts located to have a minimal impact on the primary facade?
- Are they set back and painted a receding color if visible through windows or storefronts?
- Can moment frames or reinforced bracing be added around historic storefronts in order to avoid unsightly exposed reinforcement, such as X braces, within the immediate viewing range of the public?

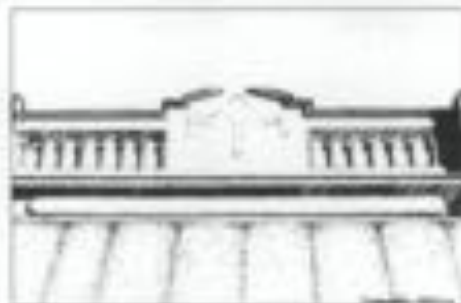
- All original building ornamentation enhances the architectural value and should be retained and maintained.

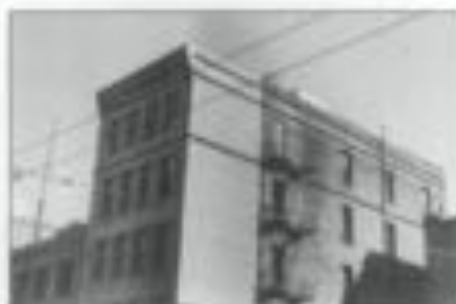
If ornamental elements must be removed during the repair process, they should be reinstalled or replaced in-kind. The use of substitute materials may be acceptable if no other options exist.

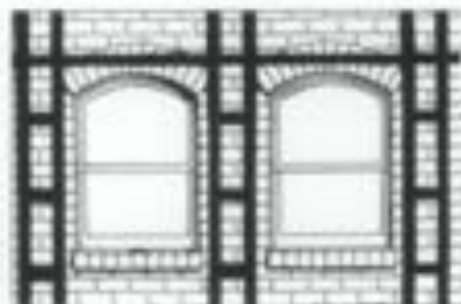
- Exterior bracing or buttressing should incorporate the building's natural lines. The exterior steel bracing appears to be an original building element because it runs parallel to the cornice line.

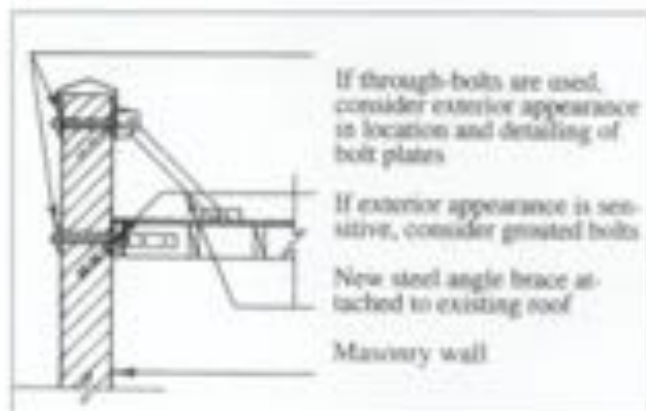
12. Bracing parapets, as illustrated here, and supporting chimneys using metal struts or ties, are simple methods to protect these heavy elements from falling. Drawing: Architectural Resources Group

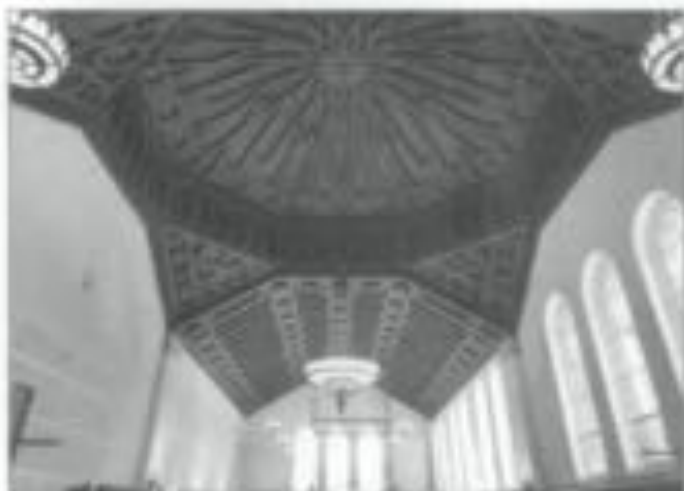
16. During the extensive rehabilitation of this historic building, new concrete, behind the new plaster finishes, strengthened the interior brick walls and additional roof reinforcement was hidden behind the repaired masonry and original ceiling. Photo © Jonathan Ferrer, courtesy UCLA Capital Program.

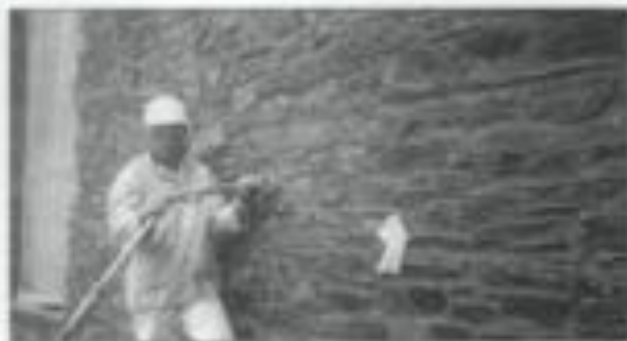
17. The internal grout injection of rubble walls can improve seismic capacity. Care must be taken in formulating the mortar grout and repairing the area where injection occurs. Photo: Architectural Resources Group, San Francisco.

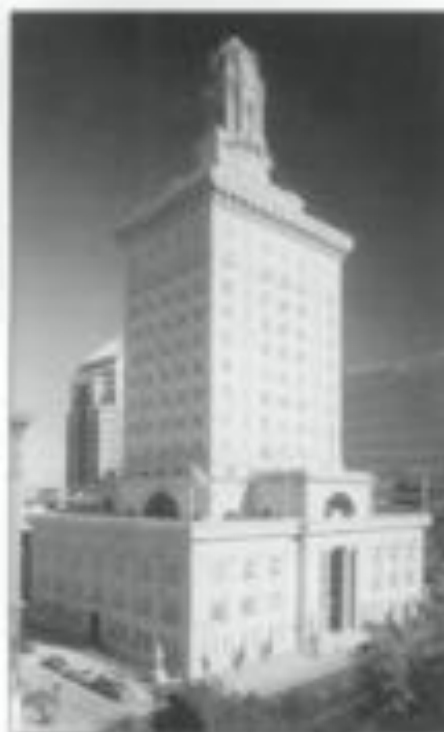
18. Oakland City Hall, California, completed in 1914, was restored to its original appearance and the computer model illustrates the comprehensive methods used to fully reinforce the building for the future. Photo © Yifeng Yu, Computer Model © Douglas Symes, San Francisco, VRN, Architects and Cary & Co., Inc., Architecture.

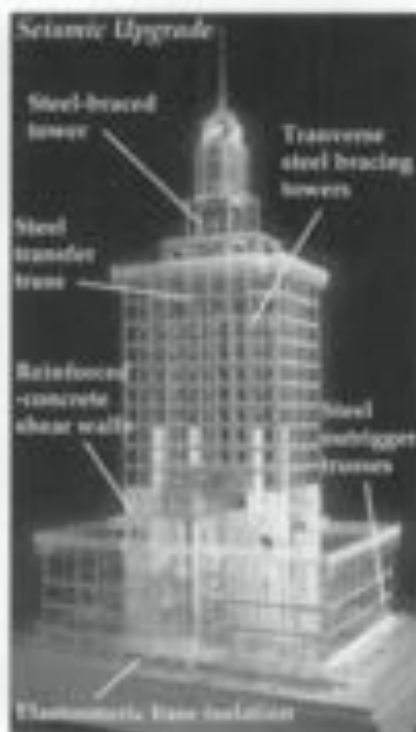
Specialized Technologies

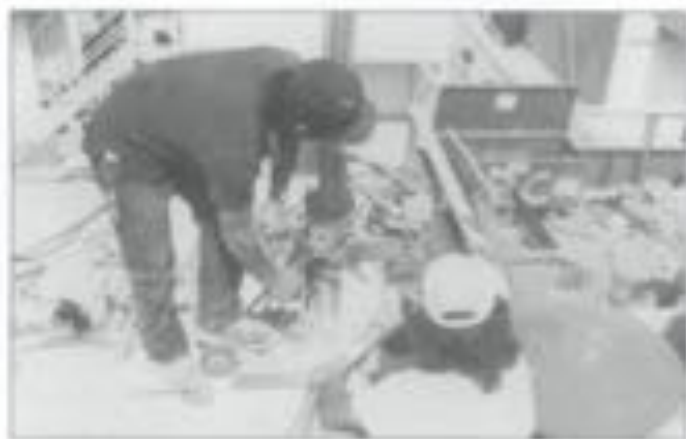
19. A system of core drilling, shown here, removes internal steel sections of unreinforced masonry from roof to foundations and fills them with grout and reinforcing rods. This may be an option for some unreinforced masonry buildings with significant interior spaces, although it is a less reversible treatment than traditional diagonal bracing or shear walls. Photo: David Lusk.

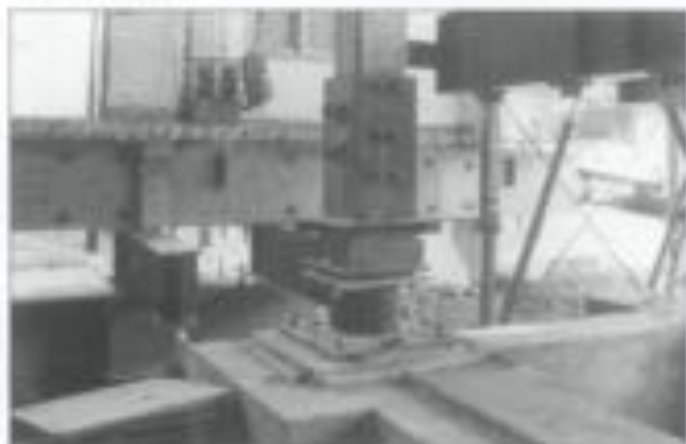
20. The new base isolator allows the structural support member at the foundation to move horizontally as it absorbs the earthquake forces. While expensive, base isolation may be justified by reducing the amount of damage to interior finishes and fixtures with traditional methods of seismic retrofit. Photo: Photo © Jonathan Favre, courtesy UCLA Capital Program.

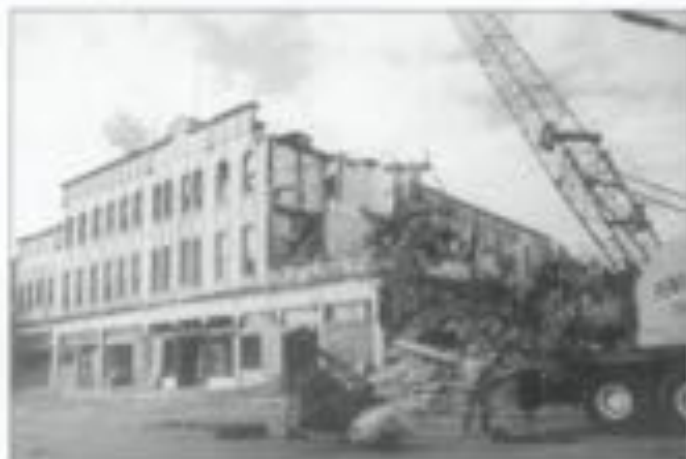
21. Without a plan in place before an earthquake, buildings that could be repaired are often torn down. The loss of significant numbers of buildings within historic districts can further erode the financial and cultural assets of an area. Photo: David Lusk.

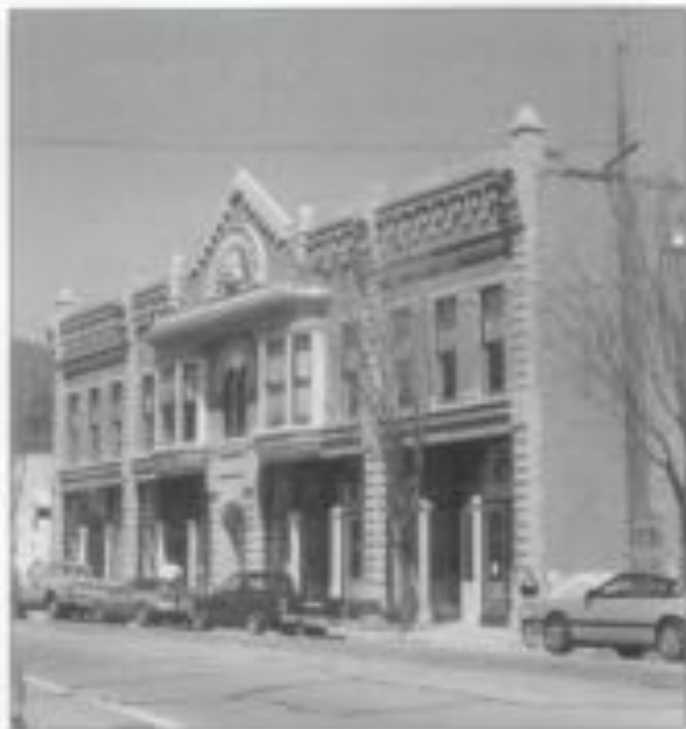
22. When undertaking a substantial rehabilitation to include seismic reinforcement, it is also an opportune time to restore lost or damaged features. The owner of this commercial building, using the Historic Rehabilitation Tax Credits, restored the original bay and parapet gables and stone detailing that had been removed in an earlier renovation. Photo: David Leck.

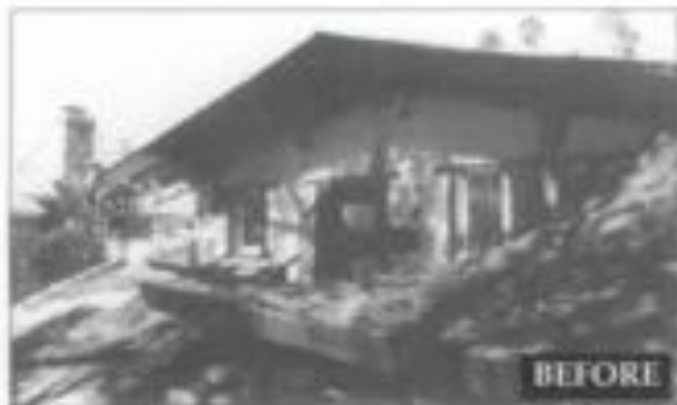
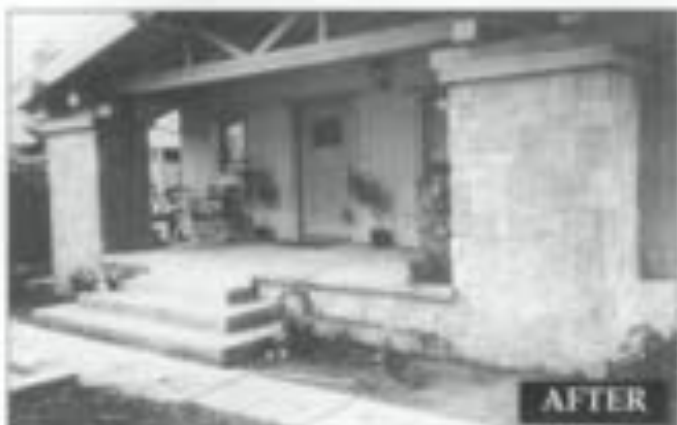
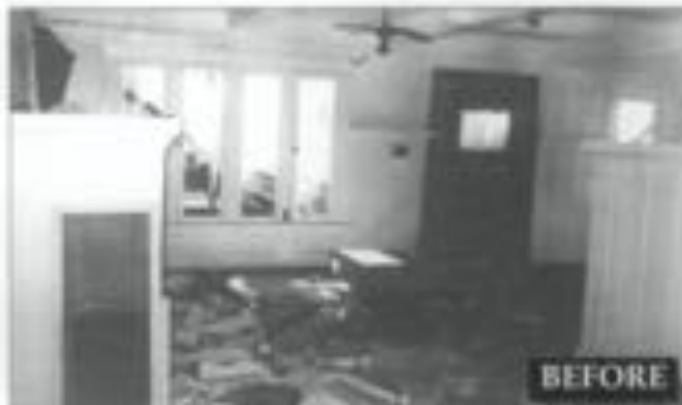
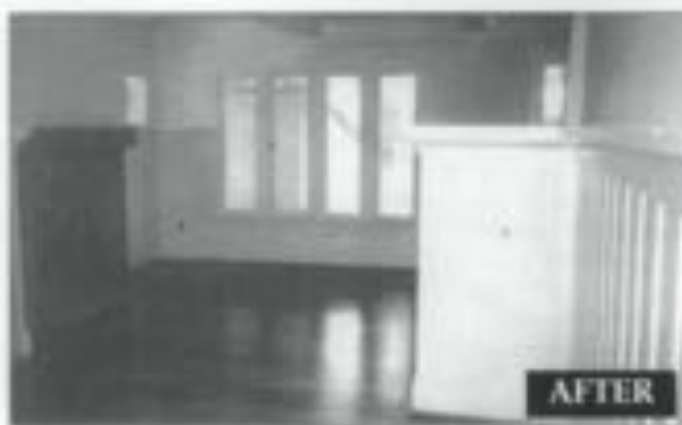
23. Both exterior and interior can be severely damaged in an earthquake. This Craftsman Style bungalow was successfully restored and seismically upgraded after the Northridge earthquake in California. Photographs: Historic Preservation Partners in Earthquake Response.

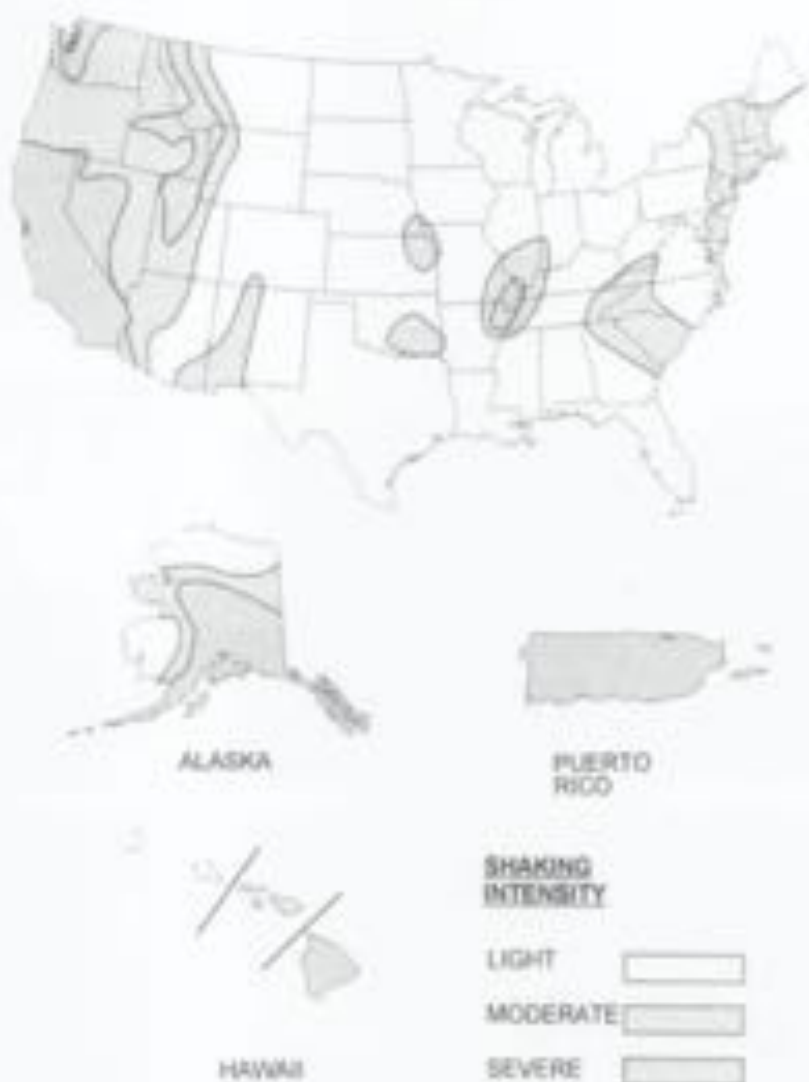
24. Seismic Map. The shading indicates areas in the United States and Puerto Rico that are affected by the probability of varying shaking intensities. The risk of severe shaking is not limited to the west coast. Maps adapted from Federal Emergency Management Agency, FEMA 74 Guide.

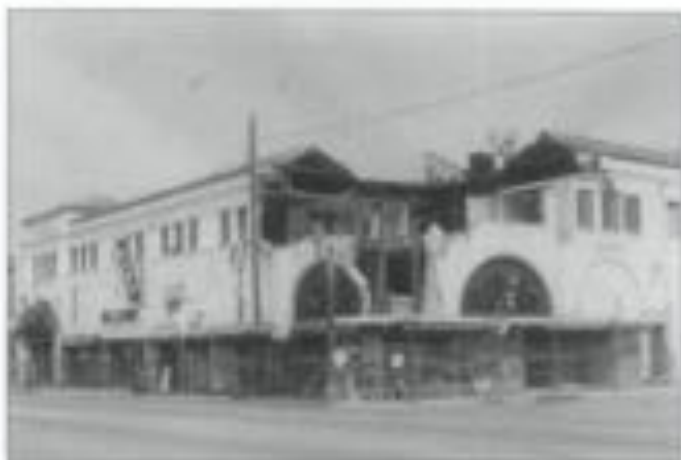
23. While it is best to seismically retrofit historic buildings before an earthquake strikes, if earthquake damage is to be repaired, it should be done in a manner respecting the historic character of the building. For this ca. 1923 Mediterranean Revival style building damaged in the Northridge Earthquake in California, financial and planning assistance from the Historic Preservation Partners for Earthquake Response made possible a sensitive rehabilitation. New structural steel and restoration of the historic stucco and decorative tile work and a repaired tile roof reinstated this earthquake damaged building as a major element of the historic district. Photo: Courtesy Historic Preservation Partners for Earthquake Response, MZA Architects.

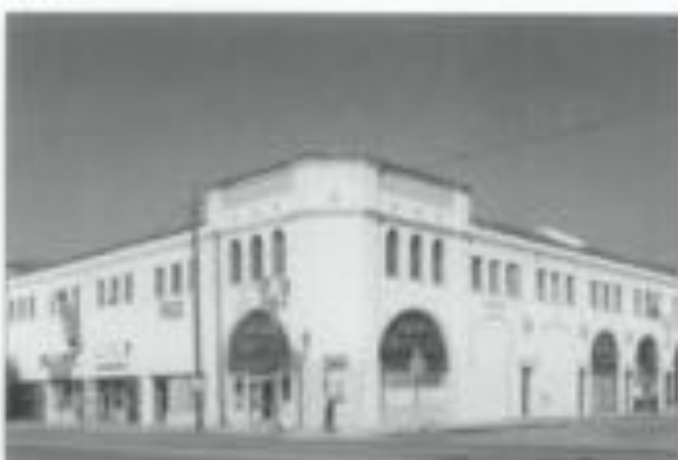
The Historic Preservation Partners for Earthquake Response was formed after the Northridge Earthquake of 1994 and was comprised of members of the National Park Service, the National Trust for Historic Preservation, The Getty Institute, The California Office of Historic Preservation, the California Preservation Foundation, and the Los Angeles Conservancy. After the earthquake, this organization provided technical assistance and grant funding to various historic buildings. Funding of 10 million dollars from the
